Prevention of EGT Overlimit Events

A number of engine Exhaust Gas Temperature (EGT) overlimit events at takeoff were reported to Airbus, including dual events leading to a significant increase in flight crew workload at low altitude.

This article recalls the importance of monitoring the EGT margin of each engine to detect any degradation in engine performance early, and provides recommendations to Maintenance, Flight Operations, and flight crews to prevent EGT overlimit events. It also reminds us of what to do in the case of an EGT overlimit indication at takeoff.

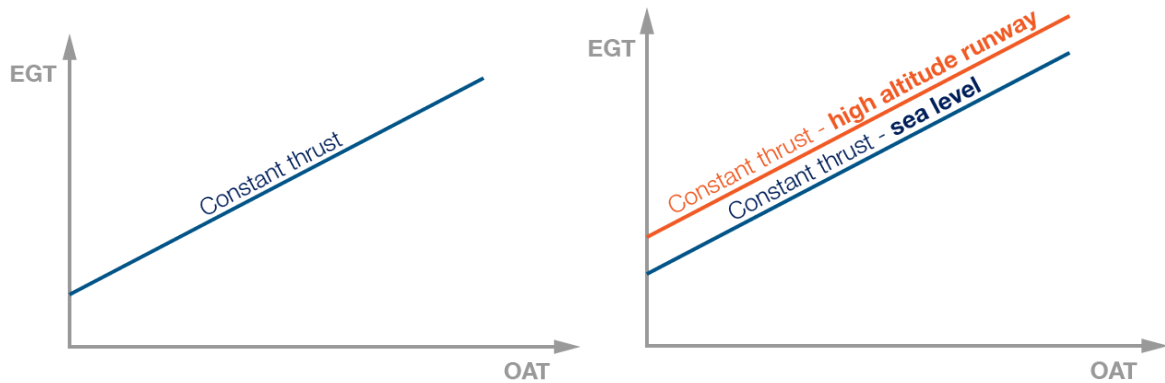
(**fig.1**) and (**fig.2**) Effect of OAT and altitude on the EGT for a constant thrust

- **Environmental parameters** such as Outside Air Temperature (OAT) (**fig.1**) and altitude (**fig.2**). For example, every increase of 1°C in OAT can lead to an EGT increase of approximately 3°C to produce the same thrust at takeoff, depending on the engine type.

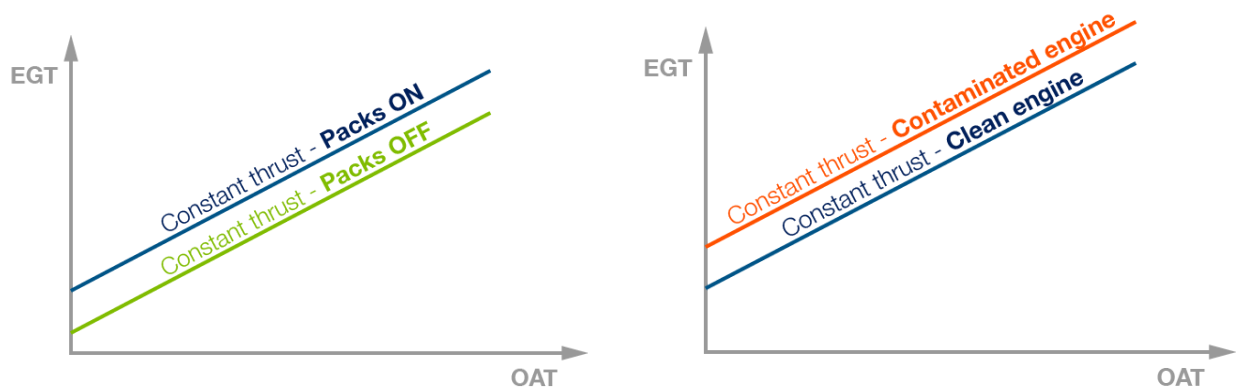
(**fig.3**) and (**fig.4**) Effect of bleed demand (packs) and engine contamination on the EGT for a constant thrust

- **Bleed demand:** Use of air conditioning packs and anti-ice increases the bleed demand on the engine and will result in a higher EGT to produce the same thrust (**fig.3**).
- **Engine contamination** (e.g. dust, pollution) can disturb the airflow through the engine, which affects the overall performance of the engine and results in higher EGT values (**fig.4**).

Performing regular engine washes will remove particles from the compressor such as dirt, oil, sand, and salt that reduce the engine efficiency. The engine wash procedure is available in the AMM/MP. Operators can request additional or specific recommendations directly from the engine manufacturer.

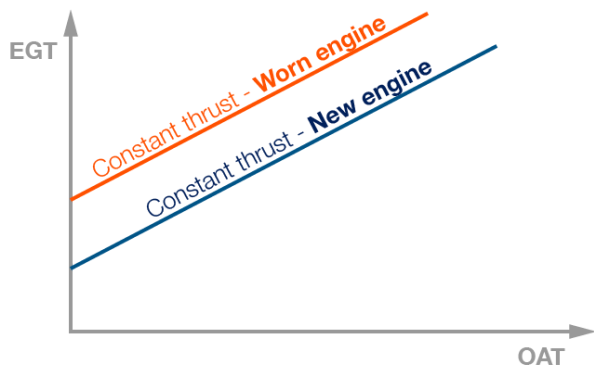
(fig.5) Effect of engine wear on the EGT

The performance of any engine progressively degrades with time due to inevitable wear of its components. This is generally due to eroded or damaged compressor foils, worn seals, and the increased clearance between rotor/stator blade tips and the stator/rotor in the compressor and turbine sections due to erosion.

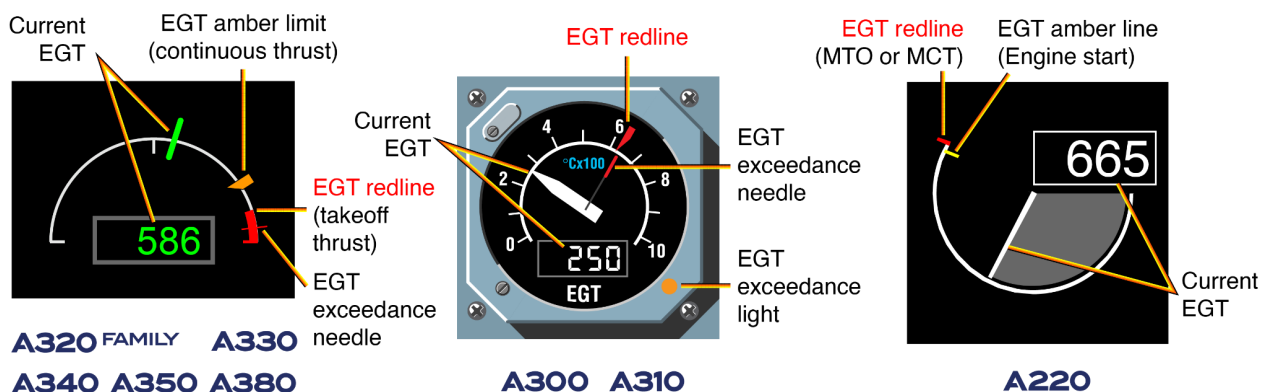
(fig.6) EGT indication

The EGT redline appears as a red line on the EGT indicator of A300/A310 aircraft and on the engine display of A220 aircraft. On A320 family, A330, A340, A350, and A380 aircraft, the EGT redline is the start of the red zone of the EGT arc on the engine display (fig.6). An EGT amber limit indicates the EGT limit for maximum continuous thrust or engine start provided in the FCOM on A320 family, A330, A340, A350, and A380 aircraft. This amber limit indication is hidden when takeoff power is applied. On A220 aircraft, an amber line indicates the EGT limit during engine start.

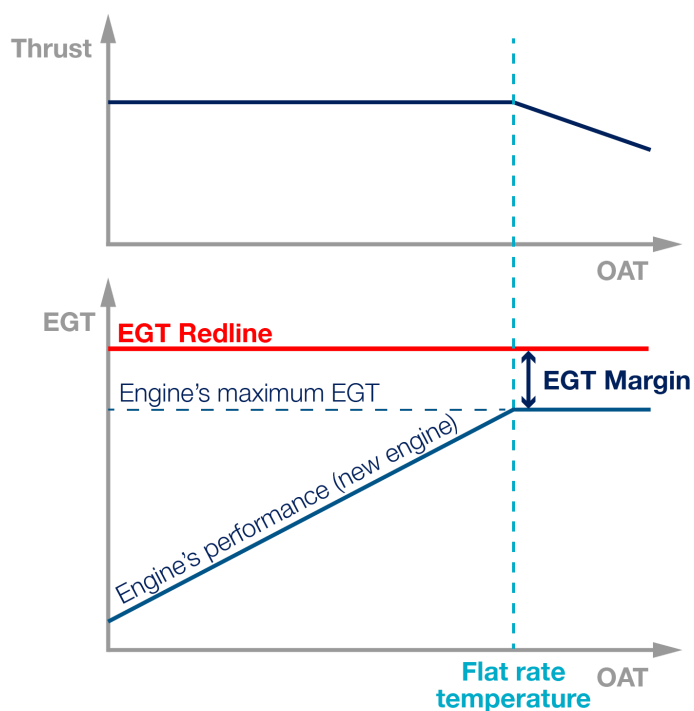
(fig.7) EGT margin

Engine manufacturers define the guaranteed maximum thrust of an engine based on its maximum limits (e.g. EGT, N1, N2) and up to a defined OAT. This OAT is called the **flat rate temperature**. It is also commonly called corner point temperature, breakpoint temperature, or kink point temperature. Above this OAT value, the engine control (FADEC) automatically manages the thrust to maintain a constant EGT. The maximum thrust and **flat rate temperature** are selected so that a new or overhauled engine has a sufficient EGT margin to the **EGT redline** (**fig.7**). This will enable the engine to sustain a certain amount of engine wear and still be capable of producing its maximum thrust rating without reaching the **EGT redline**. An OAT of 30°C at sea level (ISA +15°C) is usually defined at max take-off by engine manufacturers as a compromise for **flat rate temperature** because it enables maximum thrust in a wide range of conditions.

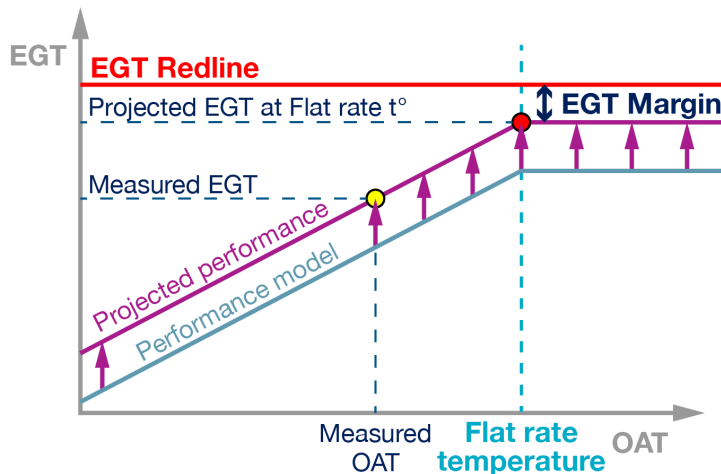
(fig.8) Computation principle of the current EGT margin of an engine (altitude and mach corrections are not represented)

Each time a takeoff is performed with TOGA thrust, the ECM tool takes a snapshot of the engine parameters and of the external conditions (e.g. OAT, pressure). The tool then uses this measurement to calculate a delta vs the engine performance model and project it to the worst condition to determine the projected EGT of the engine (**fig.8**). The difference between this projected EGT and the **EGT redline** value is the current EGT margin of the engine.

The ECM also estimates the EGT margin when a FLEX or derated takeoff is performed, however, the computation is less accurate than when TOGA thrust is used. The need to perform a regular takeoff with TOGA thrust is therefore necessary to ensure efficient EGT monitoring. This is particularly important when the engine is near the EGT redline.
