The Airbus Safety magazine

Inappropriate V/S Target during Autoflight Mode Reversion

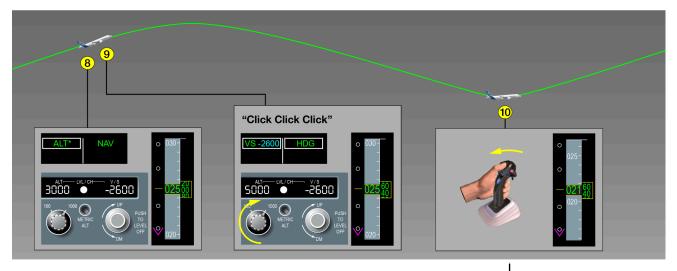
(fig.3) Event description (3 of 3)

When the flight crew increased the selected altitude from 3 000 ft to 5 000 ft on the FCU in step 9, the ALT mode was engaged. This triggered a reversion to the was mode as per flight guidance logic. Since the V/S value was modified shortly before the go-around, it was still in the memory and displayed on the FCU. This led the W/S mode to use this previously selected value instead of the current aircraft V/S. We will describe this inappropriate behavior later in this article.

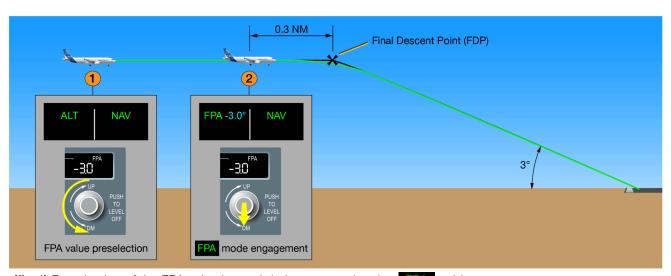
The duration of the V/S or FPA preselected value stored in the memory was increased from 10 s (on A300, A300-600, A310 aircraft) to 45 s for the A320 family, A330, A340, A350, and A380 aircraft. It enables the flight crew to 1 preselect an FPA value earlier while the aircraft flies toward the Final Descent Point (FDP) during an approach using FPA guidance, in order to 2 anticipate the engagement of the FPA mode when the aircraft reaches the FDP.

(fig.4) Preselection of the FPA value is used during approach using FPA guidance

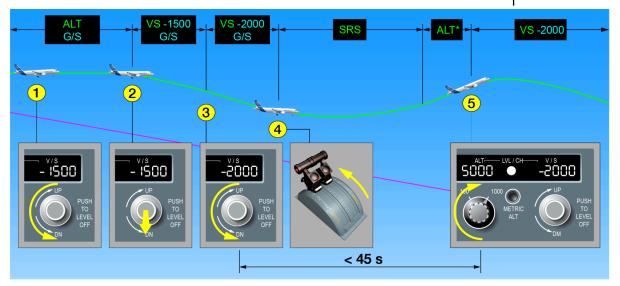
The most common scenario where the flight crew may face this issue is a go-around during or after a glide slope intercept from above, as in the example described earlier in this article. 1 A V/S value is preselected, 2 V/S mode is engaged and 3 the V/S may be adjusted. 4 A go-around is then performed. 5 If the mode reversion happens within the 45 s after the V/S value preselection or last V/S modification, the inappropriate behavior will occur.

Only A300-600, A310, and A320 family aircraft are concerned. On A330, A340, A350, and A380 aircraft, the V/S or FPA preselected value is reset as soon as the V/S or FPA is engaged.

(fig.5) Scenario 1: Go-around during glide slope intercept from above (A300-600 A310, and A320 family aircraft only)

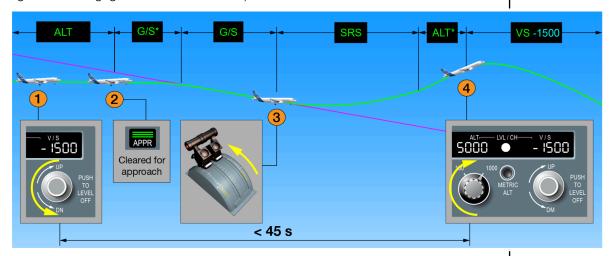
In this case, 1 a negative V/S value is preselected in anticipation of a glide slope intercept from above due to possible late ATC clearance. 2 When cleared for approach, the flight crew presses the APPR pushbutton and 6/S* mode engages, followed by 6/S mode. 3 A go-around is performed. 4 If a mode reversion happens less than 45 s after the V/S preselection, the preselected negative V/S value is used.

All aircraft are concerned by this scenario, except A220 aircraft and A350 aircraft that are equipped with PRIM 14.1. (because the V/S or FPA selected value is reset at go-around engagement with PRIM 14.1).

(fig.6) Scenario 2: Go around after glideslope interception with a preselected V/S (without engagement of the V/S mode)

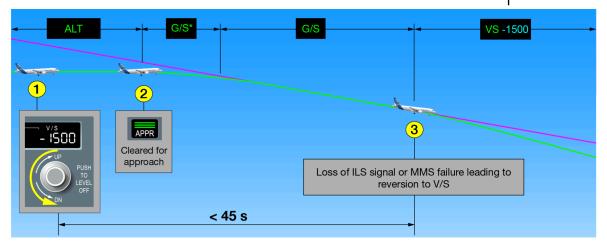
In this scenario, 1 a V/S or FPA value was preselected, as it was for scenario 2, and 2 Approach mode is engaged when cleared by ATC. A mode reversion happens during the next 45 s after the preselection due to a loss of approach mode for reasons such as:

- G/S or F-G/S, APP DES or FINAL APP mode disengagement (e.g. loss of ILS signal, MMR failure, loss of flight plan, etc.)
- LOC or F-LOC or NAV mode disengagement
- The flight crew selects a target altitude higher than the actual aircraft altitude on FCU in DES or OP DES mode.

In this case, the effect on the trajectory is generally limited due to an already descending trajectory. It may be more difficult for the flight crew to detect the behavior.

(fig.7) Scenario 3: Mode reversion due to the loss of an approach mode
