# A320 Family / A330 Prevention and Handling of Dual Bleed Loss

# Safety First

**Safety First**, #13 January 2012. Safety First is published by Airbus S.A.S. - 1, rond point Maurice Bellonte - 31707 Blagnac Cedex/France. Editor: Yannick Malinge, Chief Product Safety Officer, Nils Fayaud, Director Product Safety Information. Concept Design by Airbus Multi Media Support Ref. 20111714. Computer Graphic by Quat'coul, Fixion. Copyright: GS 420.0043/11. Photos copyright Airbus. Photos by ExM Company: P. Masclet. Printed in France by Airbus Print Centre.

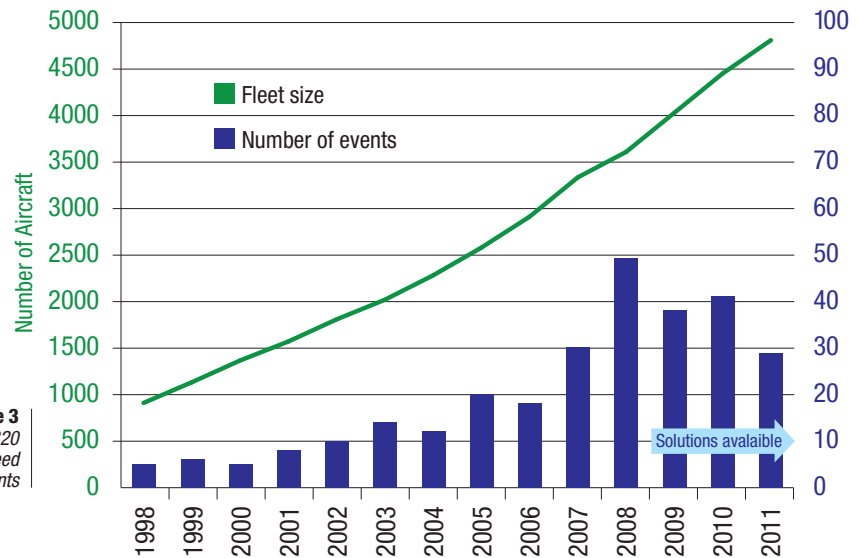
Figure 3  
Evolution of A320 Family Dual Bleed Loss events

Today, this DBL package equips more than 70% of the A320 Family fleet (either from production or by retrofit) and no reported Dual Bleed Loss has been due to the failure of these new components (fig. 3). A specific retrofit policy has been offered to support a prompt in-service implementation. The few DBL events reported on this upgraded fleet were due to installation issues, such as senseline leakage between TCT and FAV or TCT filter clogging (ref. B).

In 2008, Airbus introduced new maintenance procedures and designed a “Dual Bleed Loss package” (ref. A). This package includes a new Temperature Control Thermostat (TCT), a new Fan Air Valve (FAV) and a new Temperature Limitation Thermostat (TLT).

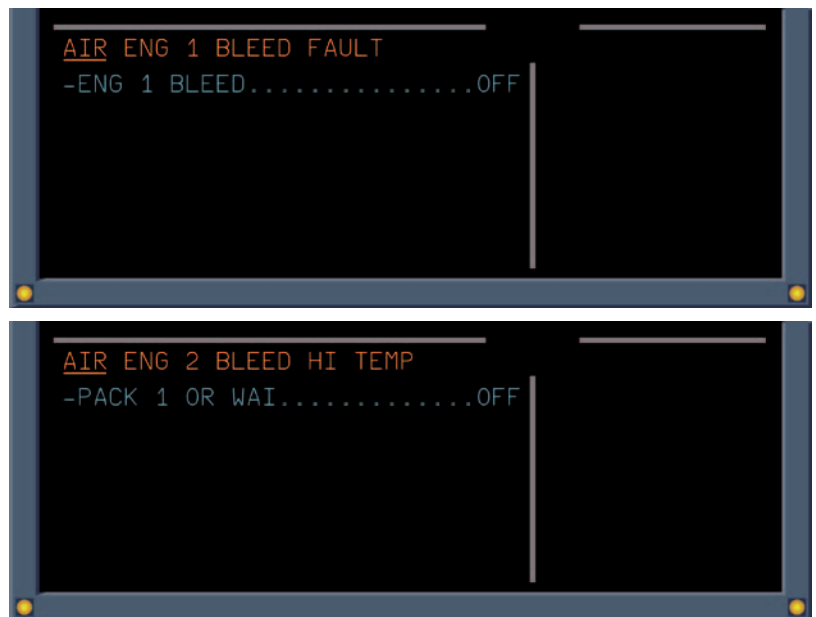
Figure 4  
ECAM AIR ENG 1(2) BLEED HI TEMP caution

The Flight Warning Computer (FWC) F6 standard, planned for certification beginning 2012, will include a new ECAM AIR ENG 1(2) BLEED HI TEMP caution that triggers when one engine bleed is OFF and the temperature of the remaining engine bleed exceeds 240°C. The associated ECAM procedure calls for one pack or the wing anti-ice to be switched OFF (fig. 4). Embodiment of the FWC F6 standard will cancel the OEB 40.

The Operational Engineering Bulletin (OEB) 40 (former OEB 203/1 issued in March 2010) was introduced to provide recommendations to monitor the temperature on the remaining engine bleed in order to prevent overheat from occurring. If the temperature increases above 240°C, the flight crew has to reduce the demand on this bleed by switching OFF one pack or the wing anti-ice system.

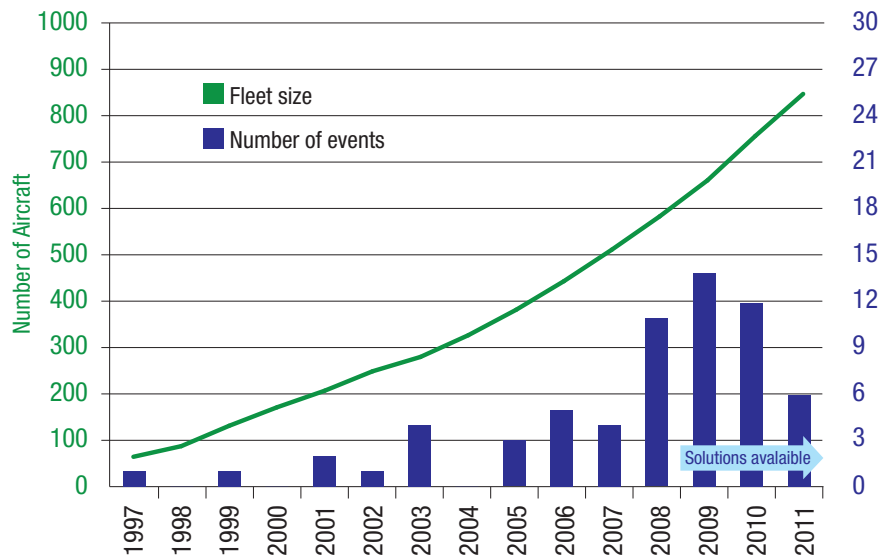
**Figure 5**  
Evolution of A330  
Dual Bleed Loss events.

The overtemperature occurrences are mainly driven by the ageing of the:

- Thermostat Controller (ThC) and/or
- Fan Air Valve (FAV)

The following technical solutions (ref. E) have significantly reduced the number of bleed losses due to overtemperature (fig. 5):

A key parameter to maintain an optimum serviceability of the component is to adjust the interval for ThC filters cleaning or replacement, depending on the severity of the operating environment. Implementation of this preventive maintenance procedure and customization of the interval are available from MPD and via specific SIL (ref. B).

The ThC has also been redesigned with a new clapper/guide material in order to further improve its reliability. This improvement is covered by a Part Number change and is fitted in production starting at MSN 1274. For the in-service fleet, the Liebherr VSB 398-36-05 released in Nov 2011 applies.

New functional test procedures have been developed to allow an earlier detection of the drift as well as an easier detection of faulty components. Specific health monitoring of the FAV is also recommended at the same interval as the ThC filters cleaning.

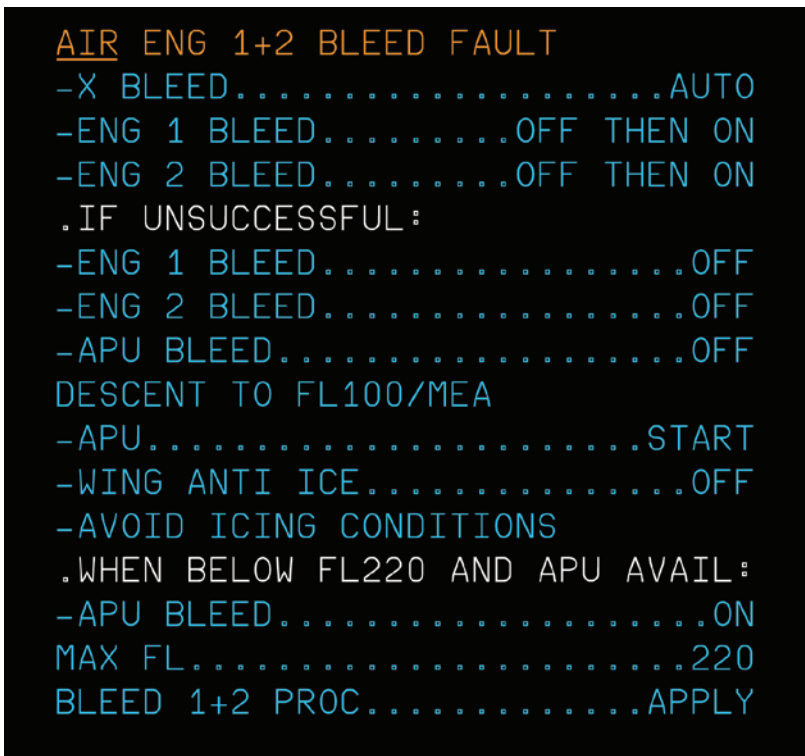
**Figure 6**  
*Typical new ECAM  
AIR ENG 1+2 BLEED  
FAULT caution and  
procedure*

A new ECAM AIR ENG 1+2 BLEED FAULT caution and procedure was designed (fig. 6).

In essence the new procedure calls for:

#### ► A single reset of each engine bleed (provided there is no bleed leak\*)

#### ► If the reset is unsuccessful, rapid initiation of the descent, when above FL100

- A320 Family: on the Flight Warning Computer (FWC) F8 standard, certification Q4 2015
- A330: on the FWC T5 standard, certification planned Q4 2012.
