A320 In-flight thrust reverser deployment

By: Thierry Thoreau
Director of Flight Safety

Despite all protective measures in place, the event described hereafter occurred in March 2004 on an A320 aircraft equipped with IAE V2500-A1 engines.

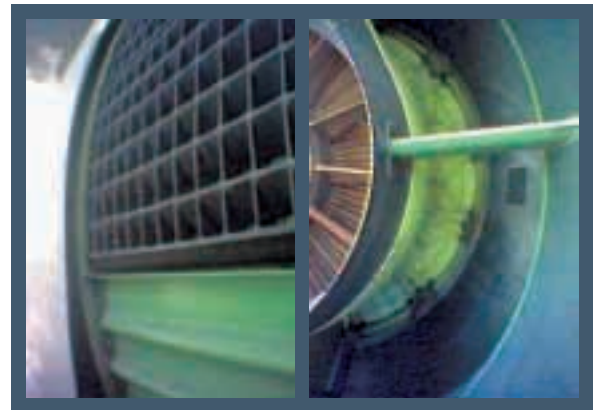
■ *Figure 1*

- Upon landing, the engine N° 1 reverser was found almost fully deployed.

- The thrust reverser sleeve locking pins (2) were not found, while the lock-out assembly was intact.
- After opening the fan cowls, both locking actuators were found lock wired in the unlock position. The HCU was properly deactivated.

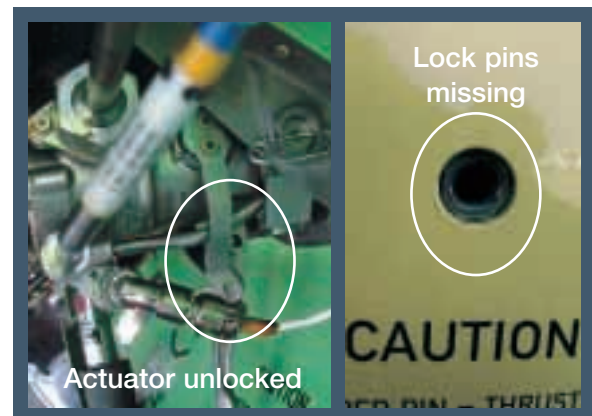
- The HCU deactivation was done properly following the AMM procedure:
 - “A. Deactivation of the Thrust Reverser HCU” procedure.
- The following AMM procedure steps were not performed , because it was not possible to do so while the thrust reverser actuators were lock wired in the unlocked position:
 - “B. Manually move the translating sleeves to the fully retracted position”
 - “C. Lock the Left and the Right Translating sleeves”
- Finally the last AMM procedure step was not done.
 - “D. Put the locking actuators in the locked position”

Due to the combination of having:

- The HCU deactivated (leading to no hydraulic power to the actuators)
- And the actuators not locked
- And the lock-out bolts not properly installed on the translating sleeves,

the translating sleeves were not locked and were free to move under aerodynamic loads.

It is absolutely necessary to strictly follow all steps of the relevant AMM Thrust reverser de-activation procedure.

Furthermore, only the required tooling must be used (appropriate locking pins,...)

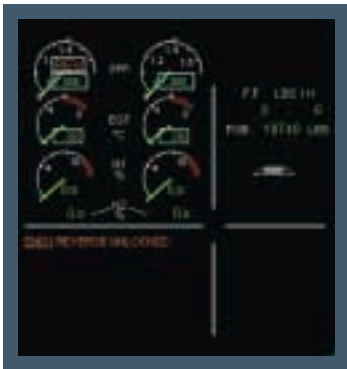
Figure 2

Prior to engine start, the ECAM warning “ENGX REVERSE UNLOCKED” was annunciated.

According to information received, maintenance personnel cancelled the “ENGX REVERSE UNLOCKED” message through the “EMER/CAN” button.

In addition, the “EMER/CANC” button should only be utilized to kill a permanent spurious warning.

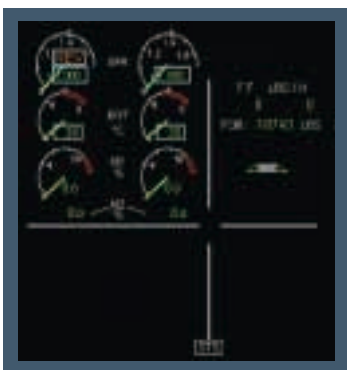
Figure 3

Upon engine start, the “ENGX REVERSE UNLOCKED” warning was then displayed under cancelled cautions, while the ECAM showed “REV” Amber in EPR gauge and “STS” indication.

However, the aircraft was dispatched with the thrust reverser unlocked and free to move under aerodynamic forces.

The “**ENGX REVERSE UNLOCKED**” and the “**REV**” Amber messages should not be present on ECAM following a proper thrust reverser deactivation. **They are both NO DISPATCH warnings.**
