# A320 landing gear downlock

# Safety First

## The Airbus Safety Magazine

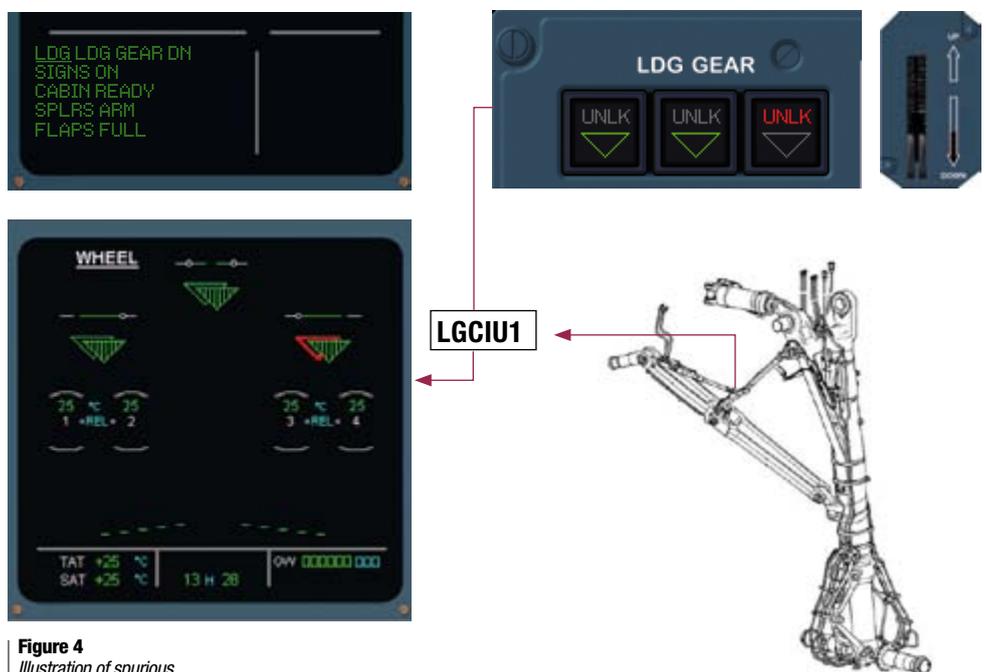
**Figure 4**  
Illustration of spurious landing gear not downlocked indication

The LGCIU1 proximity sensors located on the each landing gear strut provides the lock/unlock signal to the landing gear indication panel. Failure of one of these sensors could generate a spurious main landing gear not downlocked (“UNLCK”) red light and a single red triangle on the SD WHEEL page (fig 4).

**On gear selection, one green triangle on the ECAM SD WHEEL page and the green “LDG LDG GEAR DN” memo on the E/WD is sufficient to confirm the landing gear is down and locked.**

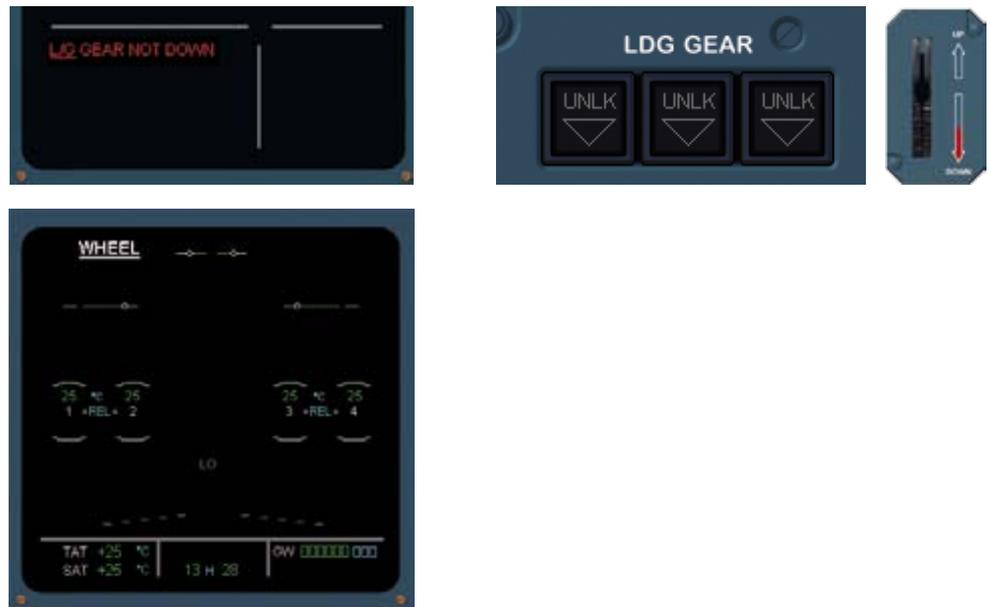
**Figure 5**  
Illustration of “L/G GEAR NOT DOWN” ECAM warning display – landing gear lever not selected but aircraft in landing configuration passing 750ft RA

The “L/G GEAR NOT DOWN” ECAM warning is triggered passing 750 ft RA in approach to warn the flight crew that the landing gear is not set to DOWN while the aircraft is in the landing configuration. This alert must not be confused with the “L/G GEAR NOT DOWNLOCKED” ECAM warning that indicates that the landing gear is detected as not downlocked by both LGCIUs (fig 5).

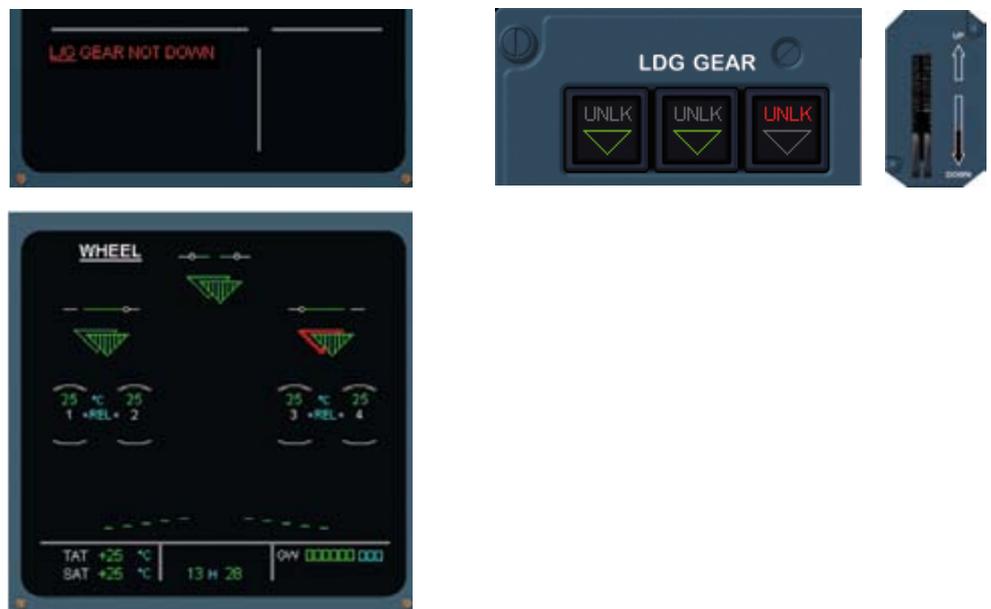
**Figure 6**  
Illustration of spurious “L/G GEAR NOT DOWN” indication

However, on the A320 Family, this warning could also be triggered when the landing gear is detected as not downlocked by one LGCIU. In this case, check that at least one green triangle is displayed on each landing gear strut on the ECAM WHEEL page. This confirms that the landing gear is downlocked. Rely also on the “LDG LDG GEAR DN” green LDG memo message to confirm that the landing gear is downlocked (fig 6).

As previously discussed , on A320 Family aircraft the “L/G GEAR NOT DOWN” warning may also appear at 750ft RA when the landing gear is confirmed down by only one LGCIU. Under these conditions the new Flight Warning Computer development FWC (F6) will inhibit the spurious “L/G GEAR NOT DOWN” message.

**As per SOP, following gear selection down, the PNF has to check for three landing gear indications on the ECAM WHEEL page: at least one green triangle on each landing gear strut is sufficient to indicate that the landing gear is downlocked. In addition, the E/W D “LDG LDG GEAR DN” green memo on the ECAM (before landing checklist) also confirms the landing gear is down and locked.**

**Caution :**  
Do not apply this procedure if at least one green triangle is displayed on each landing gear strut on the ECAM SD WHEEL page. This is sufficient to confirm that the landing gear is downlocked. Disregard any possible L/G GEAR NOT DOWN ECAM warning at 750 feet RA.
