Christopher MCGREGOR

Director, Flight Safety

A320 landing gear downlock

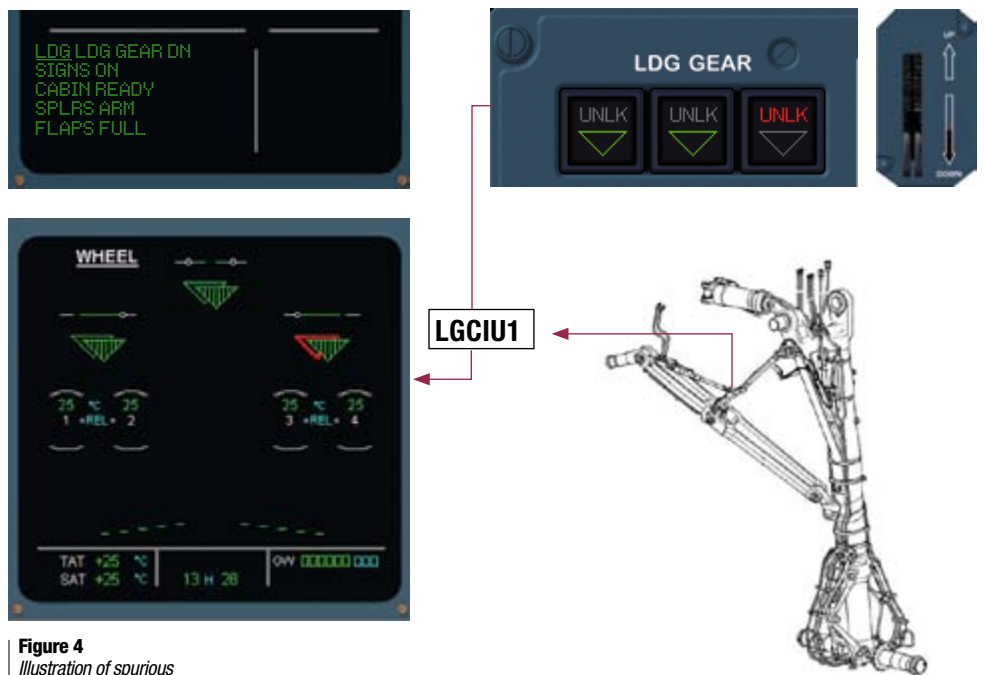
The LGCIU1 proximity sensors located on the each landing gear strut provides the lock/unlock signal to the landing gear indication panel. Failure of one of these sensors could generate a spurious main landing gear not downlocked (“UNLK”) red light and a single red triangle on the SD WHEEL page (fig 4).

Figure 4
Illustration of spurious landing gear not downlocked indication

On gear selection, one green triangle on the ECAM SD WHEEL page and the green “LDG LDG GEAR DN” memo on the E/W D is sufficient to confirm the landing gear is down and locked.

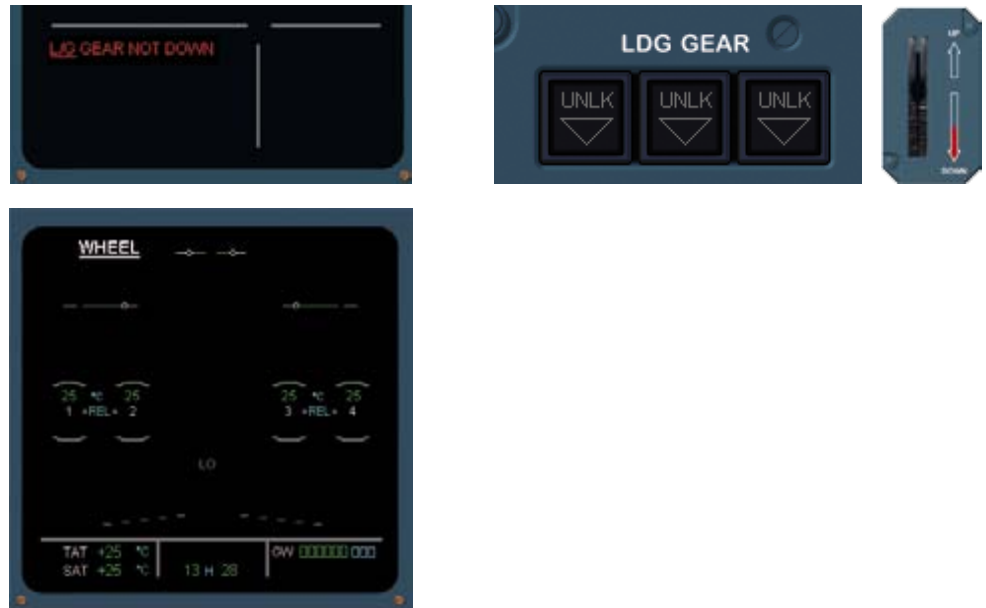
The “L/G GEAR NOT DOWN” ECAM warning is triggered passing 750 ft RA in approach to warn the flight crew that the landing gear is not set to DOWN while the aircraft is in the landing configuration. This alert must not be confused with the “L/G GEAR NOT DOWNLOCKED” ECAM warning that indicates that the landing gear is detected as not downlocked by both LGCIUs (fig 5).

Figure 5
Illustration of “L/G GEAR NOT DOWN” ECAM warning display – landing gear lever not selected but aircraft in landing configuration passing 750ft RA

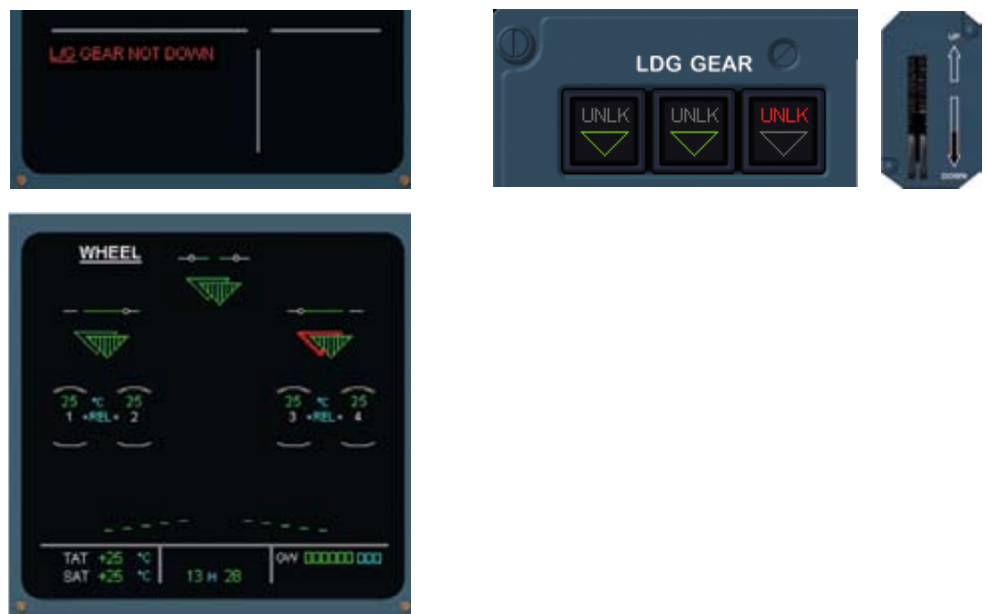
However, on the A320 Family, this warning could also be triggered when the landing gear is detected as not downlocked by one LGCIU. In this case, check that at least one green triangle is displayed on each landing gear strut on the ECAM WHEEL page. This confirms that the landing gear is downlocked. Rely also on the “LDG LDG GEAR DN” green LDG memo message to confirm that the landing gear is downlocked (fig 6).

Figure 6
Illustration of spurious “L/G GEAR NOT DOWN” indication

As per SOP, following gear selection down, the PNF has to check for three landing gear indications on the ECAM WHEEL page: at least one green triangle on each landing gear strut is sufficient to indicate that the landing gear is downlocked. In addition, the E/W D “LDG LDG GEAR DN” green memo on the ECAM (before landing checklist) also confirms the landing gear is down and locked.

Caution :
Do not apply this procedure if at least one green triangle is displayed on each landing gear strut on the ECAM SD WHEEL page. This is sufficient to confirm that the landing gear is downlocked. Disregard any possible L/G GEAR NOT DOWN ECAM warning at 750 feet RA.

As previously discussed , on A320 Family aircraft the “L/G GEAR NOT DOWN” warning may also appear at 750ft RA when the landing gear is confirmed down by only one LGCIU. Under these conditions the new Flight Warning Computer development FWC (F6) will inhibit the spurious “L/G GEAR NOT DOWN” message.
