A320/ Possible consequences of VMO/MMO exceedance

By: Michel PALOMEQUE

06 July 2008

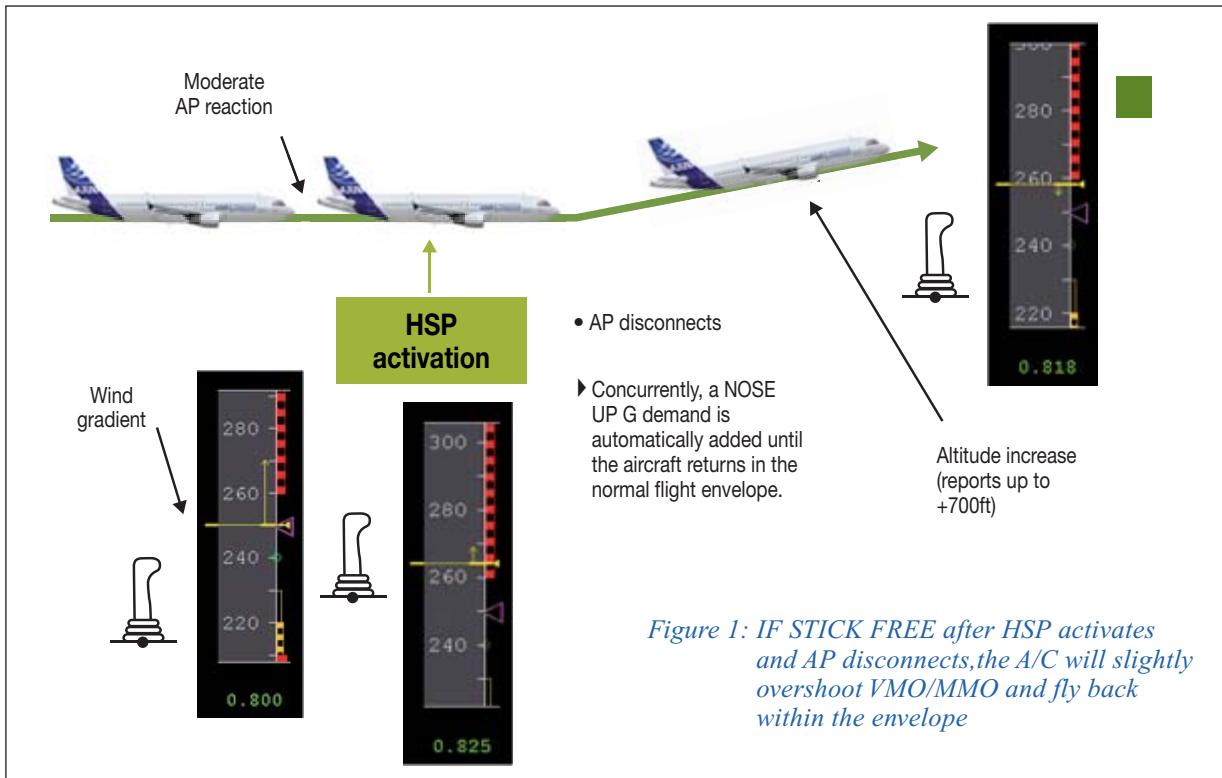
If the side stick is free, HSP activation will automatically add a small positive G demand until the aircraft returns within the flight envelope.

From experience, the altitude excursion is limited to less than 700 ft (fig. 1).

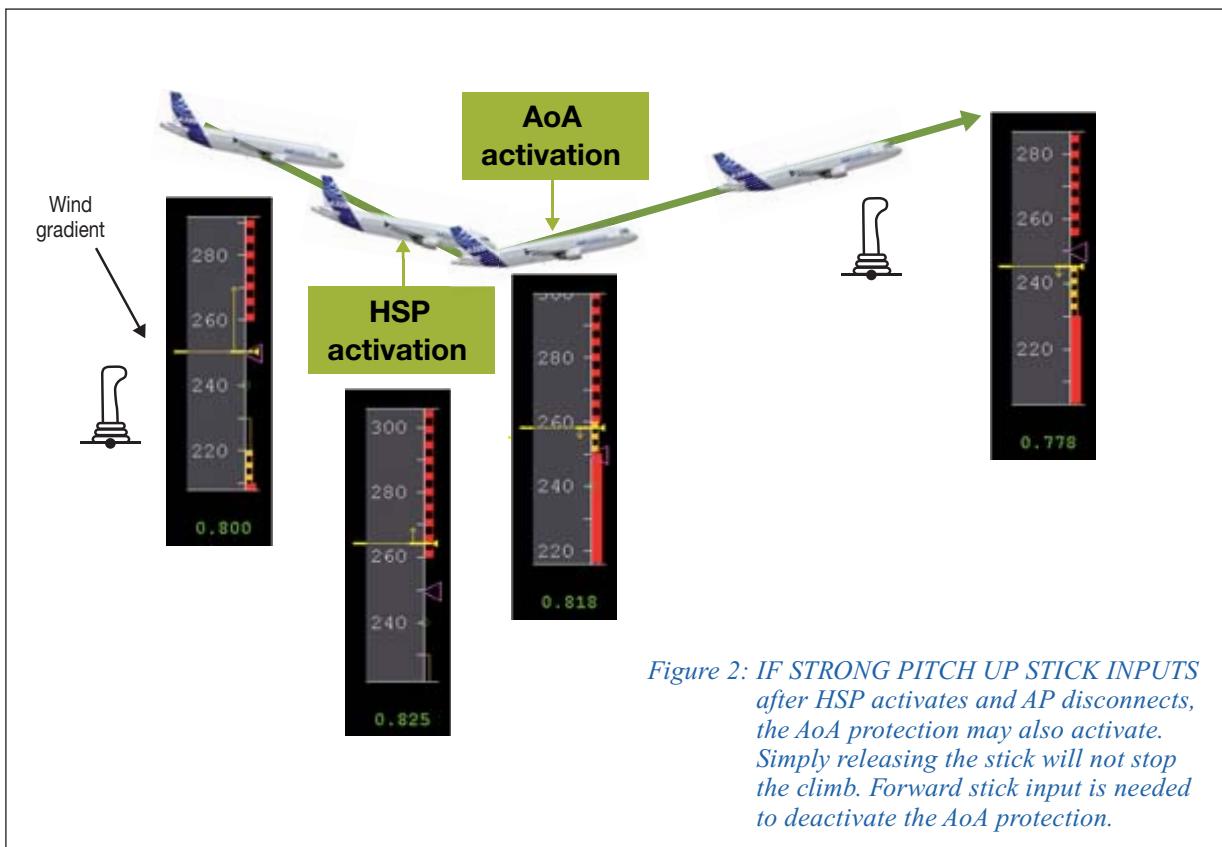
If the pilot reacts to the over speed by pulling too strongly on the side stick (in which case the pilot input will be added to the HSP input), the Angle Of Attack (AOA) protection may be triggered. This means that the aircraft will climb at the highest AOA value for as long as the protection is activated. Since deactivation may only be achieved through nose down side stick input, simply releasing the stick will not stop the climb.

Delayed reaction from pilots in applying forward stick input results in large altitude excursions (fig. 2).

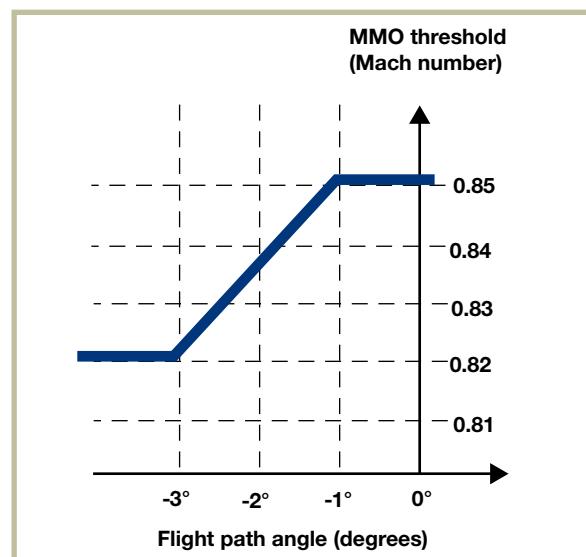
Figure 3: L84/L93 Mach threshold for HSP activation/AP disconnection.

In the L84/L93 standards, the Mach threshold is a function of the Flight Path Angle and is identical for the whole A320 family. The main aim is to have a better protection of the aircraft during cruise (fig. 3).

L83/L91 standards	L84/L93 standards
A319/ A320	M. 83
A318/ A321 ¹	M.83 (3 second filter) M.86 (no filter)
