# A330-300

## Trimmable Horizontal Stabilizer Damage

**By: Marc BAILLION**  
*Flight Safety Manager*

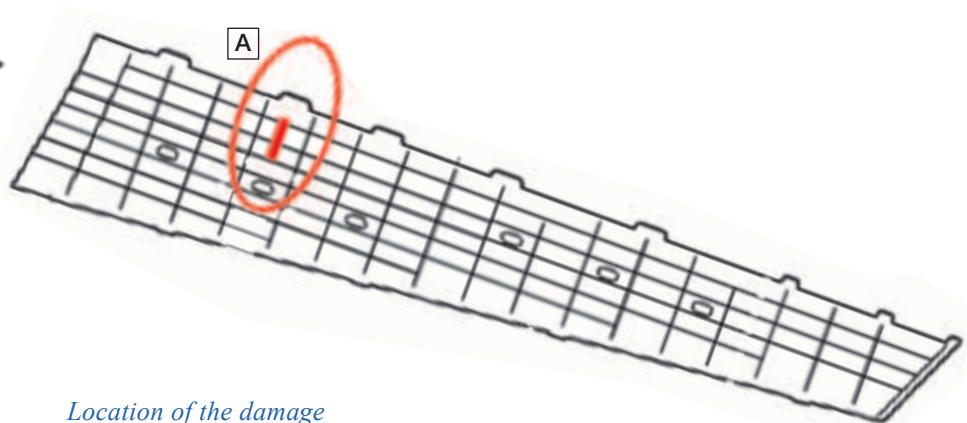
The external cut was measured to be about 330mm length by 3mm width, in line of flight, located at the THS bottom skin panel, just behind second THS inboard handhole access panel.

*Location of the damage*

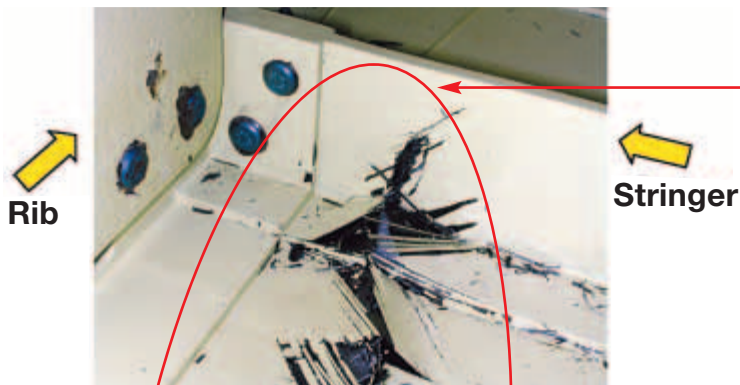
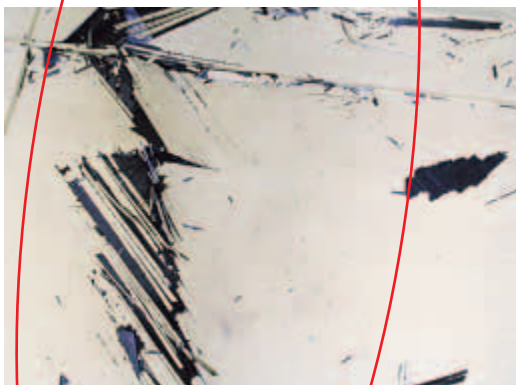
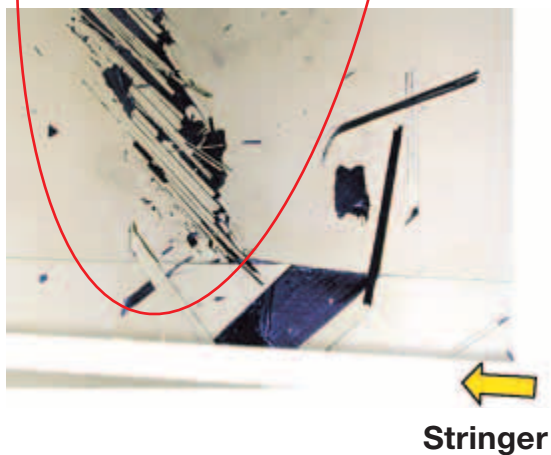
*Resulting internal delamination*

As per the inspection, the monolithic CFRP panel was found cracked throughout the cut length, with large delaminations in the surrounding area.

Two stringers located on the THS bottom skin panel had been severely damaged.

Internal views of the THS are shown opposite.

The aircraft required immediate appropriate repair, as the temporary repair did not restore the required structural integrity of the THS.

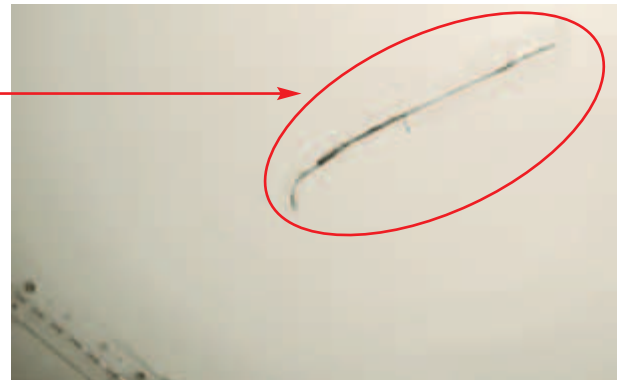
On 21<sup>st</sup> of August 2004 upon landing, the subject airplane was found with a torn lower skin of the right hand THS Lateral Box. This damage was thought to be due to a Foreign Object Damage (FOD) and resulted in a leaking Trim Tank.

*External view of the damage*

Based on external visual findings, the operator performed a temporary repair, by filling the damage

with adhesive (EA934) and covered with two layers of Glass Fiber Reinforced Polymer (GFRP) plies. Trim tanks were emptied and a/c was flown back under MEL.
