# A340 Thrust Reverser Unlocked

**By: Vincent SWIDERSKI**  
*A340 Propulsion System Engineer CFM56-5C*  
**Per-Oliver GUENZEL**  
*A330/A340 Flight Safety Coordinator*

**Safety First**  
# 03 December 2006

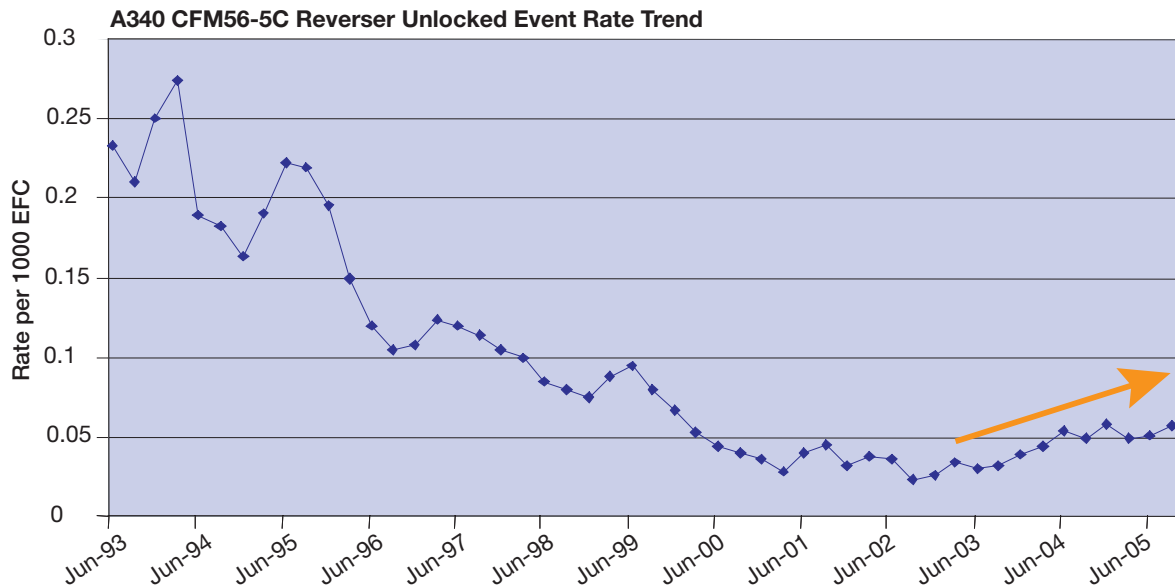
Fig 1: Trend of the “Rev Unlock” event rate since Entry Into Service

However, this rate has been rising again in the last 2 years, as highlighted on Figure 1.

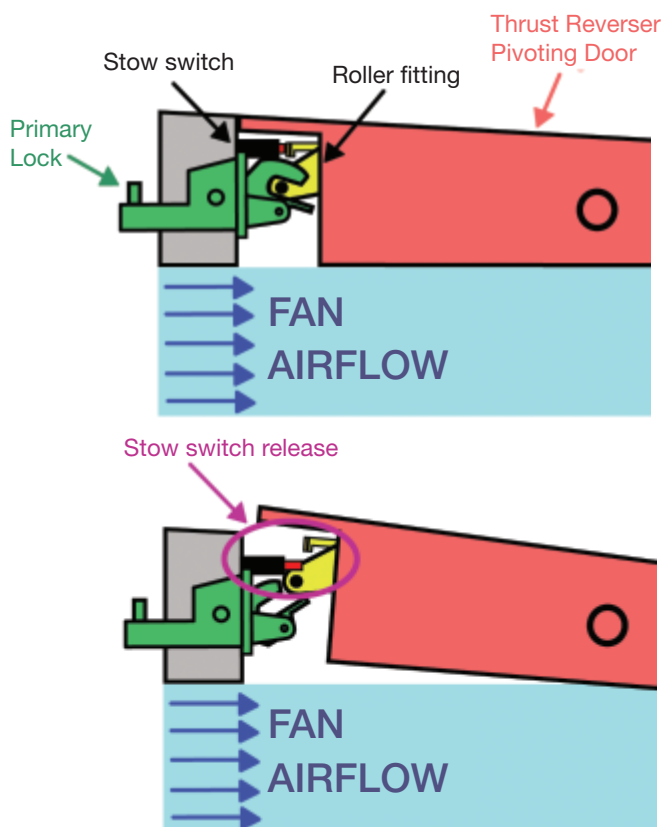
When the locking system is not pressurized, the secondary lock is engaged, ready to retain the actuator in its almost full-retracted position. If the primary lock fails, the door will extend slightly above the flush position before the secondary lock engages. In that case, the stow switch sensor is released (Fig 3), which leads to the generation of an “**ENG X REV UNLOCKED**” warning on the ECAM.

Fig 3: Release of the stow switch with Primary lock open

The continuous feedback from the operators allowed identifying that the primary lock rotating cam can fail to hook the roller-fitting due to:

- An insufficient actuator stroke;
- An incorrect rigging of the roller fitting;
- A primary lock contamination, which can prevent the rotating cam from moving freely;
- An undesirable hydraulic pressure spike in the actuation system, which can prevent the primary lock from hooking completely.

This is why troubleshooting has to be done in accordance with Ref. D or E in order to find the root cause and to apply the appropriate corrective action.

To ensure a fleet-wide application, the BPM has been included in a Service Bulletin (Ref C) that is referenced as a scheduled maintenance task at each ‘C’ in the MPD (ref. H).

In addition to those practices, a final solution will introduce a set of improvements to the locking system by addressing the above root causes. See also ref. G for further information.
