Avoiding Dual Bleed Loss

Safety First

Safety First
07 February 2009

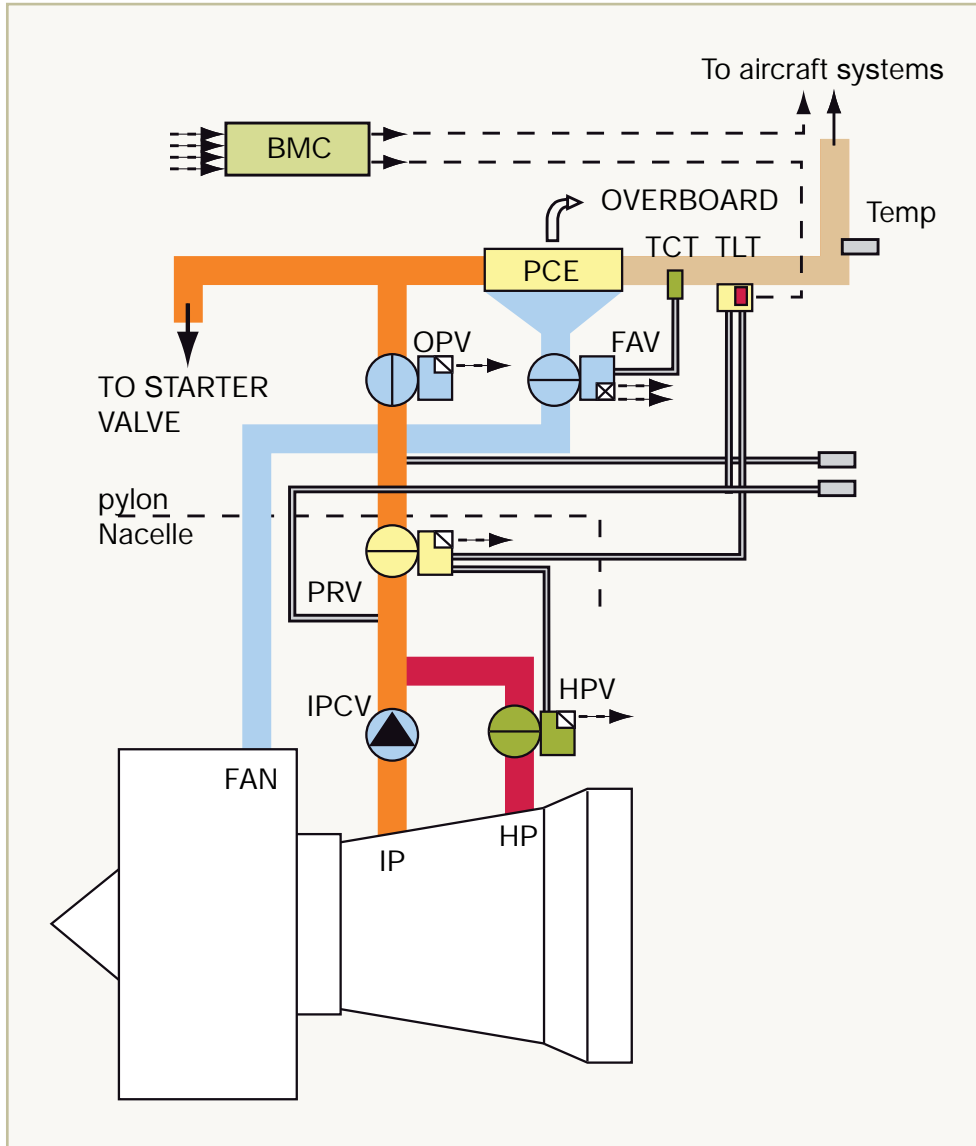
Figure 2: Main components description

The dual bleed loss events usually happen when one bleed fails, resulting in the remaining bleed on the other engine to compensate for it.

The augmented flow of warm air from the engine core leads to a corresponding increase in the flow of cold air from the Fan to the Precooler.

In case of one engine bleed loss, the remaining bleed fails when the Fan Air Valve (FAV) does not let enough cold air reach the Precooler (PCE).

This causes the temperature downstream of the PCE to reach the 260°C (500°F) over-temperature threshold, which induces the automatic closure of the bleed system.

- Leakage of the TCT to FAV sense line
- TCT drift / failure
- Or FAV leakage / failure.

- Design
 - The TCT has been modified to react faster to excessive temperatures, thereby ordering the FAV to increase the cold air supply earlier than before (ref D)
 - In order to address the leakage issue, the FAV has been modified to include a seal between the actuator and actuator cover (ref E)
 - The pressure limitation function has been shifted. Even though the TLT function is not a root cause of bleed failure, it is considered to be an aggravating factor for an already degraded system (ref F)
 - New tooling is being developed to allow bleed air system health checks and to improve trouble shooting efficiency. These tools are expected to be available by the end of 2009.
