# Braking system cross connections

**By: Thierry THOREAU**  
*Director, Flight Safety*

Safety First  
# 07 February 2009

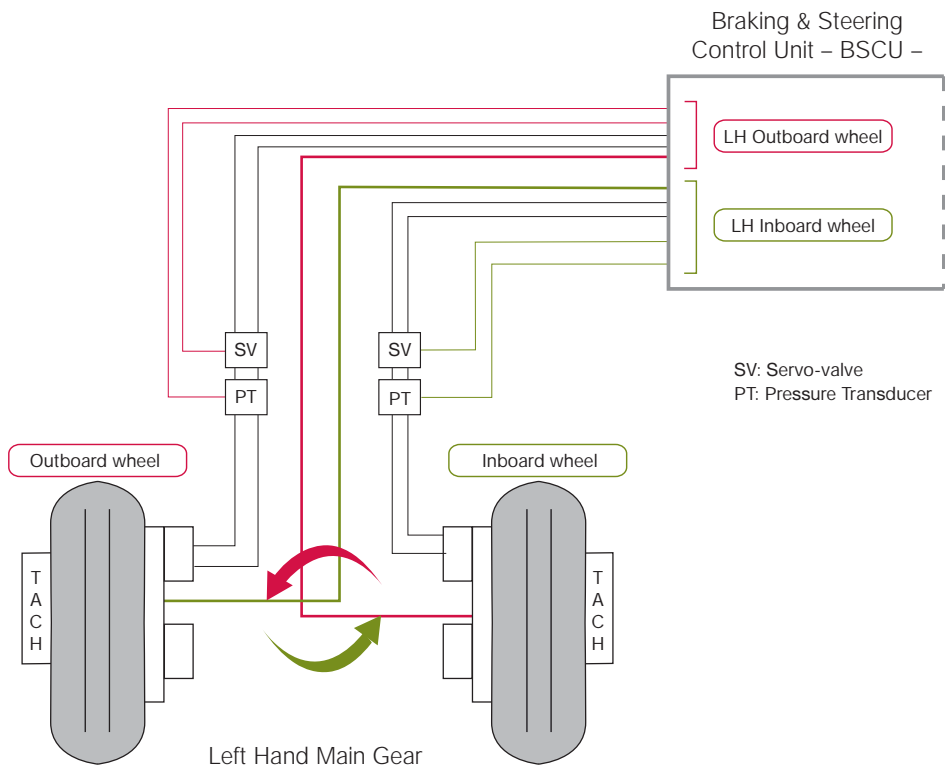
Figure 1: Schematic of tachometer cross connections

- A few cases of Main Landing Gear — MLG — tachometer cross connections have been reported. These cross connections were done at the level of the wheels axis, as shown on figure 1.

The Aircraft Maintenance Manual – *AMM – task 32-42-00-720-002* is specifically designed to detect cross connections.

AMM indicates in a specific note that: *“You must do this test if there is a risk of wiring cross connections between two tachometers (replacement of the MLG or of the electrical harness of the MLG)”.*

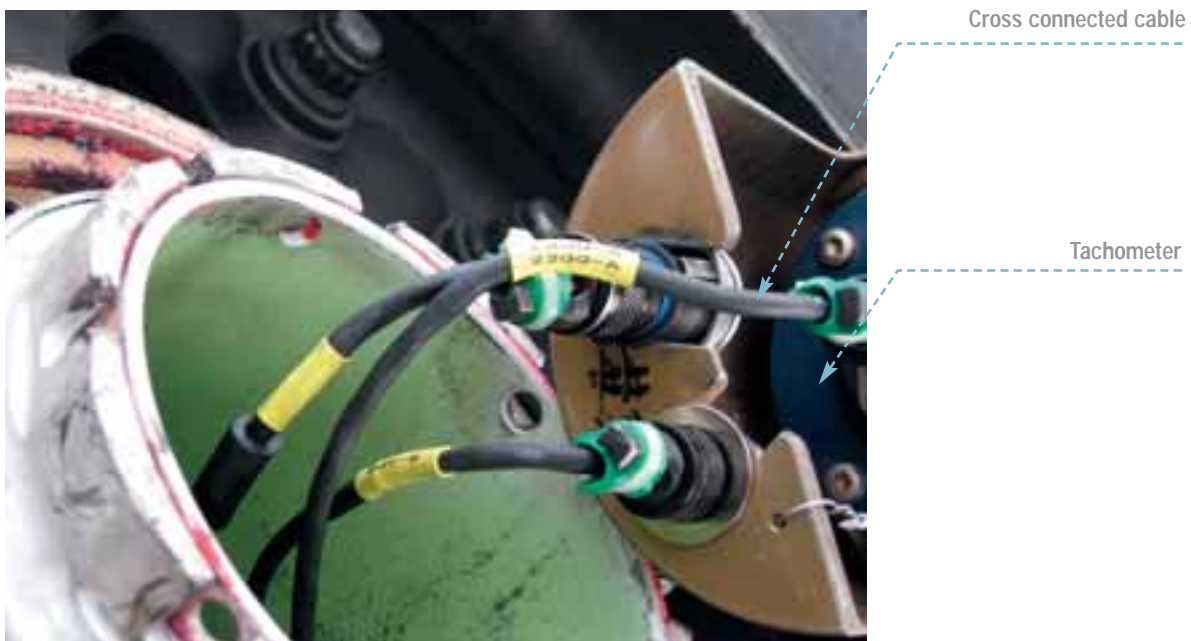
Figure 2: Picture of tachometer cross connections

Figure 2 shows an actual cross connection on the right hand side main gear. The cable labelled 19GG-A/22GG-A connected to the tachometer (the blue cylindrical equipment

which can be partially seen on the right hand side of the picture), should in fact have been the cable 20GG-A/21GG-A.

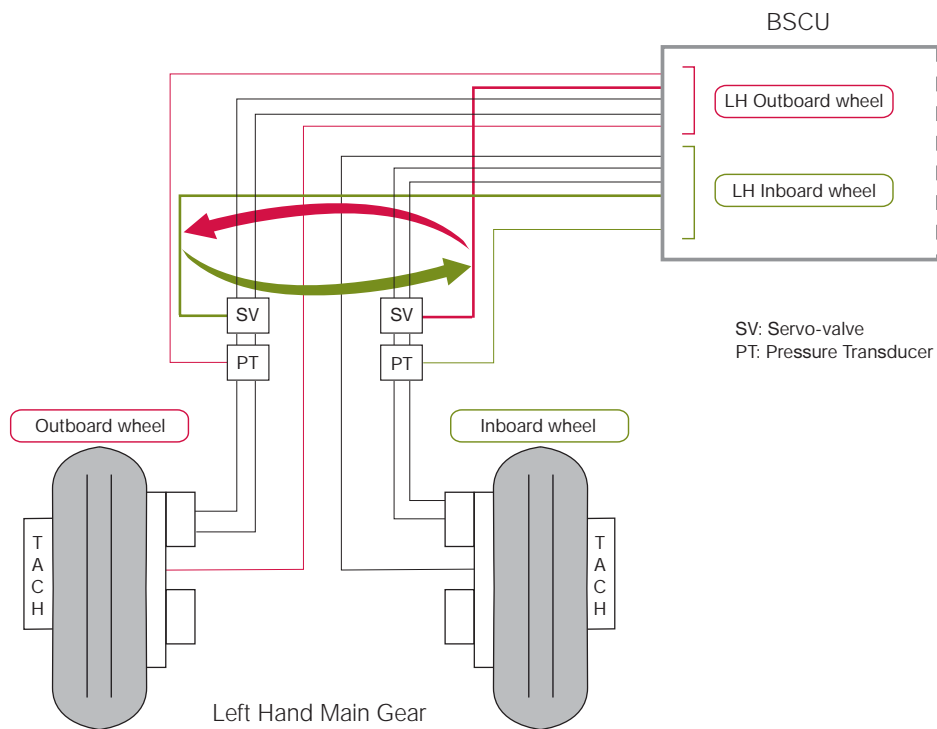
*Figure 3: Schematic of servo-valve cross connections*

It involves the connections to the servo-valves, as shown on figure 3.

The lower number of cases that have been reported can be explained by the fact that the flanges supporting the servo-valve cables have different lengths. This type of cross connections are thus more difficult to realize.

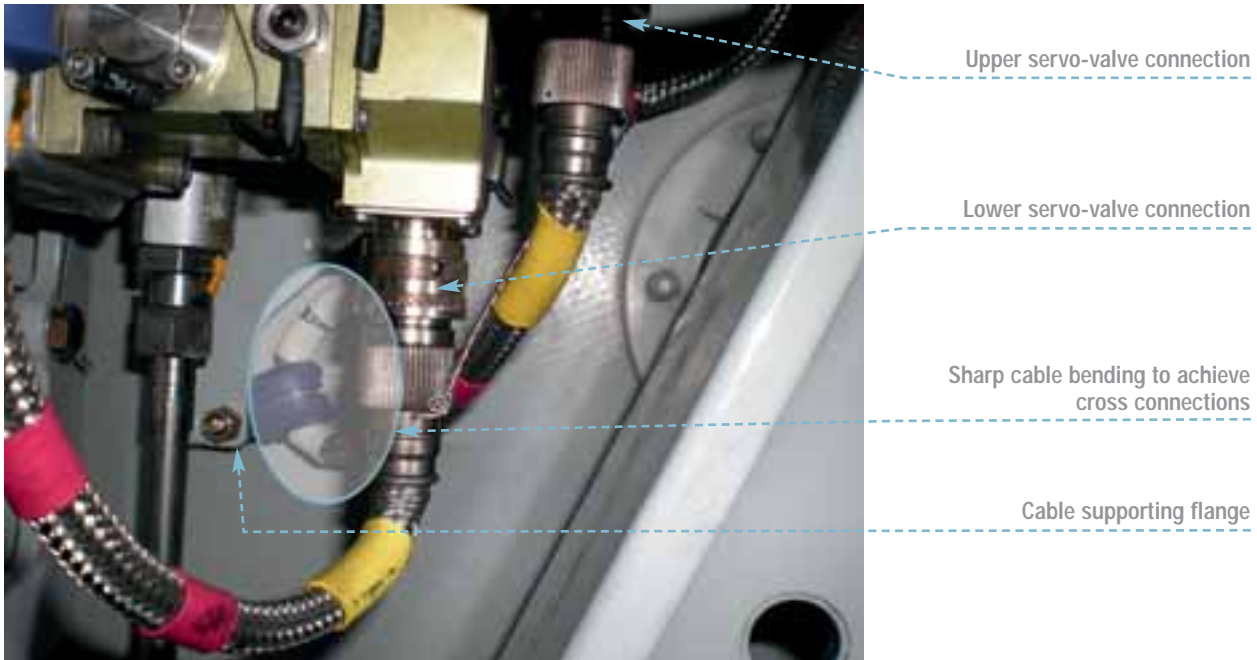
Figure 4: Picture of servo-valve cross connections

Figure 4 shows an example of servo-valve cross connections.

It shows that the flange supporting the cable to the lower servo-valve allows an easy connection only on the lower servo-valve.

In this case, the flange forced the cable wrongly connected to the upper servo-valve to make an excessively sharp bend.

This task is now also required further to the installation of servo-valves.
