Facing the Reality of Everyday Maintenance Operations

This article will cover the subject of tooling issues related to engine removal and installation procedures. However, the points raised here are illustrative as well of other maintenance operations.

The Airbus Safety Magazine

Safety First, #13 January 2012. Safety First is published by Airbus S.A.S. - 1, rond point Maurice Bellonte - 31707 Blagnac Cedex/France. Editor: Yannick Malinge, Chief Product Safety Officer, Nils Fayaud, Director Product Safety Information. Concept Design by Airbus Multi Media Support Ref. 20111714. Computer Graphic by Quat'coul, Fixion. Copyright: GS 420.0043/11. Photos copyright Airbus. Photos by ExM Company: P. Masclet. Printed in France by Airbus Print Centre.

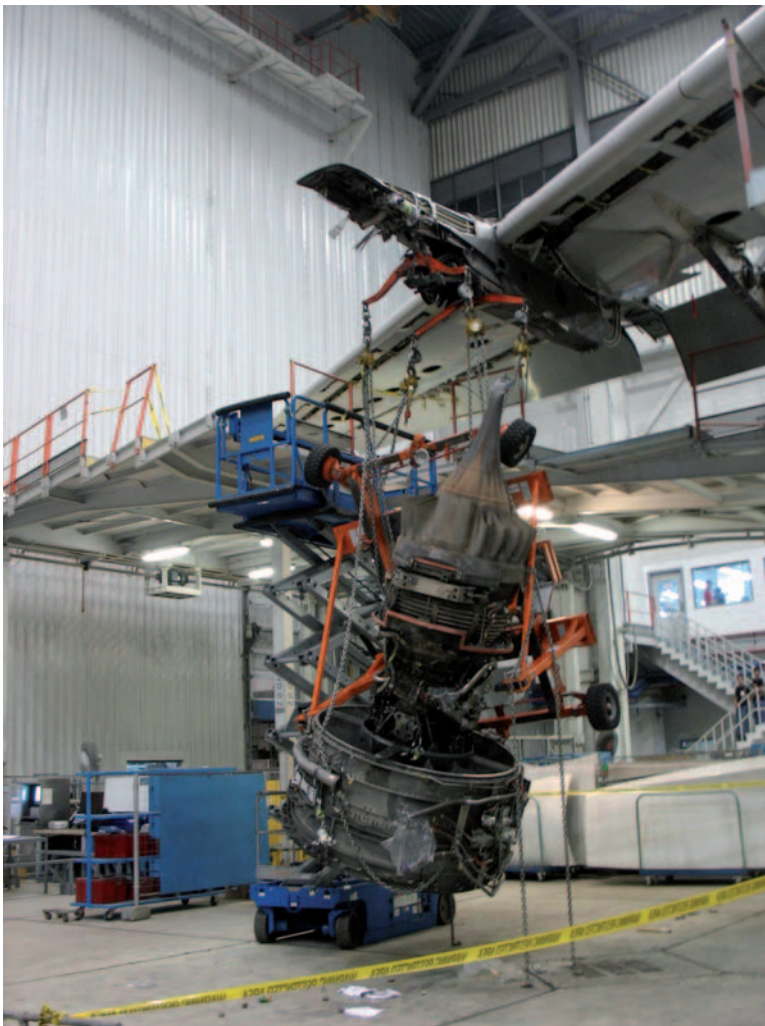
- ▶ On the first occurrence, one of the bootstraps failed, causing an engine to drop by a distance of three feet (**fig. 1**).
- ▶ On the second event, an engine fell to the ground during its removal. The forward left chain pulley disengaged while the maintenance team was performing Aircraft Maintenance Manual (AMM) subtask 71-00-00-020-053-A (**fig. 2**).

The reported problems in the use of the engine tools (the bootstrap), are not related to any one particular Airbus type. The majority of these incidents are the consequence of one, or a combination of the following reasons:

- ▶ Use of tools not listed in the AMM, and not approved by Airbus.
- ▶ Not using appropriately maintained tools.
- ▶ A too high pre-load applied to the tool, which can damage the tool.

Figure 1
Consequence of failed bootstrap

Airbus therefore recommends that Airlines and Maintenance Centers use only the specific tools called for in the Airbus and/or Vendor documentation, and that users ensure that they are built by the approved manufacturer.

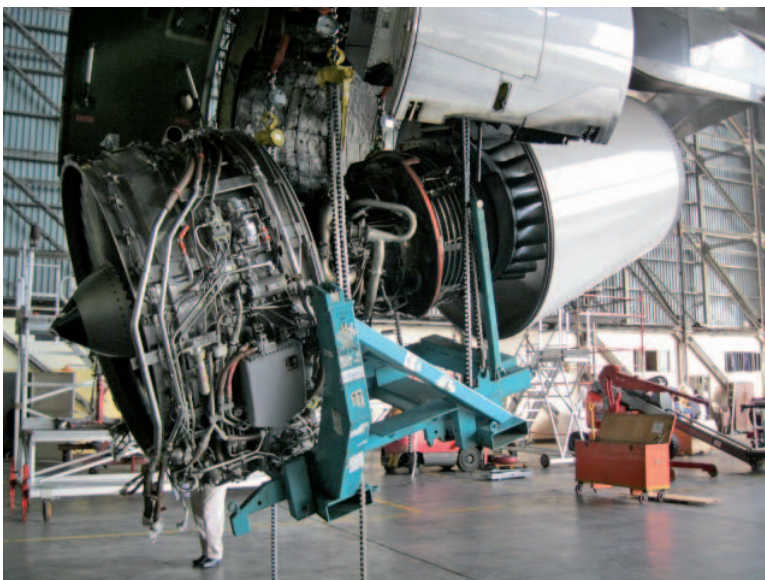
Figure 2
consequence of disengaged chain pulley

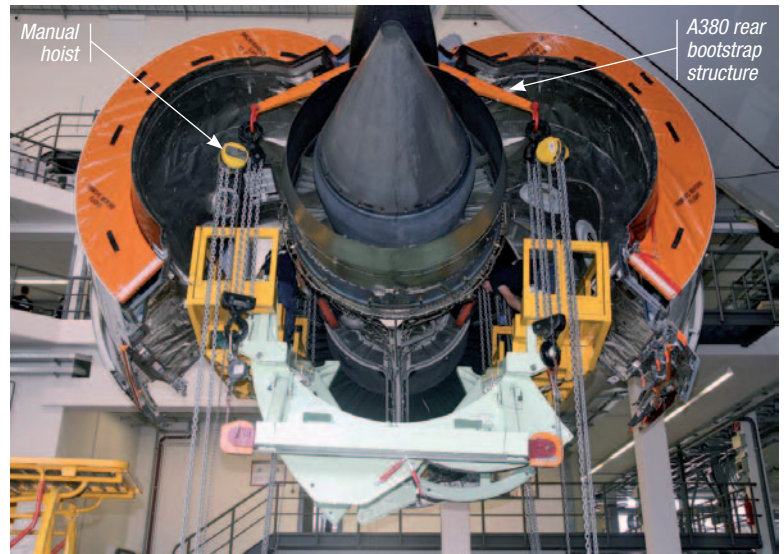
- The bootstrap structure, which is the interface between the pylon and the lifting device. This structure has to be periodically inspected and tested. A visual inspection should be done at each tool use. If any cracks or impacts are identified, the tool should not be further used.

Periodical tests consist of applying a load to the structure (125% of the Working Load Limit for Airbus tooling). Measurements are taken before and after the test, and should provide the same result. If the load test provides different results, the tool is damaged and should be discarded.

Investigations of several cases of engine drops have determined that the hoist maintenance had never been done, and that the braking system was either damaged or showed presence of oil.

Figure 3
A380 bootstrap structure

- ▶ Use only GSE/tools specified in the Airbus and/or Vendor documentation and to ensure that they are built by the approved manufacturer.
- ▶ Adhere to the GSE/tool manufacturers maintenance instructions.
- ▶ Closely follow the procedures described in the Aircraft Maintenance Manual.

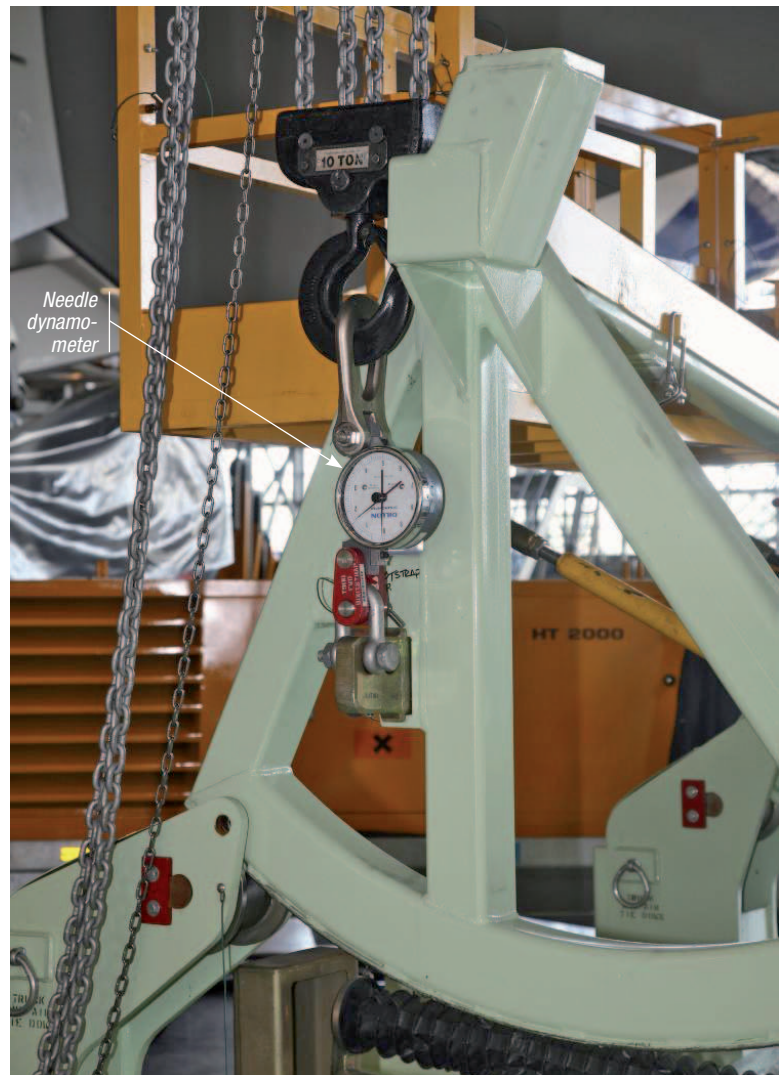
Figure 4
Needle dynamometer

The bootstrap system is equipped with needle dynamometers (fig. 4) indicating the applied loads. The approaching phase is sensitive because the technicians have to continuously monitor the loads applied on the bootstrap system. Several mechanics, working as a unit, are required to perform this operation. They have to ensure proper communication amongst the team in

order to ensure a balanced bootstrap movement and an adequate load monitoring at all times. An overload may cause a life threatening structural failure of the bootstrap.

The AMM provides the references for the standard tool, which in combination with the described procedures ensures a safe operation during engine removal and installation.
