# FCTL check after EFCS reset on ground

**By: Kristjof TRITSCHLER**  
*Flight Safety Manager*  
Germanwings

**Albert URDIROZ**  
*Flight Safety Director*  
Airbus

Safety First  
# 06 July 2008

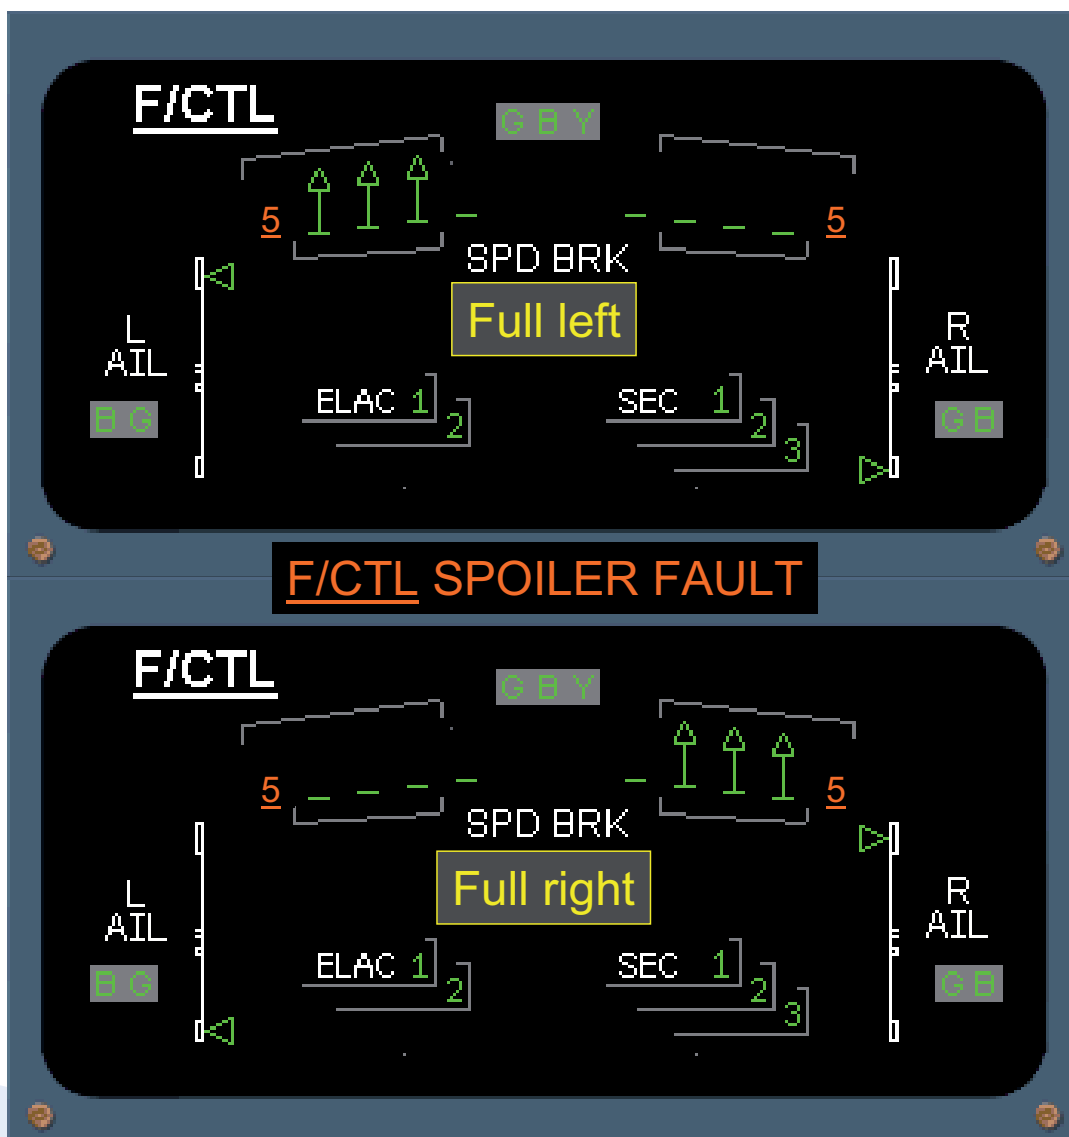
The aircraft was dispatched with a LH spoiler actuator #5 in faulty condition.

When the crew taxied the airplane, the spoiler anomaly was captured during the pre-flight control checks.

The crew performed roll inputs with the sidesticks and the SEC detected the lack of response of LH spoiler 5 by monitoring the difference between the

order given and the position of the spoiler. The EFCS computer SEC2, that controls spoilers 5, disabled the two spoilers 5 as a pair.

**F/CTL SPOILER FAULT** was triggered, and spoiler shown as FAULT RETRACTED (5) on the ECAM F/CTL page.

Figure 1: Spoiler 5 fault during F/CTL check

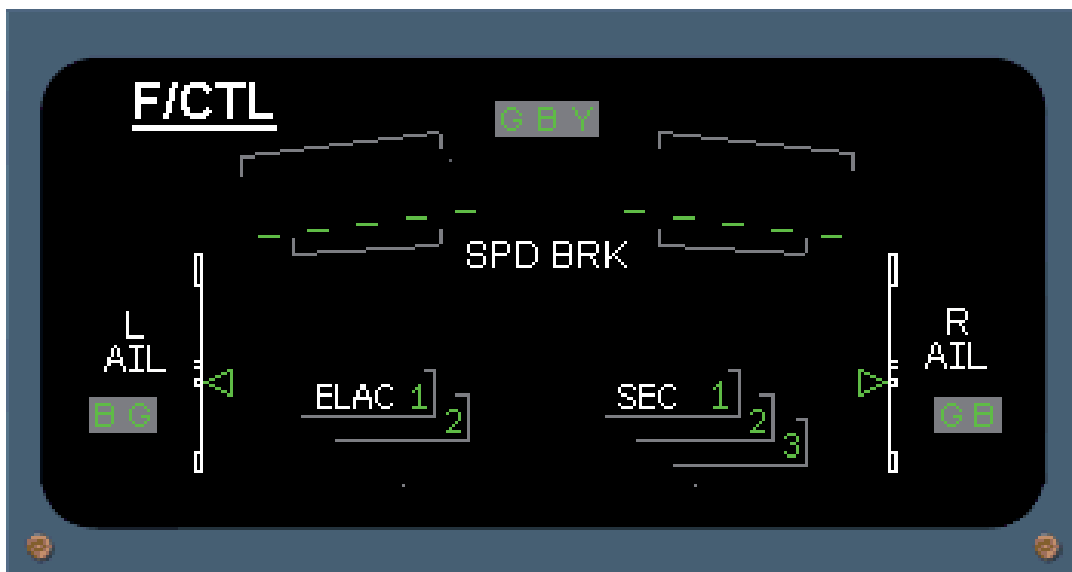
The crew reset the SEC in an attempt to recover control of spoilers 5. As a result, ECAM indications went back to normal,

i.e. F/CTL SPOILER FAULT cleared and spoilers 5 were displayed back to GREEN on the F/CTL page (fig.2).

Figure 2: All GREEN after SEC reset

Through the SEC reset, the monitoring system of the spoilers was reinitialized and this cleared the fault message. The faulty condition, however, remained.

The capture by the monitoring system, based on the difference between given order and position of the flight control, would have required a second flight control check.

As the flight resumed, aerodynamic forces extended the faulty LH spoiler, forcing the flight crew to counteract the LH roll tendency.

Once in level flight, recordings indicate that about 4° of RH rudder trim was necessary to compensate for the uncommanded spoiler extension. The crew was able to fly to its original destination.

In order to stress the need to perform a Flight Control Check **after** the resetting on ground of the EFCS, it was decided to add a note in the “ELAC or SEC malfunction” part of the 3.04.24 Computer Reset Table (P5).

***If a reset of an EFCS or EFCU computer is performed on ground, it must be followed by a flight control check***
