Fuel pumps left in OFF position

By: Frédéric COMBES
Director, Flight Safety

Safety First
07 February 2009

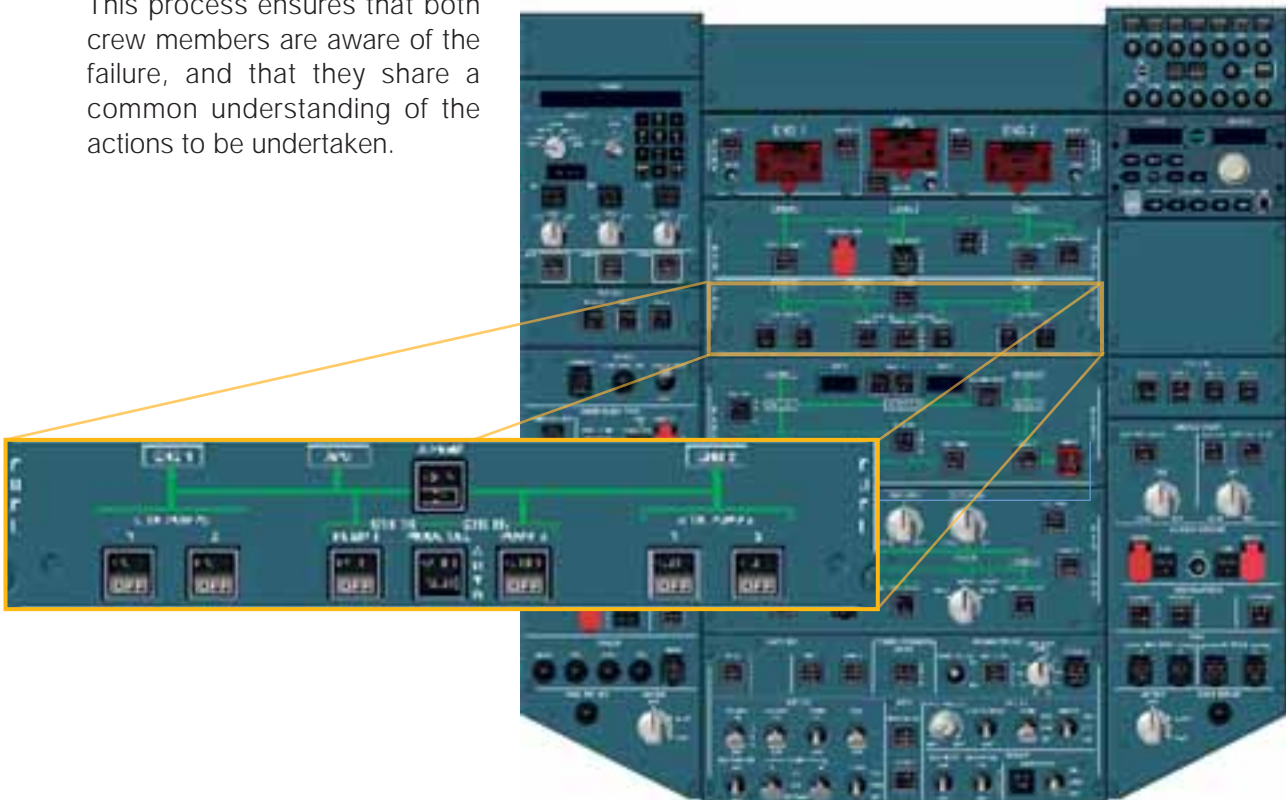
At the beginning of the Cockpit Preparation checklist for the Overhead Panel, the SOPs request the crew to extinguish all white lights (pushbutton switches) on the overhead panel, as applicable during the scan sequence. This ensures that both the center tank and wing tank pushbutton switches are selected to the ON position prior to flight, except for the center tank if OEB 178 applies.

With the center tank and wing tank fuel pumps I in the OFF position, this is how the overhead panel would look like; notice the six illuminated white pushbutton lights:

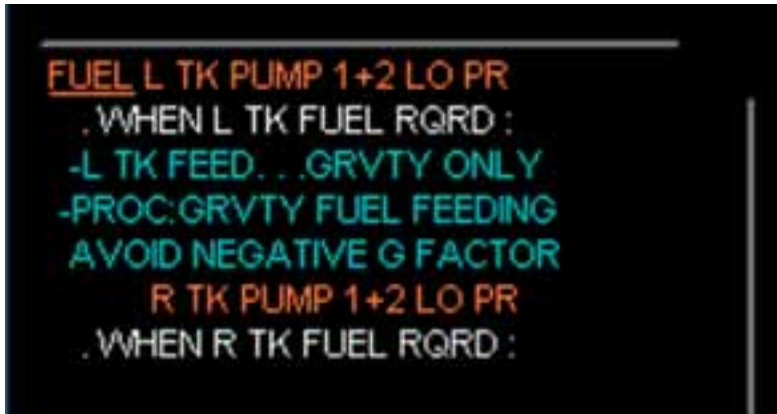
(ECAM upper display – E/WD – Warning part)

- Second barrier:
30 seconds after the first engine start (flight phase 2), if the wing tank fuel pumps are still

in the OFF position, the dedicated ECAM Caution will trigger, and the FUEL page will be displayed:

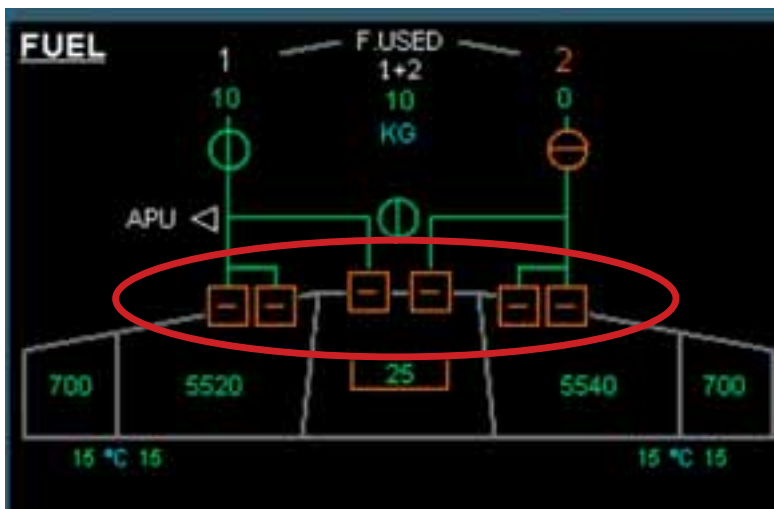
(ECAM lower display SD)

Symbol

means:
PUMPS OFF

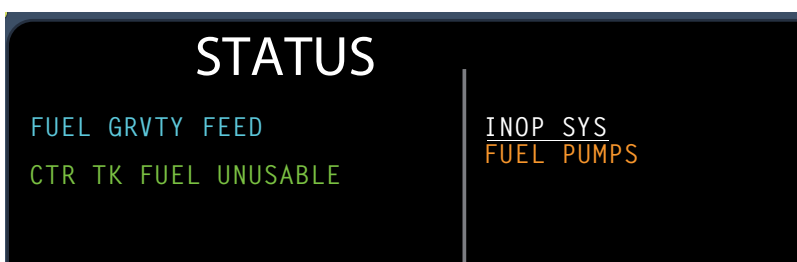
- Third barrier:
Clearance of an ECAM Caution leads to the display of the STATUS page:
