Go-Arounds at Addis Ababa due VOR Reception Problems

By: Jean Daney

Director of Flight Safety

Safety First

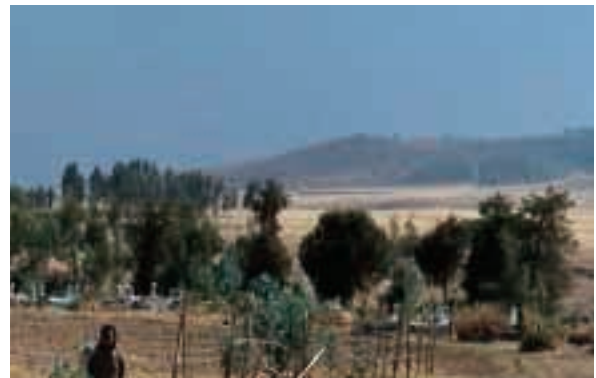
There is a significant ridge running approximately 135°T from the first of the above peaks and running out into the plain at about 6nm from the VOR. This ridge is the one referred to in later sections of this report. A further ridge runs approximately 215°T from the same peak towards the eastern outskirts of the city. This runs out into the plain approximately 3.5nm north of the airport.

This photograph shows the NW to SE ridge running down towards the approach path. It was taken from near the village of Leghedadi 10nm NW of the airport looking WSW from a range of approximately 5nm.

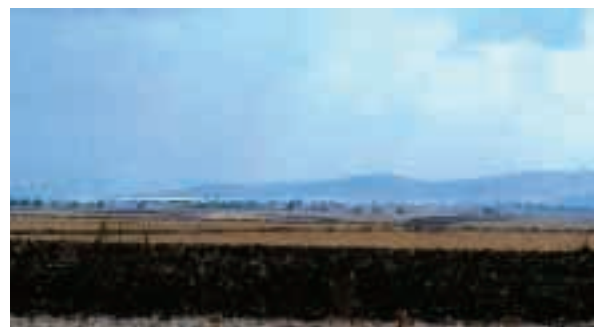
This picture shows the same ridge from a range of about 8nm from the NW of Leghedadi.

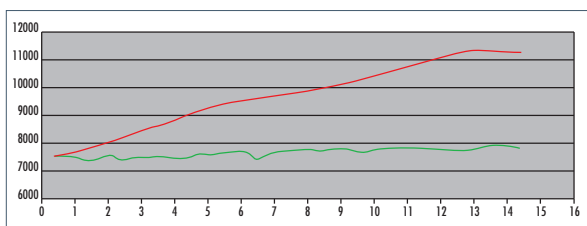
Figure 1 shows the profiles for the approach carried out on the return from Djibouti which was carried out visually. The terrain profile is typical for a correct approach path with the characteristic gentle slope of the plain from west to east. Other characteristic features are the river valley at 6.5D and the double depression on the final approach to the threshold.

The distance scale on this figure can be directly related to DME distance from the “ADS”. In Figures 2 & 3, the 13nm marker can be taken as 13D from the “ADS”, but other distances do not relate to DME as the aircraft was not flying towards the DME facility. The distances have been corrected to take account of the varying groundspeed during each approach.

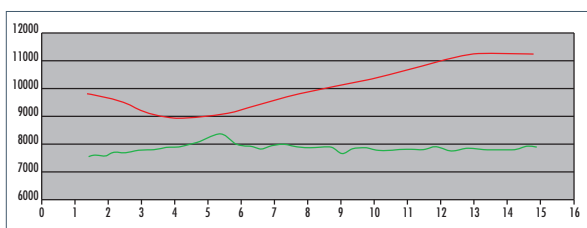
Figure 2 shows the profiles for the first approach at HAAB. Notable points are the non-sloping nature of the terrain between 15nm and 6nm and the high point at just over 5nm. There is also a marked valley at 9nm and a lesser one at 6.5nm.

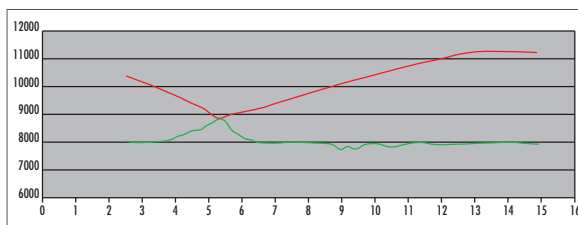
The analysis revealed that at some point on both approaches the aircraft had passed over a ridge of high ground not normally encountered on the 25L approach. At the point at which the second go-around had been initiated the aircraft had passed over the ridge with a clearance of 55' as shown by the radio altimeter recording. At no time were the crew aware of this close proximity to the ground.

Figure 3 shows the profiles for the second approach at HAAB. Here, the notable points are again the flat terrain between 15nm and 7.5nm and the high point at just over 5nm. The river valley is still apparent at 9nm, but has split into two. The terrain clearance at the point of go-around is 55’.

- HAAB to be treated as a Category 'C' airport,
- Operations to HAAB to be conducted by GPS equipped aircraft only,
- Approach to be discontinued if VOR indications differ from GPS derived FMGS indications by more than 5°,
- The MDA for the 25L VOR/DME procedure raised to 9380' amsl (1790' aal) in association with a minimum visibility of 5KM,
- Approach to be discontinued if no visual contact with the runway approach lights at ADS DME 5nm (FAF). (ie MAP is ADS 5DME)

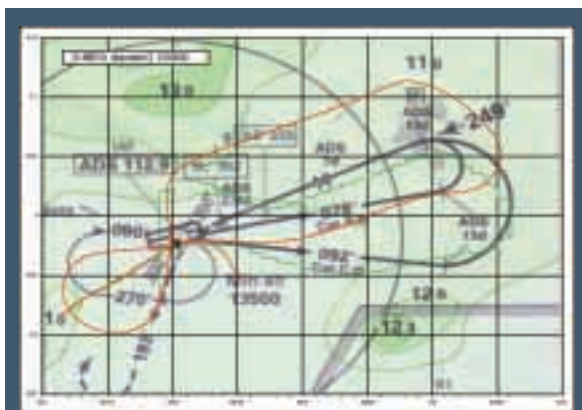
Figure 4 on shows the track for the second approach.

Initially, as the procedure is commenced, the FMGC track and still track appear to be following the procedural 094°T track. The FMGC track then starts to deviate to the south and the aircraft is turned left to correct taking the still air track to the north of the required track. This correction brings the FMGC position slowly back to the required track, but the still air track is moving well north.
