Near CFIT event during Non Precision Approach

By: Panxika Charalambides
Flight Safety Manager

Safety First
05 December 2007

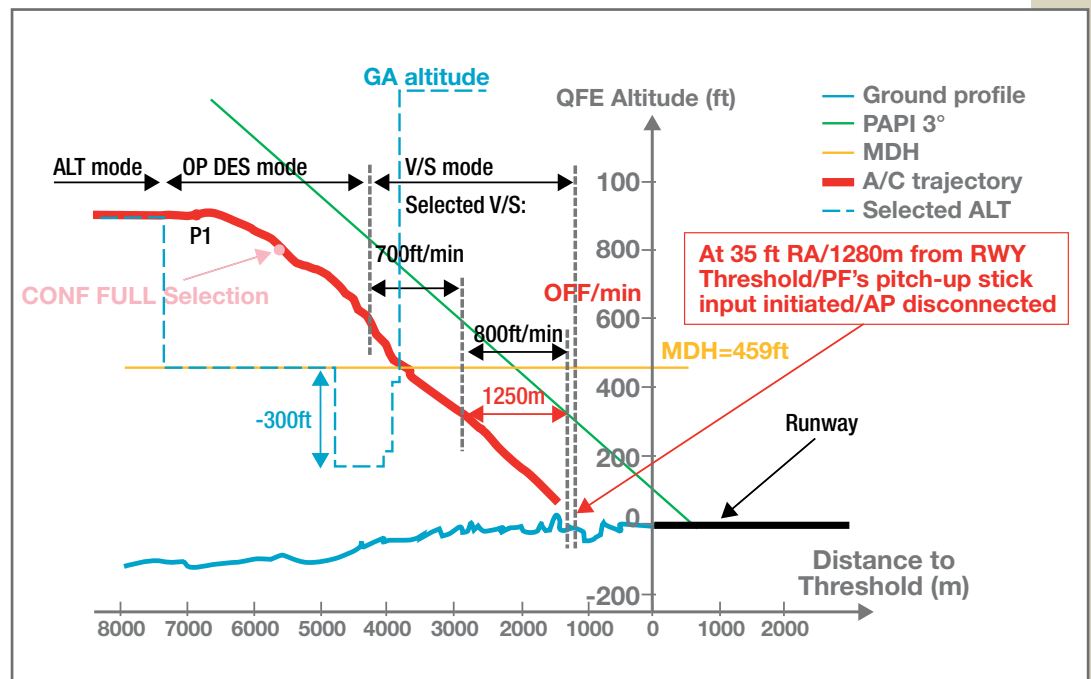
Descent profile

The figure here below presents the descent profile from "P1"

- Shortly before over-flying "P1", MDA altitude was selected on the FCU, and the OP DES longitudinal autopilot mode was selected so that a thrust reduction was progressively commanded to target idle thrust, while the autopilot pitch mode maintained the speed target.
- At that stage the aircraft was in slats/flaps configuration 3, gear down, both flight directors engaged, autopilot N°2 engaged.

- For the whole approach the autopilot lateral mode remained in NAV mode.
- **At 800ft QFE, 3NM from runway threshold**, shortly after over-flying the last altitude constraint "P1" full slats/flaps configuration was selected.
- **At 680ft QFE, 2.6NM from runway threshold**, whereas the rate of descent was 1000ft/min, an altitude 300ft below MDA was selected on the FCU.
- **At 600ft QFE, 2.3NM from runway threshold**, while the current rate of descent was -1400ft/min, the crew selected the autopilot V/S mode with initially a selected V/S of -700ft/min. From that time auto-thrust was therefore engaged in speed mode. Target speed was Vapp (VLS +5kts).

- 1/ As this approach was performed in GPS primary (In this case only GPS and IRS data are used for the aircraft position computation) the accuracy of the recorded aircraft position is very good.
- 2/ In managed guidance only (FINAL APP mode engaged) when the aircraft reaches MDA (MDH) -50ft or 400ft (if no MDA/MDH entered) the autopilot automatically disengages.
- 3/ As noticeable on the figure here above, from MDA altitude this final descent was performed on a 3° slope.

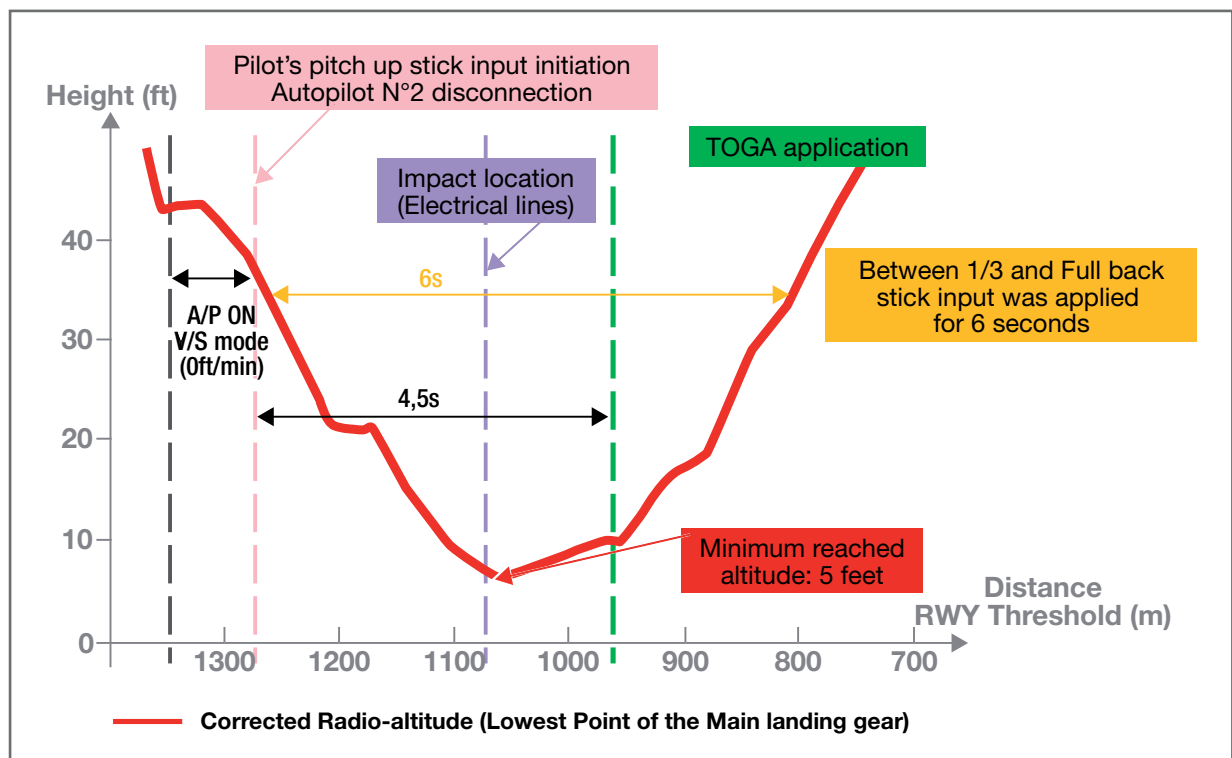
Zoom on pilot's take-over phase

The figure here below presents a zoom on the pilot's take-over phase:

- The radio-altimeter parameters recorded in the DFDR (here plotted in red) indicate the distance between the lowest point of the main landing gear and the ground.

- The initial PF's pitch-up stick input was followed by permanent pitch-up stick input (between 1/3 and full back stick input) applied for 6 seconds, so that the aircraft stopped descending and started to climb.

- Minimum recorded altitude was 5ft RA reached at about 1100m from the runway threshold.
- The estimation of the impact location indicates that, at that moment, the aircraft impacted the electrical lines.

- At 10ft RA, 4.5 seconds after the initial PF's pitch-up stick input, thrust levers were moved forward to TOGA detent.
- 43 seconds after TOGA application, landing gears were selected up.

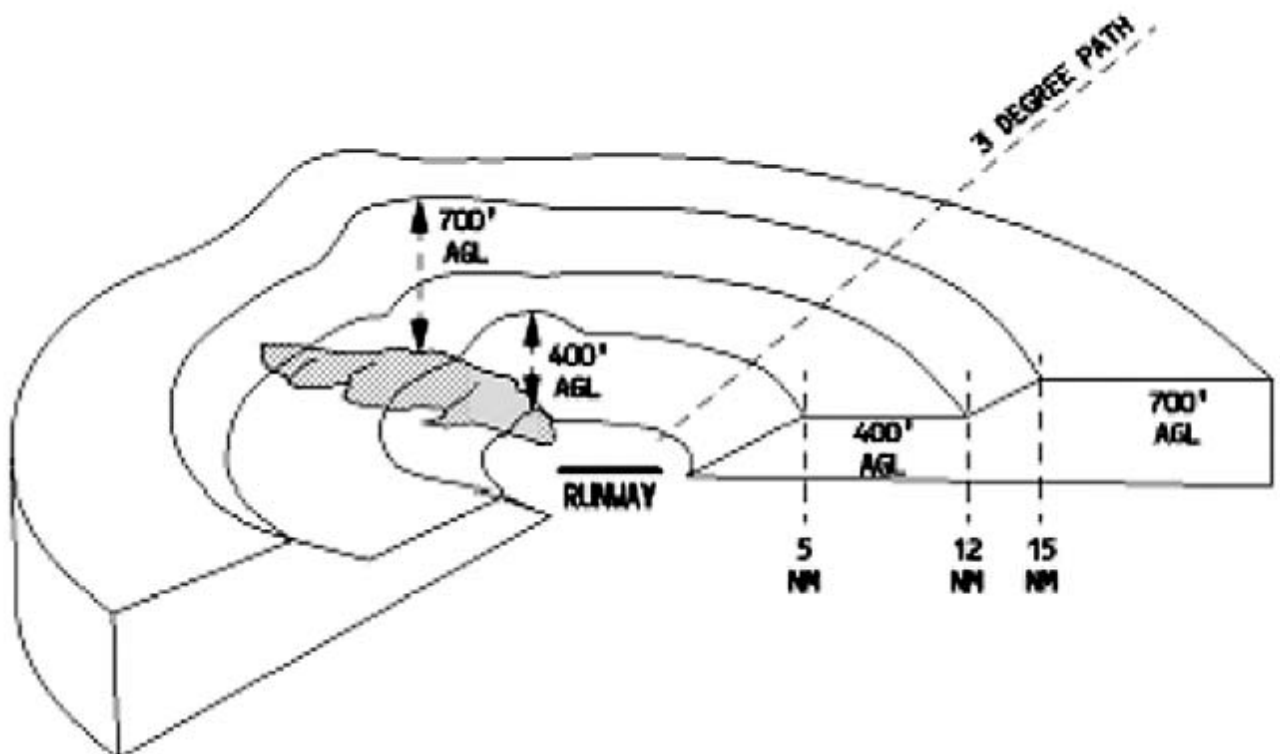
But as shown on the sketch here below there is a progressive desensitization of this function when the aircraft approaches the runway. In particular, in a circle centered on the runway, a full desensitization exists i.e. no warning when the aircraft is very close to the runway.

With the EGPWS software version fitted on this particular aircraft, the Terrain Clearance Floor function had a higher desensitization zone than current EGPWS, so that no alert was given when the aircraft descended very close to the ground. With the latest EGPWS software version (the aircraft was equipped with a GPS), an alert would have been triggered about 20s before impacting the electrical lines (at about 200ft QFE).

Note: The desensitization area depends on the FMS estimated position accuracy. In particular this software release allows for the GPS position data to be used directly, resulting in much smaller estimated error values that allow for smaller desensitization areas. This latest software version was revised to optimize the envelope profile and to reduce the minimum desensitization area to a circle with a radius of 0.25NM, whereas such radius was 1NM for the software version installed on the aircraft at the time of the event. This results in significantly improved protection for "landing short" accidents.

Upgrade to last EGPWS software standard (P/N 965-1676-002) for any Airbus aircraft type: Please refer to OIT ref. SE 999.0050/06/VHR dated 18 April 2006. Please refer to last ref. SIL 34-080 revision

This last, free of charge, EGPWS software version is available for any Airbus aircraft type since May 2006.
