Pitot Probes Obstruction on Ground

By Albert URDIROZ
Flight Safety Manager

Safety First

Safety First
03 December 2006

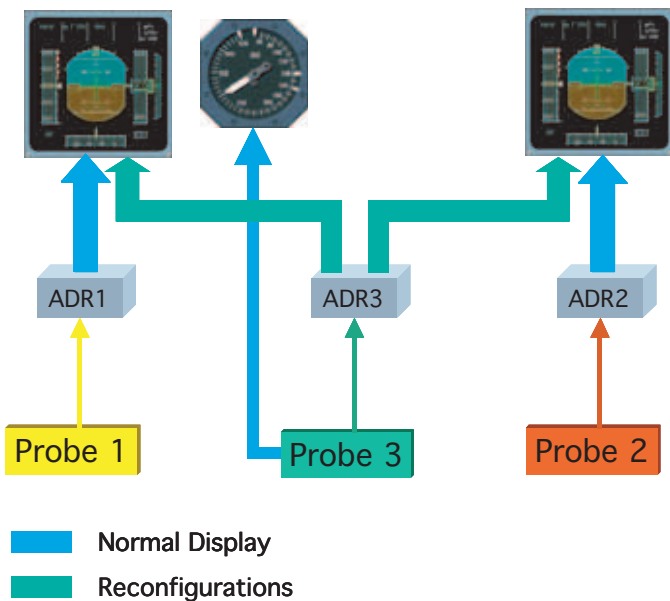
The following sketch presents the typical architecture valid for all Airbus aircraft.

In the event referred to above, no reconfiguration to ADR3 was reported, and the information displayed on the standby indicator was the sole reliable.

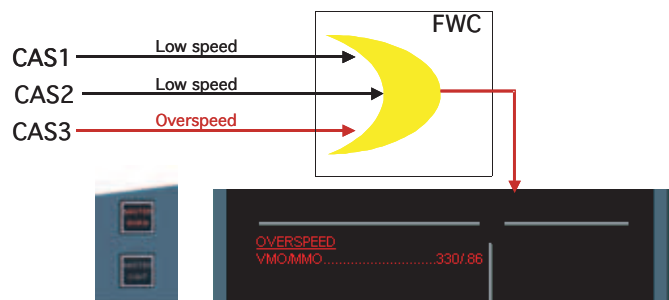
CAS3 being accurate during subject event, and over speed warning being computed on the basis of an «OR» condition of CAS1, 2 & 3 versus VMO/MMO, the over speed situation indicated by the Flight Warning System was actual.

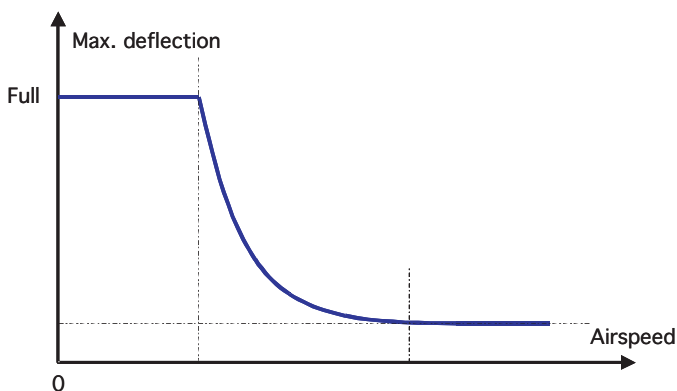
Flight controls surfaces gain efficiency with speed. For instance, the roll rate achieved with 5 degrees of aileron deflection will be much higher if aircraft flies at VMO/MMO than at low speed. This implies that, when AFS and EFCS use a too low airspeed:

- Orders to the flight controls would be too strong and may cause over-reaction, either in manual or automatic flight;
- Limitation of rudder deflection will not be adapted to airspeed (Refer to sketch).

Possible consequences in this extreme situation are loss of control or exceedance of design loads. Given these risks, all efforts should be made to maintain reliable operation of airspeed indication systems, or flight should be cancelled as soon as unreliable airspeed condition is detected.
