Preventing Fan Cowl Door Loss

This article provides an update on the design and procedure improvements introduced on the Airbus fleet to prevent fan cowl door loss events.

Safety first, #28 April, 2019. Safety first is published by Airbus S.A.S. - 1, rond point Maurice Bellonte - 31707 Blagnac Cedex/France. Publisher and Editor: Yannick Malinge, Chief Product Safety Officer. Concept Design by Airbus Multi Media Support 20190588. Reference: X00D16031905 Issue 28. Photos by Airbus, G. Estragnat, S. Ramadier.

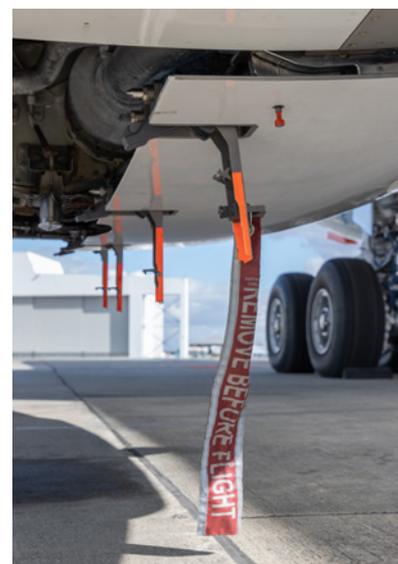
(fig-1)

An improved latch with a key and a **REMOVE BEFORE FLIGHT** flag attached to the key (**fig.1**) has been introduced in December 2015 on the A320ceo aircraft. The key is needed to open the latch. When the fan cowl door is opened, the key remains on the latch. It can only be removed if the latch is fully closed. When not used, the latch key has to be stored in the cockpit with the landing gear pin.

Latch with key and "Remove before flight" red flag on A330neo aircraft

The following Airworthiness Directives (ADs) mandate the retrofit of this new lockable latch on A320ceo aircraft equipped with IAE and CFM56 engines:

Engine	SB	AD	AD Compliance date
CFM56-5A/5B	71-1068	EASA 2016-0257	24-MAR-2019
		FAA 2018-05-04	11-MAR-2021
IAE V2500	71-1069	EASA 2016-0053	24-MAR-2019
		FAA 2017-13-10	03-AUG-2020

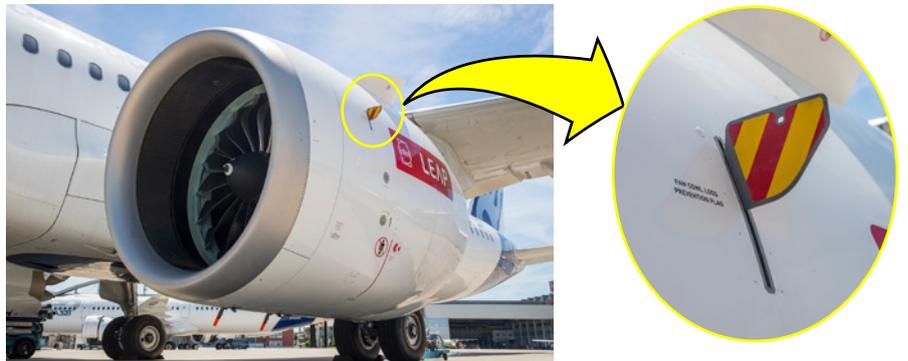
In addition to the cowl position monitoring, a prevention flag extends mechanically from the surface of the left hand fan cowl when the forward latch is opened to warn the ground personnel and the flight crew that the latch is not closed **(fig.2)** on A320neo equipped with CFM LEAP-1A engines.

(fig.2)
Mechanical prevention flag on an A320neo equipped with LEAP engines

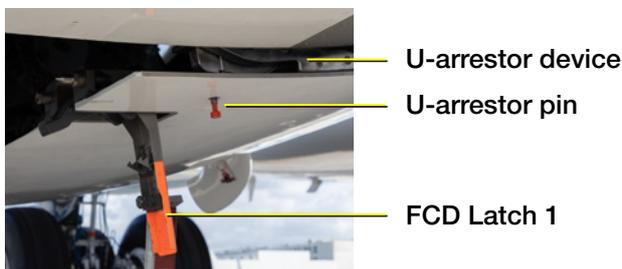
A U-arrestor device holds the fan cowls in a partially open position when the cowls are lowered on A340 equipped with TRENT 500 engines and on A330neo with TRENT 7000 engines. It is obvious to the operator that the cowls are not fully closed when looking from below or from the side of the cowl. The U-arrestor pin must be pressed to close the fan cowl door **(fig.3)**.

(fig.3)
A330neo U-arrestor

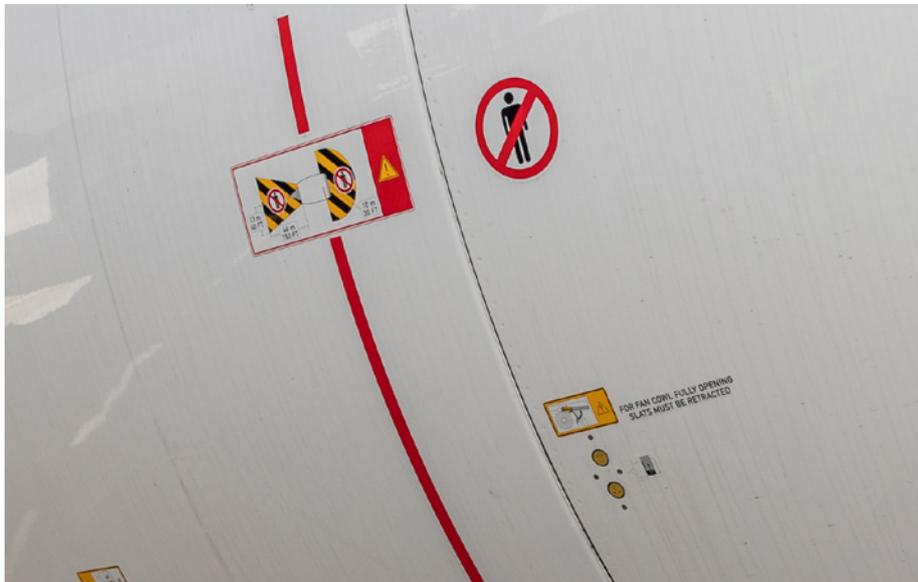
(fig.4)

If the fan cowl door latches are left open on the A350 or A380 aircraft, the latch access panel cannot be closed. This will be visible to ground operator or flight crew during an exterior walkaround check **(fig.4)**.

Engine of an A350 with fan cowl door latch access panel open

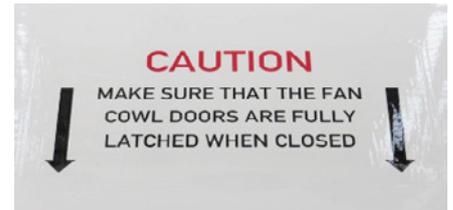
(fig.6)

Decals with cautions located at eye level ensure that fan cowl doors are closed and correctly latched before flight **(fig.6)** on A320 aircraft. They are installed on recent A320ceo production aircraft and on A320neo. They can also be installed by retrofit with the following VSBs:

Eye level decal with cautions

- VSB RA32071-117 on CFM56-5A/5B
- VSB NAC-71-0235 on IAE V2500 ■

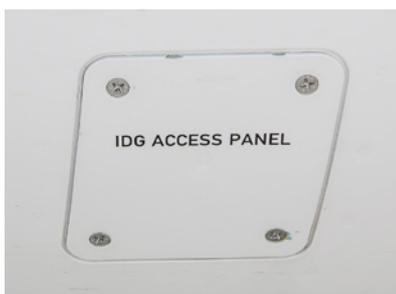
(fig.8)

An optional IDG access door is available on A320ceo aircraft equipped with CFM56-5A/5B engines. IDG oil level can be checked via this access door without opening the fan cowl doors. A320neo LEAP, A330ceo RR Trent 700 and A340-500/600 RR Trent 500 are already equipped with this IDG access door **(fig.8)**.

IDG oil access door on A320neo LEAP

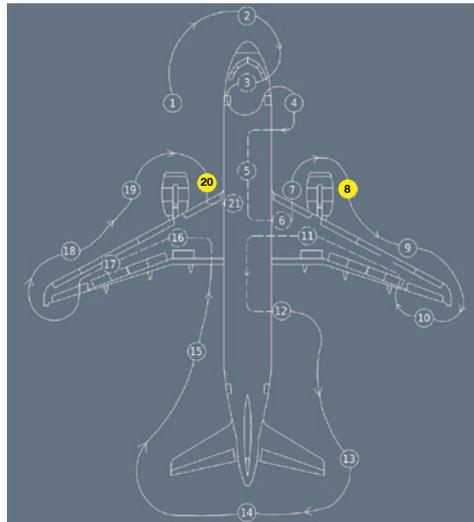
(fig.11)

Airbus updated the exterior walkaround section of the FCOM Standard Operating Procedures for all aircraft by introducing additional steps in the walkaround (**fig.11**). This change requests that the correct latching of the fan cowls is now checked from both sides of each engine.

Additional steps at stations 20 and 8 in the exterior walkaround of the A320 FCOM

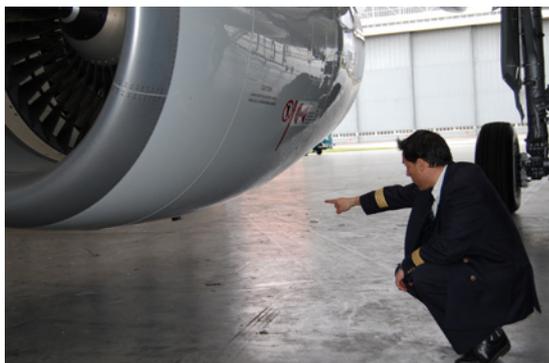
(fig.12)

The most effective way to confirm that all latch handles are correctly engaged and flush with the fan cowls is to crouch down to get a good line of sight with the latches. The flight crew needs to check on both sides of the engine to confirm there is no gap around the cowl and all latches are secured (**fig.12 and fig.13**). Use a torch light if the lighting conditions are poor or if the inspection is done by night. ■

The flight crew should crouch down to correctly check the fan cowl door latching

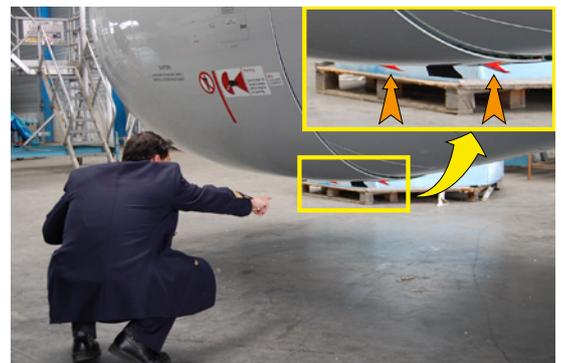
(fig.13)

Incorrect latching: The latches are not flush with the nacelle and there is a small gap around the cowl
