**Marc BAILLION**

**Lorraine DE BAUDUS**

# Radio Altimeter erroneous values

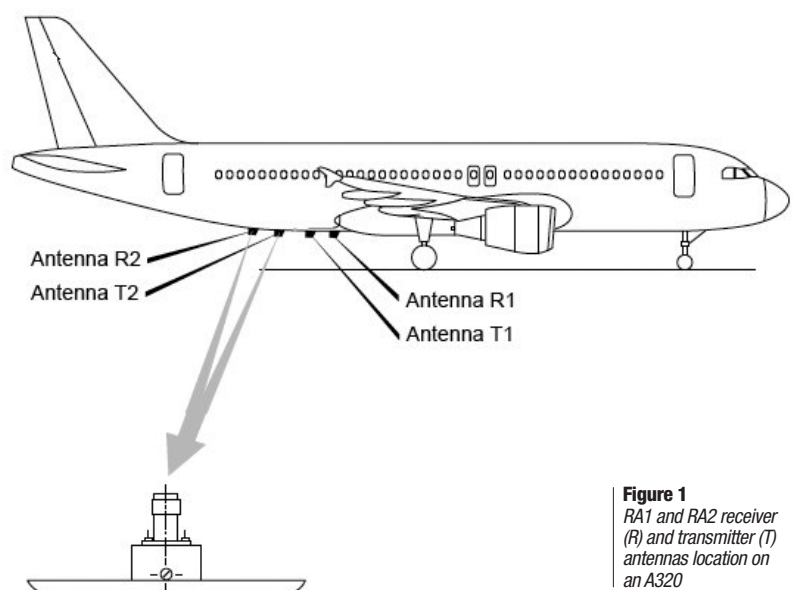
**Figure 1**  
RA1 and RA2 receiver (R) and transmitter (T) antennas location on an A320

All Airbus aircraft, except the A380, are equipped with two RAs, which provide height information to several aircraft systems (fig. 1).

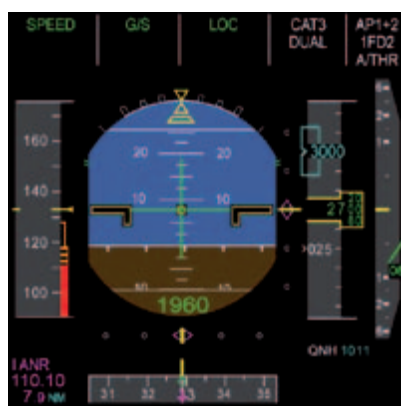
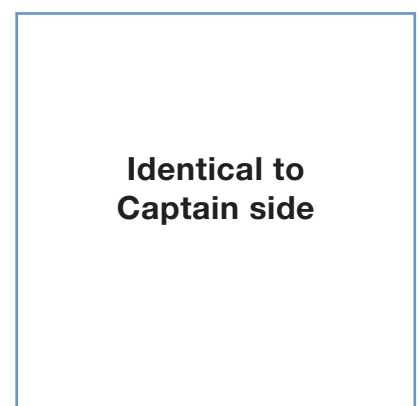
**Figure 2**  
Both RAs provide correct height of 1 960 ft

▶ Figure 2 shows the crew's PFDs before the RA1 issue. Both RAs function properly and provide the same height of 1 960 ft. The vertical mode is on G/S, and the lateral mode is on LOC. The A/THR is engaged in SPEED.

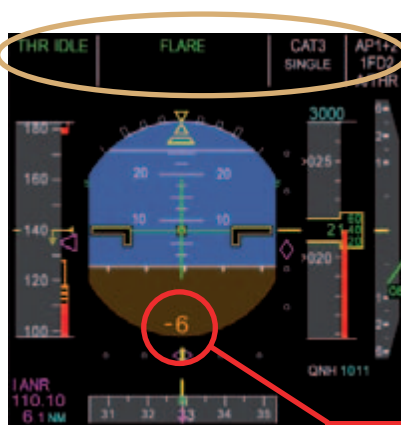
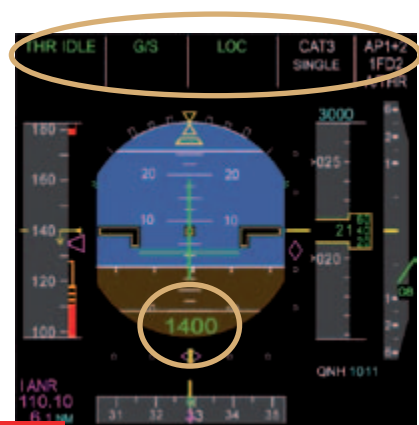
**Figure 3**  
Erroneous RA 1 reading is - 6 ft, correct RA 2 reading is 1 400 ft. Both AP/FDs are engaged

▶ Figure 3 RA 1 provides an erroneous height indication of - 6 ft, while RA 2 delivers the correct height of 1 400 ft.

Erroneous RA

► RA 2 provides height information to PFD 2 and to AP 2.

- The RA reading on PFD 2 is 1 400 ft
- AP 2 is still engaged in G/S vertical mode and LOC lateral mode. PFD 2 therefore displays “G/S” and “LOC” on the FMA.

► AP 1 is engaged in FLARE mode and one RA height goes below 200 feet. In addition, the difference between both RA height indications is greater than 15 feet.

- The AUTOLAND warning lights are activated.

- ▶ During all phases of flight, the flight crew must monitor and crosscheck all primary flight parameters and FMA indications.
- ▶ During ILS (or MLS, GLS) approach with AP engaged, in the event of an unexpected THR IDLE and FLARE modes engagement, the flight crew must immediately react as follows:
  - **Immediately perform an automatic Go Around** (thrust levers set in TOGA),
- Or
- **Immediately disconnect the AP**, then continue the landing using raw data or visual references (FDs set to OFF) or, perform a manual Go Around with thrust levers set to TOGA (significant longitudinal sides-tick input may be required).

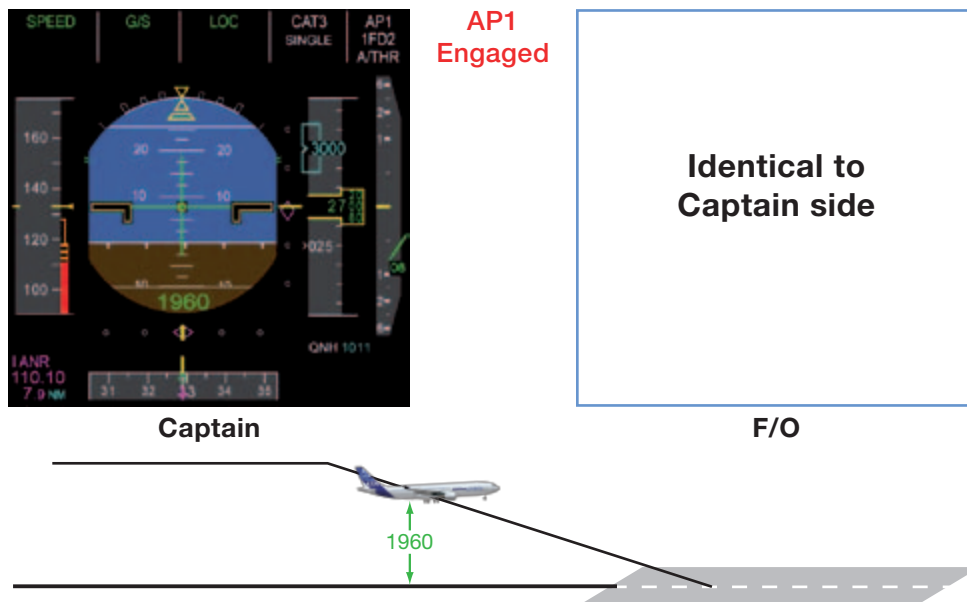
**Figure 4**  
Both RAs provide correct height of 1 960 ft

► Figure 4 shows the crew’s PFDs before the RA1 issue. Both RAs function properly and provide the same height of 1 960 ft. The vertical mode is on G/S, and the lateral mode is on LOC. The A/THR is engaged in SPEED.

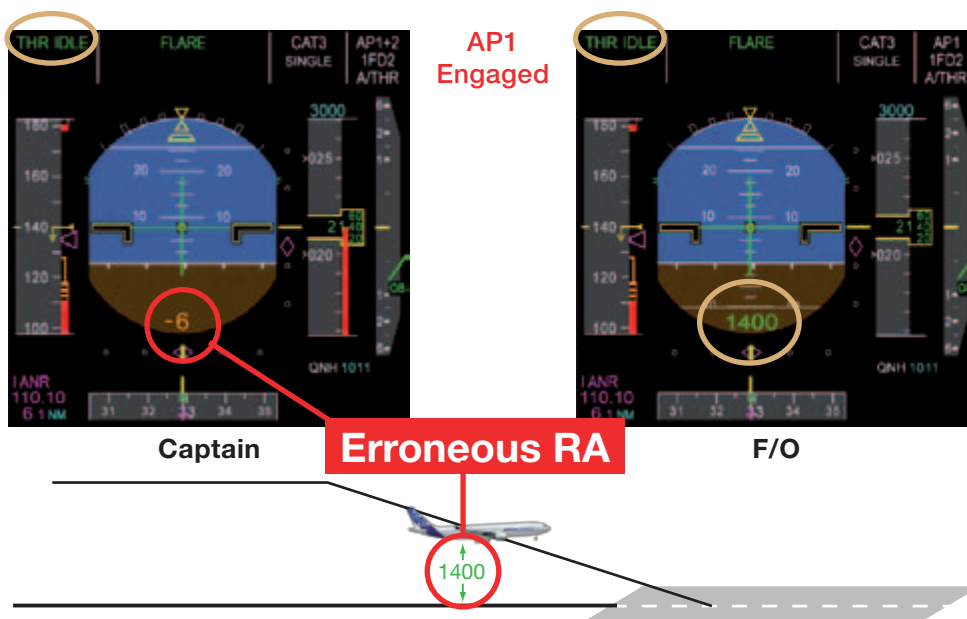
**Figure 5**  
Erroneous RA 1 reading is – 6 ft, correct RA 2 reading is 1 400 ft. AP 1 and both FDs are engaged

► Figure 5 shows that RA 1 provides an erroneous height indication of – 6 ft, while RA 2 delivers the correct height of 1 400 ft.

► RA 1 provides height information to PFD 1, AP 1 and to the A/THR (the A/THR uses the same RA as the master AP).

- The RA reading on PFD 1 is – 6 ft
- AP 1 engages in FLARE mode and displays “FLARE” on the FMAs of PFD 1 and PFD 2.
- The A/THR engages in RETARD mode and displays “THR IDLE” on the FMAs of PFD 1 and PFD 2.

► RA 2 provides height information to PFD 2.

- The RA reading on PFD 2 is 1 400 ft.

► AP 1 is engaged in FLARE mode and one RA height goes below 200 feet. In addition, the difference between both RA height indications is greater than 15 feet.

- The AUTOLAND warning lights are activated.

In the examples above, the risk of early flare engagement due to the too low height indication is compounded by the possible impact on the aircraft protections. On the A320 Family, for example, the CONF FULL High Angle of Attack Auto Pilot disconnection is not available in the event of a very low erroneous RA height indication.

Therefore, if a manual takeover is not performed when this early flare engagement occurs, the Angle Of Attack will increase and may reach the stall value.
