Radio Altimeter erroneous values

Safety First

Safety First, #11 January 2011. Safety First is published by Airbus S.A.S., 1, rond point Maurice Bellonte, 31707 Blagnac Cedex/ France. Editor: Yannick Malinge, Chief Product Safety Officer, Nils Fayaud, Director Product Safety Information. Concept Design by Airbus Multi Media Support Ref. 20101536. Computer Graphic by Quat'coul. Copyright: GSn°420.0190/10. Photos copyright Airbus. Photos by ExM Company: H. Berenger, P. Masclat, H. Goussé. Printed in France by Airbus Print Centre.

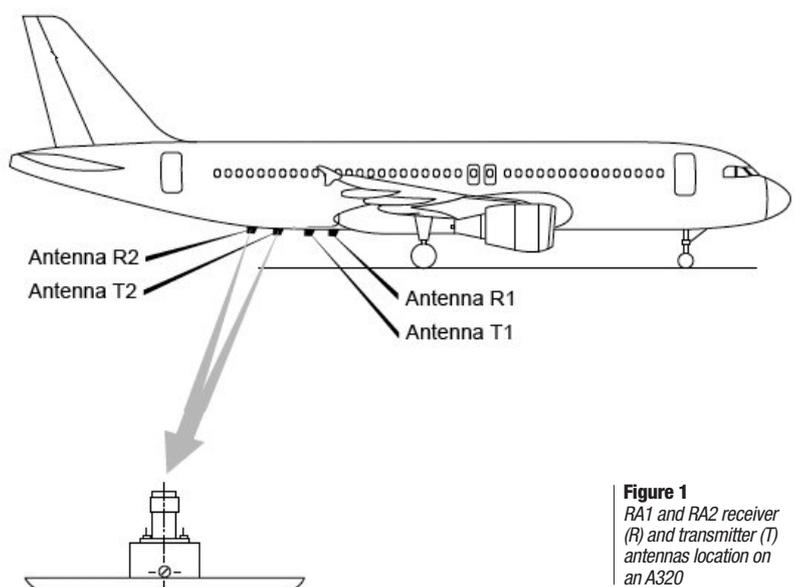
Figure 1
RA1 and RA2 receiver (R) and transmitter (T) antennas location on an A320

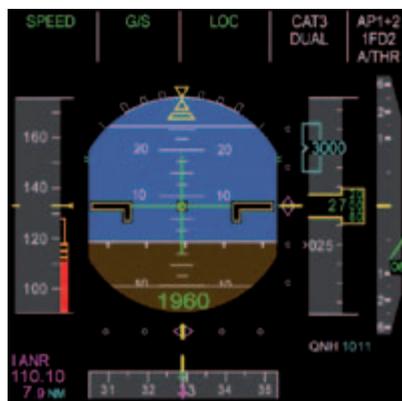
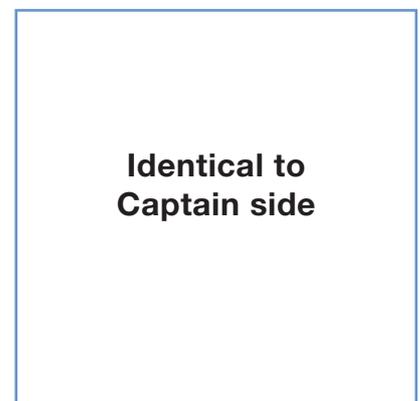
Figure 2
Both RAs provide correct height of 1 960 ft

▶ Figure 2 shows the crew's PFDs before the RA1 issue. Both RAs function properly and provide the same height of 1 960 ft. The vertical mode is on G/S, and the lateral mode is on LOC. The A/THR is engaged in SPEED.

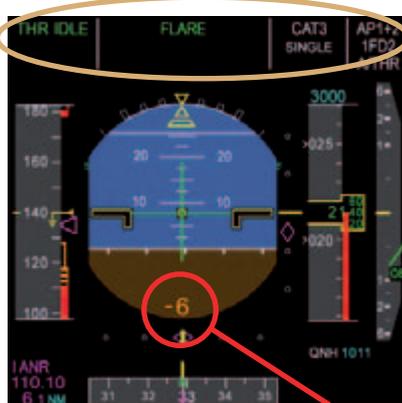
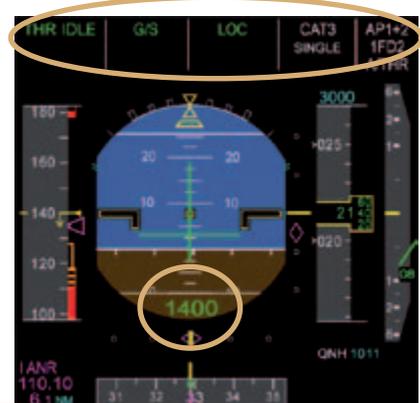
Figure 3
Erroneous RA 1 reading is - 6 ft, correct RA 2 reading is 1 400 ft. Both AP/FDs are engaged

▶ Figure 3 RA 1 provides an erroneous height indication of - 6 ft, while RA 2 delivers the correct height of 1 400 ft.

► RA 2 provides height information to PFD 2 and to AP 2.

- The RA reading on PFD 2 is 1 400 ft
- AP 2 is still engaged in G/S vertical mode and LOC lateral mode. PFD 2 therefore displays “G/S” and “LOC” on the FMA.

► AP 1 is engaged in FLARE mode and one RA height goes below 200 feet. In addition, the difference between both RA height indications is greater than 15 feet.

- The AUTOLAND warning lights are activated.

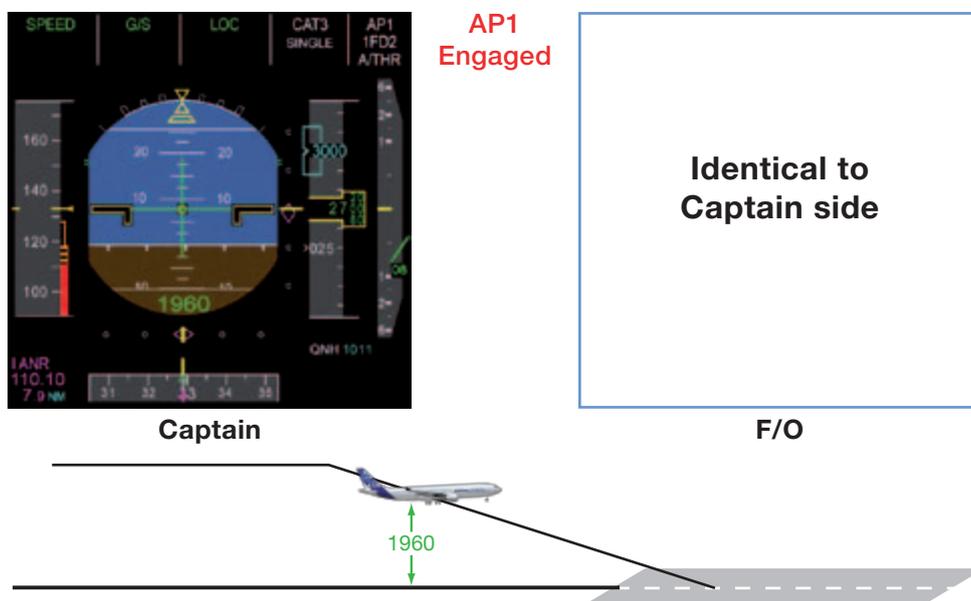
Figure 4
Both RAs provide correct height of 1 960 ft

► Figure 4 shows the crew’s PFDs before the RA1 issue. Both RAs function properly and provide the same height of 1 960 ft. The vertical mode is on G/S, and the lateral mode is on LOC. The A/THR is engaged in SPEED.

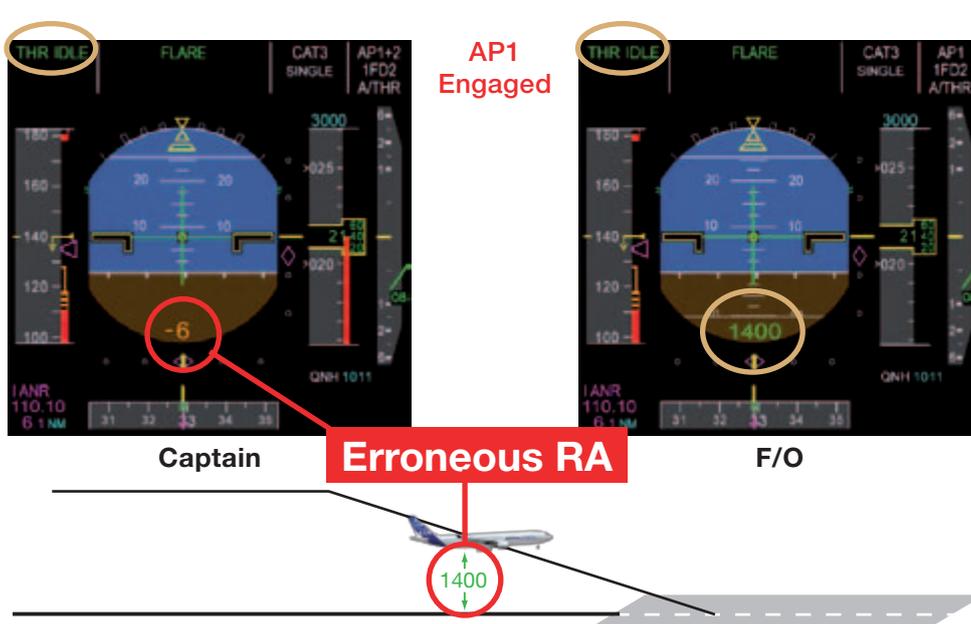
Figure 5
Erroneous RA 1 reading is – 6 ft, correct RA 2 reading is 1 400 ft. AP 1 and both FDs are engaged

► Figure 5 shows that RA 1 provides an erroneous height indication of – 6 ft, while RA 2 delivers the correct height of 1 400 ft.

► RA 1 provides height information to PFD 1, AP 1 and to the A/THR (the A/THR uses the same RA as the master AP).

- The RA reading on PFD 1 is – 6 ft
- AP 1 engages in FLARE mode and displays “FLARE” on the FMAs of PFD 1 and PFD 2.
- The A/THR engages in RETARD mode and displays “THR IDLE” on the FMAs of PFD 1 and PFD 2.

► RA 2 provides height information to PFD 2.

- The RA reading on PFD 2 is 1 400 ft.

► AP 1 is engaged in FLARE mode and one RA height goes below 200 feet. In addition, the difference between both RA height indications is greater than 15 feet.

- The AUTOLAND warning lights are activated.

In the examples above, the risk of early flare engagement due to the too low height indication is compounded by the possible impact on the aircraft protections. On the A320 Family, for example, the CONF FULL High Angle of Attack Auto Pilot disconnection is not available in the event of a very low erroneous RA height indication.

Therefore, if a manual takeover is not performed when this early flare engagement occurs, the Angle Of Attack will increase and may reach the stall value.

- ▶ During all phases of flight, the flight crew must monitor and crosscheck all primary flight parameters and FMA indications.
- ▶ During ILS (or MLS, GLS) approach with AP engaged, in the event of an unexpected THR IDLE and FLARE modes engagement, the flight crew must immediately react as follows:
 - **Immediately perform an automatic Go Around** (thrust levers set in TOGA),
- Or
- **Immediately disconnect the AP**, then continue the landing using raw data or visual references (FDs set to OFF) or, perform a manual Go Around with thrust levers set to TOGA (significant longitudinal sides-tick input may be required).
