Runway Excursions at Take-off

By: Jean Daney
Director of Flight Safety

The Airbus Safety Magazine

02 September 2005

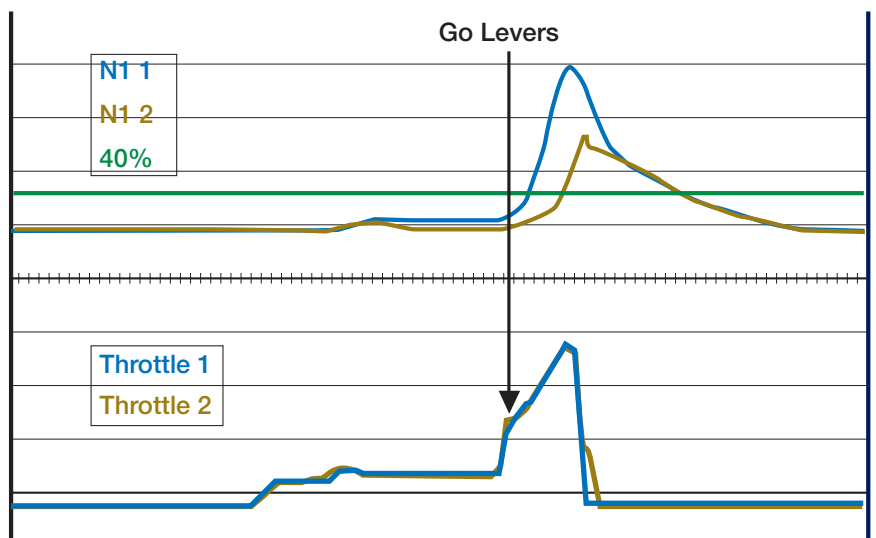
There have been two events involving an A310 and an A320 that resulted in the aircraft exiting the runway during the take-off run. The circumstances that caused these events are very similar:

During the alignment on the runway centreline before take off, one throttle was advanced slightly above the other. This led to a situation where one engine was at idle and the other was slightly above idle. Then, the go-levers were triggered (A310) or the thrust levers were advanced (A320) without prior N1 stabilization. The engine that was above idle accelerated faster than the other, leading to an asymmetrical thrust increase. In both cases, the take off was rejected but the aircraft left the side of the runway at low speed. Here are presented the curves retrieved from the DFDR:

Engine acceleration depends on acceleration schedule (FF vs N2) and throttle movement. There are two types of acceleration:

- Slow throttle movement "behind" the engine acceleration schedule: Thrust is function of the throttle position.
- Fast/normal throttle movement "ahead of" the engine acceleration schedule: Thrust is function of the max acceleration schedule capability

The time to accelerate the engine up to the takeoff power depends on the initial power level: acceleration from min ground idle is slow, while acceleration from intermediate thrust is fast.

At low power setting, engines may have different acceleration profiles while the same acceleration profile for both engines is available from a certain amount of thrust.

As a summary, asymmetrical power increase can occur if the go-levers are triggered (A310) or the thrust levers are advanced (A320) without N1 stabilization while:

- One engine is at idle and the other is slightly above idle
- One engine is slower to accelerate than the other.

FCOM recommendations:

A310:

- Slightly advance throttles and monitor spool-up until both engine are above idle (approx 40% N1) or
- Slightly advance throttles and monitor spool-up until both engine are aligned and stabilized between 1.05 and 1.10 EPR with no more than 0.002 EPR difference between both engines.

Regular communication to pilots: It is important to emphasize the understanding of engine response at takeoff thrust setting, particularly the requirement of setting a similar N1 (or EPR) on both engines, prior to setting the takeoff thrust during type rating and recurrent training. Airbus encourages airlines to share these lessons-learned through Airline's bulletin to all pilots.

Operational documentation improvements: Airbus will enhance the wording of the FCOM and add a note in the wide body FCOM and single aisle and long range FCTM to emphasize the fact that if this procedure is not properly applied, it may lead to asymmetrical thrust increase and, consequently, to severe directional control problem.
