**Benoît DUVAL**

Safety Enhancement Manager
Aircraft Architecture and Integration

Transient Loss of Communication due to Jammed Push-To-Talk

A320 and A330/A340 Families

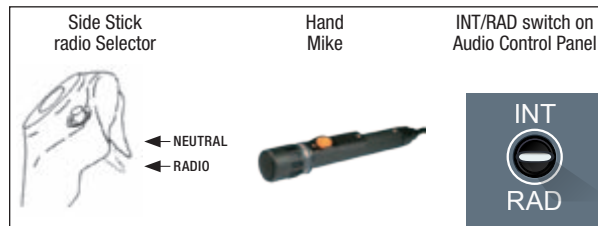
Figure 2
Push-To-Talk devices

When a Push-To-Talk device is jammed in the transmit position, the VHF transceiver transmits continuously as soon as it is selected, and no reception is possible on the tuned frequency.

In normal operation, on hearing the 5 audio “beeps” the crew has to release and press again the PTT selector/button to continue the transmission. But if the Push-To-Talk device is jammed the transmission may not be resumed on the selected radio, which will be limited to reception only. In this case, an ECAM COM VHF (1 or 2 or 3) EMITTING caution is also triggered after 60s.

The way to handle the situation in this case, is to first check the PTT transmission selector and try to release it. Then, if this does not work, isolate the jammed PTT and the associated Audio Control Panel by deselecting all the VHF transmission keys on the ACP1. It is then possible to use the ACP2 and the associated PTT devices, on the F/O side, to establish a new VHF transmission.

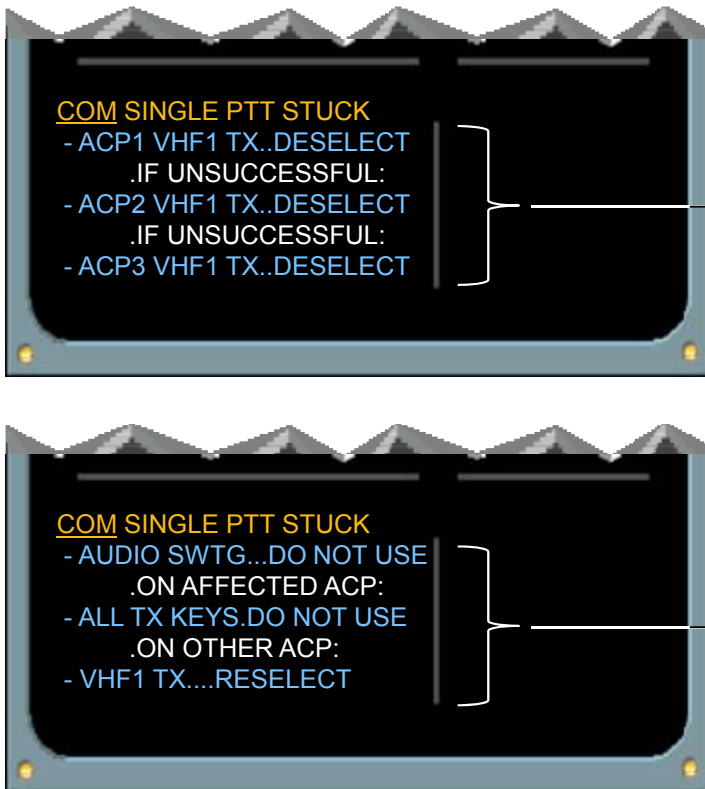
Figure 6
New ECAM COM SINGLE PTT STUCK caution with associated procedure

Configuration: one PTT jammed, VHF1 transmission, and Audio Switching rotary switch on NORMAL position.

1st part of the procedure: identification of the affected side
These 5 procedure lines disappear as soon as the VHF1 transmission key has been deselected on the affected side (the side where the PTT is jammed).

2nd part of the procedure: reconfiguration on the other side
Once the VHF1 has been deselected on all ACPs, the procedure requests the crew to not use the audio switching, nor any transmission keys on the affected ACP. Then, the procedure requests to reselect the VHF1 transmission key on the other ACP.

To assist the crew to recover correct communication in case of a jammed PTT, a new amber COM SINGLE PTT STUCK caution has been developed. This alert will trigger when a PTT is detected continuously activated during 40s and will provide a new procedure to guide the crew through the two following steps :

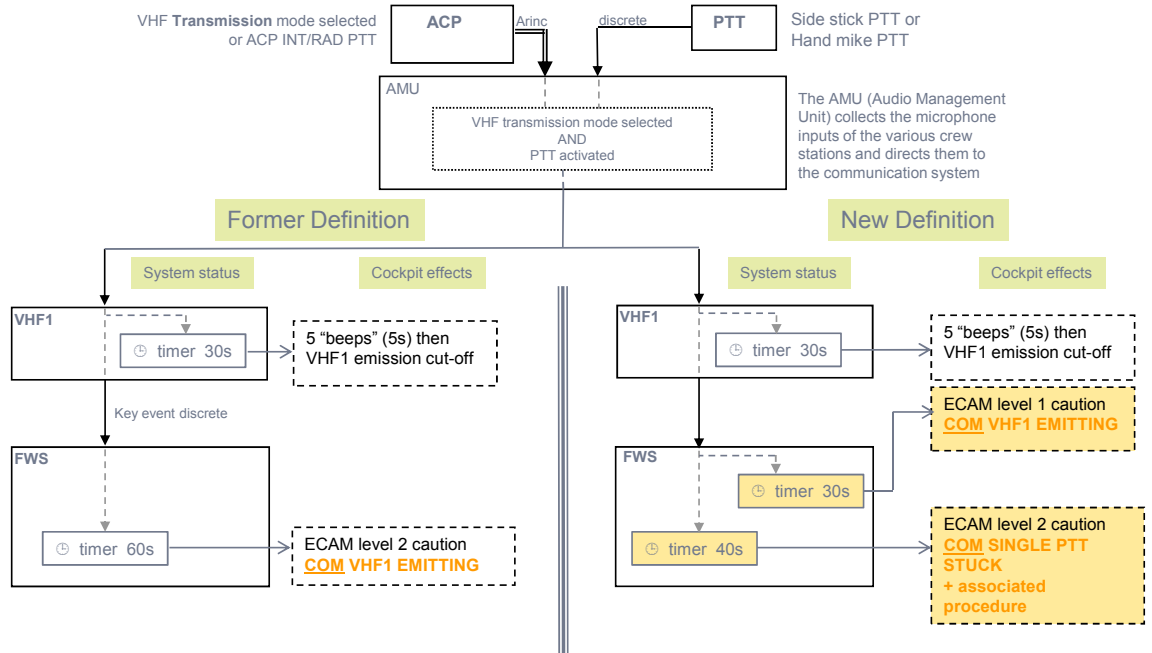
Figure 7
Current and future
ECAM definition in
case of PTT stuck
(example for VHF1)

In association with the introduction of this new alert, the COM VHF 1 (2) (3) EMITTING alert will be

triggered simultaneously with the audio “beeps”, i.e. 30s after the start of the transmission, to reinforce the awareness that the transmission will be cut-off.

The introduction of the COM SINGLE PTT STUCK caution will lead to the downgrading of the COM VHF 1 (2) (3) EMITTING alert from a level 2 to a level 1 caution, which implies that there will be no associated Single Chime nor Master Caution light.

On the A320 Family, these improvements will be implemented on the Flight Warning Computer (FWC) H2-F7 standard (availability planned in December 2012).

On the A330/A340, these improvements will be implemented on the FWC T5 standard (planned in January 2013) for the A330 and A340-500/600, and from the L13 standard (planned in August 2013) for the A340-200/300.

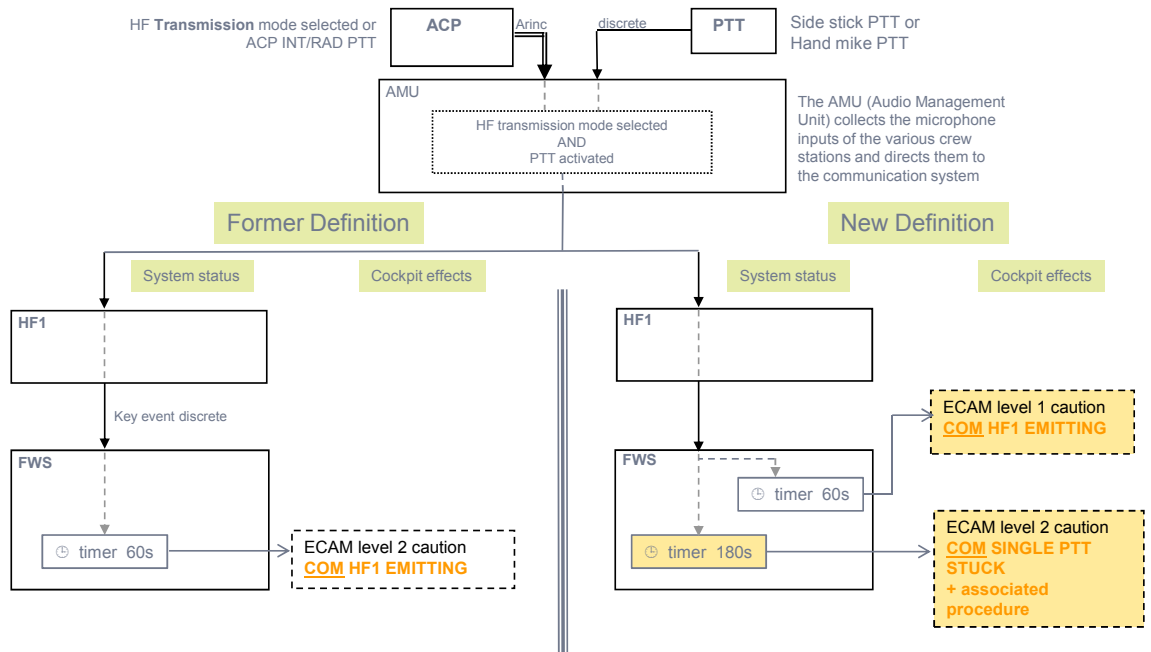
Figure 8
Current and future
ECAM definition in
case of PTT stuck
(example for HF1)

The COM SINGLE PTT STUCK caution described above will trigger as well for HF communication. The only difference will lie in the delay of activation: to take into account the longer average length of messages of HF transmissions, the caution will trigger only when a

PTT is detected continuously activated during 180s.

As for the VHF associated alert, the COM HF (1 or 2) EMITTING caution (level 2) will likewise be downgraded to a level 1 caution.
