Transient Loss of Communication due to Jammed Push-To-Talk

A320 and A330/A340 Families

The Airbus Safety Magazine

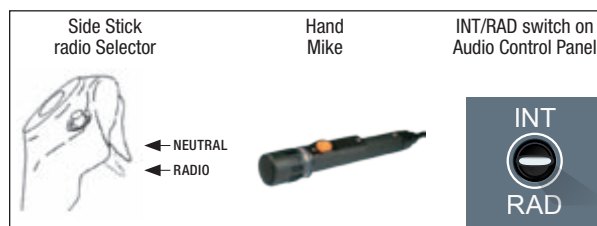
Figure 2
Push-To-Talk devices

devices: side stick radio selector, hand mike PTT, or INT/RAD switch on the ACP (fig.2).

When a Push-To-Talk device is jammed in the transmit position, the VHF transceiver transmits continuously as soon as it is selected, and no reception is possible on the tuned frequency.

In normal operation, on hearing the 5 audio “beeps” the crew has to release and press again the PTT selector/button to continue the transmission. But if the Push-To-Talk device is jammed the transmission may not be resumed on the selected radio, which will be limited to reception only. In this case, an ECAM COM VHF (1 or 2 or 3) EMITTING caution is also triggered after 60s.

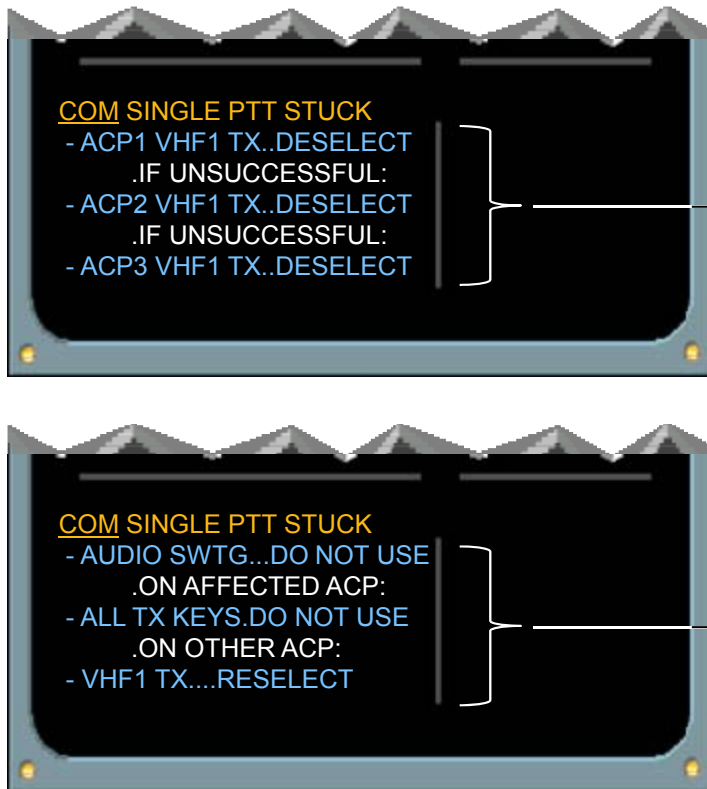
Figure 6
New ECAM COM SINGLE PTT STUCK caution with associated procedure

Configuration: one PTT jammed, VHF1 transmission, and Audio Switching rotary switch on NORMAL position.

1st part of the procedure: identification of the affected side
These 5 procedure lines disappear as soon as the VHF1 transmission key has been deselected on the affected side (the side where the PTT is jammed).

For example, if the F/O side stick PTT is jammed, these lines will disappear as soon as the VHF1 transmission key has been deselected on the ACP2.

2nd part of the procedure: reconfiguration on the other side

Once the VHF1 has been deselected on all ACPs, the procedure requests the crew to not use the audio switching, nor any transmission keys on the affected ACP. Then, the procedure requests to reselect the VHF1 transmission key on the other ACP.

To assist the crew to recover correct communication in case of a jammed PTT, a new amber COM SINGLE PTT STUCK caution has been developed. This alert will trigger when a PTT is detected continuously activated during 40s and will provide a new procedure to guide the crew through the two following steps :

- Identification of the side affected by the jammed Push-To-Talk.
- Reconfiguration on the non affected side.

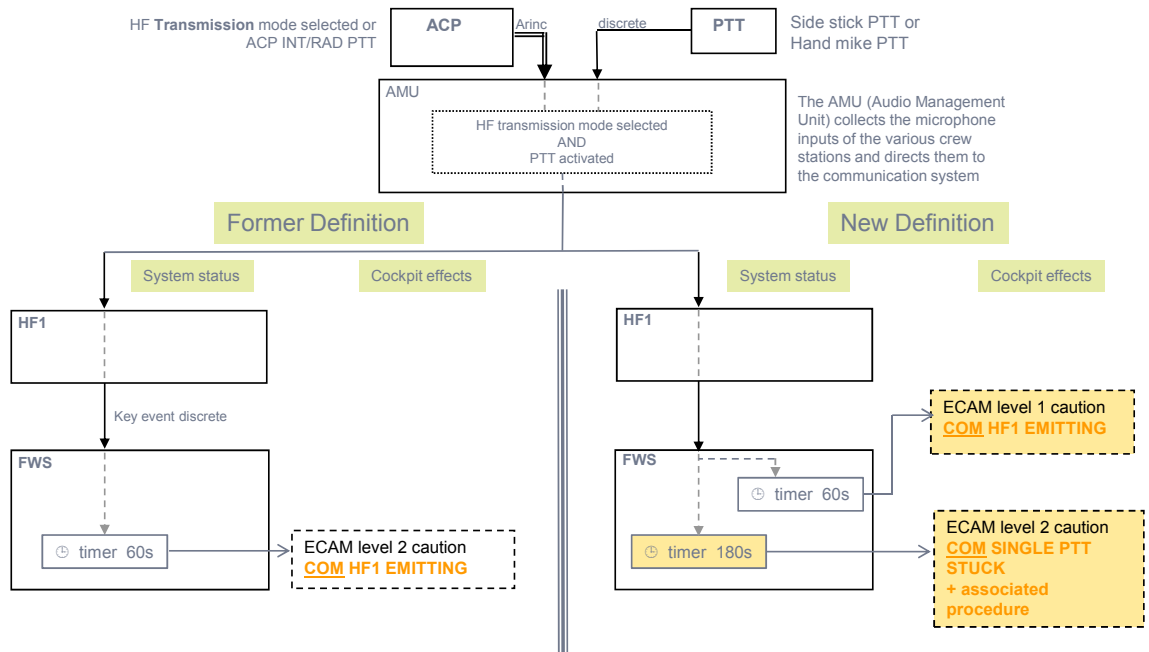
Figure 8
Current and future
ECAM definition in
case of PTT stuck
(example for HF1)

The COM SINGLE PTT STUCK caution described above will trigger as well for HF communication. The only difference will lie in the delay of activation: to take into account the longer average length of messages of HF transmissions, the caution will trigger only when a

PTT is detected continuously activated during 180s.

As for the VHF associated alert, the COM HF (1 or 2) EMITTING caution (level 2) will likewise be downgraded to a level 1 caution.

The differences between the present and future ECAM definitions for the HF transceivers are summarized in [fig. 8](#).
