# A320 Family cargo Containers/pallets movement

No crew likes the idea of Unit Load Devices (ULD – containers and pallets) moving around in the cargo holds of their aircraft during flight. This type of occurrences may have multiple causes.

**Safety first, #18** July, 2014. Safety first is published by Airbus S.A.S. - 1, rond point Maurice Bellonte - 31707 Blagnac Cedex/France. Publisher: Yannick Malinge, Chief Product Safety Officer, Editor: Corinne Bieder, Director Product Safety Strategy & Communication. Concept Design by Airbus Multi Media Support 20141680. Reference: GS 420.0045 Issue 18. Photos by Airbus, H. Goussé, Lindner Fotografie, A. Doumenjou, C. Brinkmann, JB. Accariez, HGE, W. Schroll, S. Ramadier, F. Lancelot, F. Lepissier, A. Barth, P. Masolet, M. Fyrol, Aneese, P. Pigeyre. Computer rendering by Fixion. Printed in France by Art & Caractère.

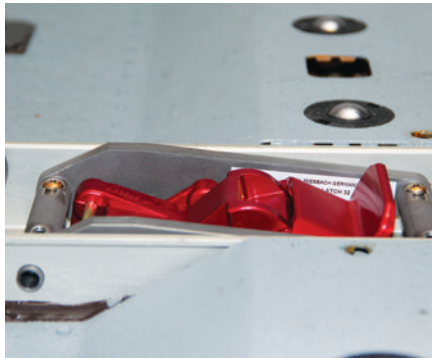
XZ latch in down position

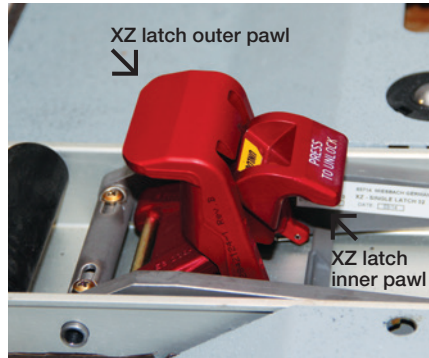
XZ latch in intermediate position (not yet locked)

A weak spring may not extend the inner pawl enough when the outside pawl is lifted up, leaving the latch in an intermediate (unlocked) position. The new design calls for an increased spring force.

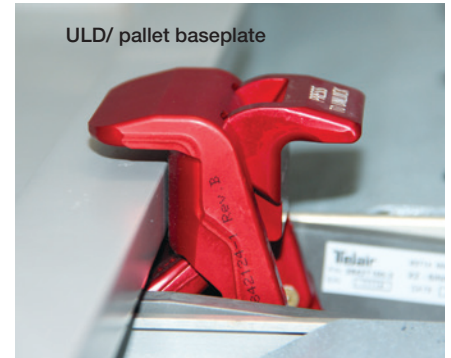
XZ latch raised and locked Interface with ULD/ pallet baseplate

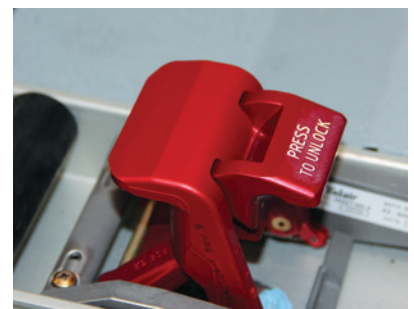
**(fig.5)**

This design equally calls for the addition of an easily visible yellow indicator when the latch is in intermediate position, i.e. not raised enough to be in the locked position **(fig.5 and 6)**.

Latch correctly locked: the yellow indicator is not visible

This latch (Part Number 2842T100-3) has been introduced in production from MSN 0573 onwards (Feb 1996) and is proposed through the Illustrated Parts Catalogue (IPC) as alternate.

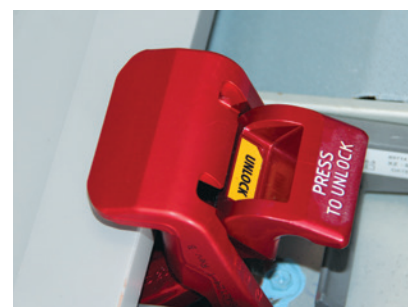
**(fig.6)**

Latch in intermediate position, not correctly locked: the yellow indicator is visible

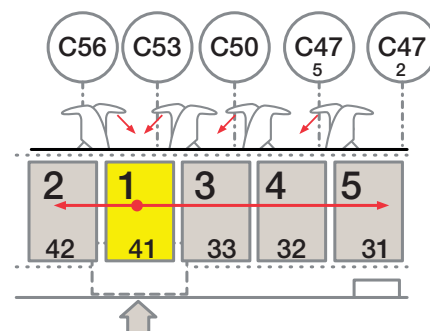
**(fig.7)**  
Recommended A321 AFT cargo hold loading sequence

An object falling from an improperly closed container/pallet on the inner pawl could lead to a latch disengagement.

Possible movement of the inner pawl of the Latch

procedure, proposed in SIL 25-162, remains identical for all holds and aircraft types. Its application will ensure that the inner pawl of the latch, i.e. the movable pawl, will always be blocked by the adjacent ULD/ pallet baseplate **(fig.7)**.

To mitigate this risk, a specific loading procedure is recommended when cargo holds are not fully loaded. This
