The Airbus safety magazine

#28

Safety first, #28 July, 2019. Safety first is published by Airbus S.A.S. - 1, rond point Maurice Bellonte - 31707 Blagnac Cedex/France.

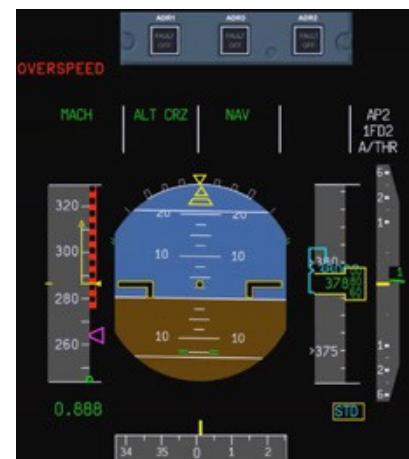
(fig.1)

An A340 aircraft was flying at FL380 with a managed Mach number of 0.82 and a tailwind of around 64 kt. Prior to reaching top of descent, a sudden drop in tailwind of 41 kt in 14 seconds caused a significant airspeed increase and triggered an OVERSPEED warning for 9s despite the thrust reduction commanded by the autothrust (A/THR) (**fig. 1**).

View of the PFD at the time of the overspeed

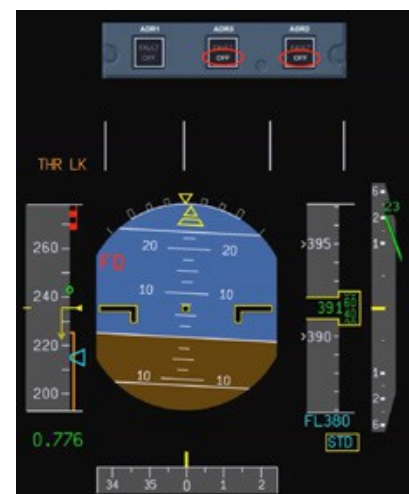
(fig.2)

The flight crew erroneously applied the OEB49 procedure and switched off the ADR 2 and ADR 3 about 15 seconds after the autopilot disconnection. This caused the aircraft to revert to Alternate law, with the loss of the FD bars and disconnection of autothrust. As a consequence, the thrust remained at the current value which was still idle at that time (**fig. 2**). Indeed the THR LK function at autothrust disconnection maintains the thrust at its current value until the thrust levers are moved again. This is indicated by the associated “**ENG THRUST LOCKED**” ECAM alert that requests to move the thrust levers and the “**THR LOCK**” displayed on the FMA.

View of the PFD after switching off ADR2 and ADR3

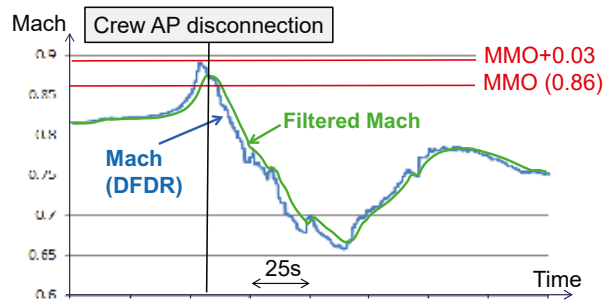
(fig.3)

Evolution of the filtered Mach versus the current Mach and versus the autopilot automatic disconnection threshold value ($M_{MO}+0.03$)

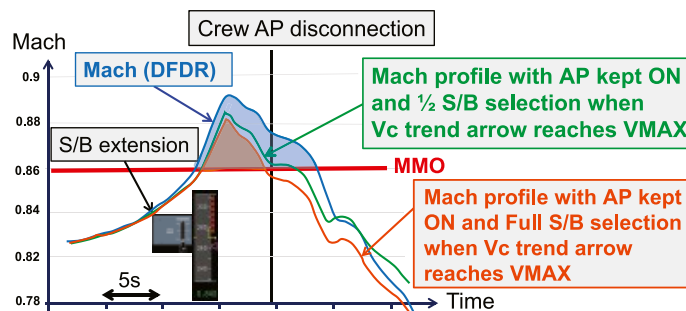
(fig.4)

In addition, the use of speedbrakes (S/B) is an efficient way to limit the V_{MO}/M_{MO} overshoot in cruise. This event has been simulated with autopilot kept ON and S/B selection at the time the V_{ctrend} arrow reaches V_{MAX} . The comparison of the event Mach with the Mach resulting from these simulations shows that the use of AP combined with a S/B extension would have minimized the altitude excursion as well as the V_{MAX} overshoot and overshoot duration (fig.4).

Comparison of the recorded Mach evolution with the simulated Mach evolutions if AP was kept ON with the selection of half and full S/B when the V_c trend arrow reached V_{MAX}

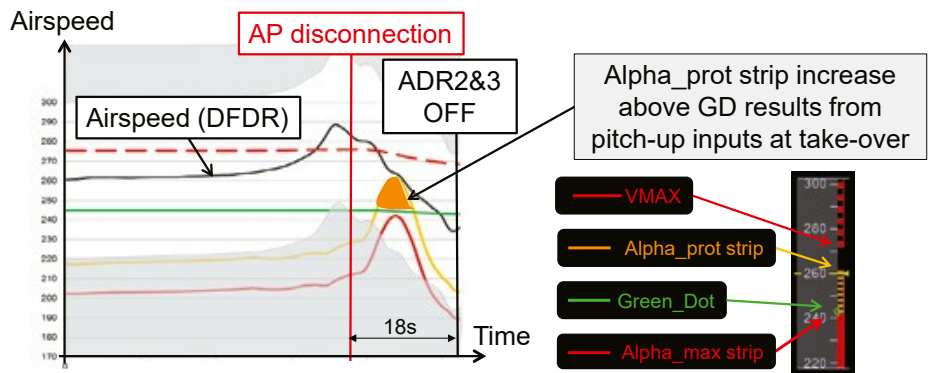
In the event described, the flight crew of the A340 improperly applied OEB49. The **αProt** strip increase above green dot speed did not occur with Mach increasing and in stabilized wings-level flight, but instead resulted from sidestick pitch up inputs **(fig.7)**.

The preventive entry condition of the OEB49 was therefore not fulfilled. The reactive entry was not fulfilled either as the aircraft was climbing when the OEB was applied.

(fig.7)
Plot of the recorded airspeed, green dot speed, Valpha prot, Valpha max and Vmax during the event

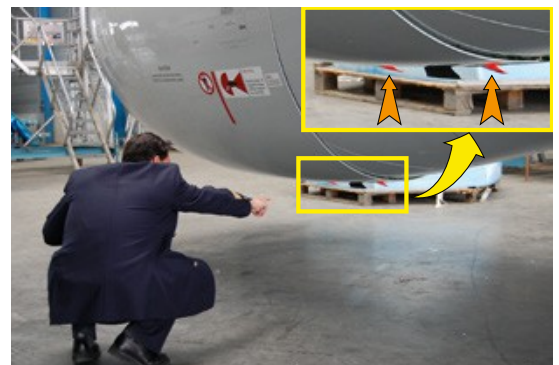
(fig.13)

Incorrect latching: The latches are not flush with the nacelle and there is a small gap around the cowl

The most effective way to confirm that all latch handles are correctly engaged and flush with the fan cowls is to crouch down to get a good line of sight with the latches. The flight crew needs to check on both sides of the engine to confirm there is no gap around the cowl and all latches are secured (**fig.12 and fig.13**). Use a torch light if the lighting conditions are poor or if the inspection is done by night. ■

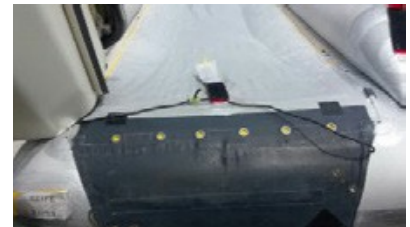
(fig.2)

“ A door slide with an incorrect routing of the electrical harness can impede the evacuation of the passengers, or block door opening sequence and prevent the slide deployment. ”

Example of a deployed slide with an electrical harness incorrectly routed. In this case, the harness could impede the evacuation.

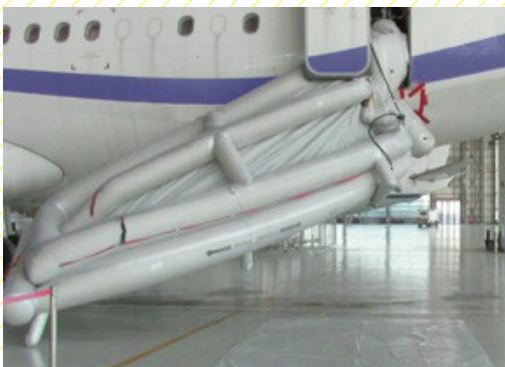
(fig.3)

Showing an incorrect slide deployment where the reservoir was activated and began to inflate the slide before it had cleared the door. The slide wrapper modification is designed to prevent this kind of occurrence.

This modification is known as the slide wrapper and it is installed via the following Service Bulletins (SB): SB A320-25-1B81, SB A320-25-1B82, SB A320-25-1B83, or SB A320-25-1B84. Embodiment of this modification is mandated by the EASA AD 16-0043 (March 2019 compliance)

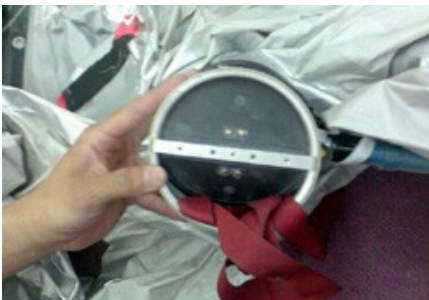
(fig.5)
Aspirator flapper valve blocked in the open position due to a foreign object ingestion.

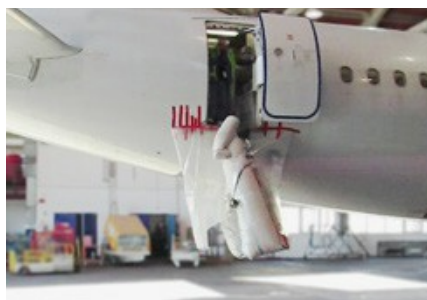
Some operational deployment tests were reported as unsuccessful due to ingestion of the fuselage protection material **(fig.6)**. Fuselage protection must be done according to AMM/MP procedure to avoid ingestion of any protection materials into the aspirator during any operational test of a slide. Operators must not use protection materials other than those recommended by the AMM/MP.

(fig.6)
Incomplete inflation due to obstructed aspirator inlet caused by non-standard fuselage protection during a slide deployment test.

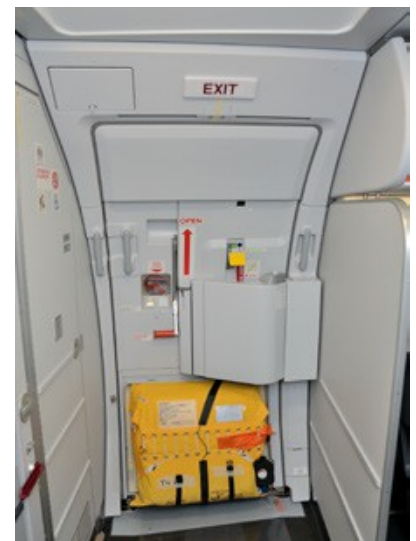
(fig.7)
Removal of the decorative cover of a slide for a deployment test does not provide a realistic operational configuration.
