The Airbus Safety magazine

Under the Spotlights

Two recent events with damage to the passenger windows of the aircraft were reported to Airbus. Similar events also happened on non-Airbus aircraft. The damage was caused by the heat of spotlights used during promotional filming sessions. One of these events could have had serious safety consequences as damage was not detected on ground, and caused some window panes to detach from the aircraft during the next flight.

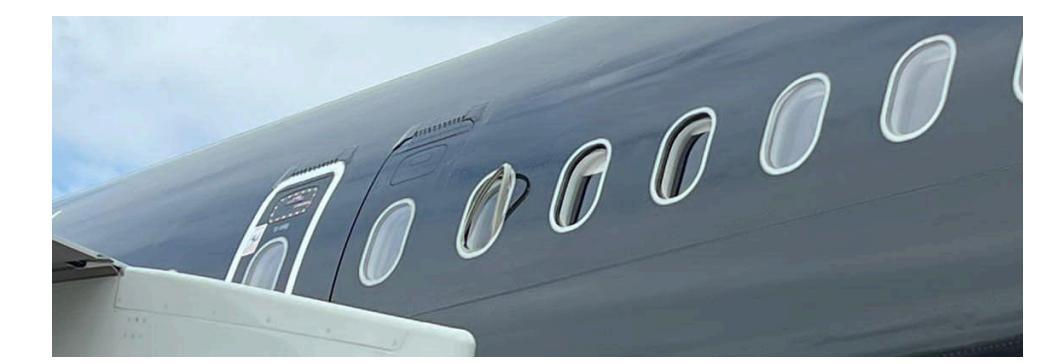
An A321neo aircraft was performing a positioning flight before several sectors of operations. A limited number of people including some cabin crew members were on board. The aircraft was climbing toward its target altitude. At 10 000 ft, one of the cabin crew noticed an excessive amount of cabin noise and cold temperature while walking toward the empty middle part of the aircraft. He discovered that one of the windows on the left side of the cabin appeared to have slipped down from its usual position and that the window seal was flapping in the outside airflow (fig.1). He immediately informed the flight crew who decided to descend to 9 000 ft and to perform an in-flight turnback. The aircraft landed safely and without further incident.

(fig.1) Picture of the window during the event (source: operator)

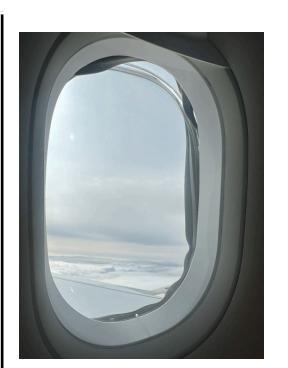
When on the ground and with the aircraft parked, the flight crew performed an inspection of the aircraft exterior. They observed that two windows were missing and one was dislodged **(fig.2)**. Damage to the lower side of the left stabilizer, probably due to an impact of a departing part, was also noticed. Further inspection revealed that two additional windows were damaged on the left side of the fuselage and one window also showed signs of damage on the right side of the fuselage.

(fig.2) Picture of the damaged and missing windows after landing (source: investigation board)

- Two window assemblies completely missing (one pane was retrieved on the runway)
- One window with missing outer pane
- Deformation of several other window panes
- Window seals in degraded condition
- Visible burn marks
- Melted foam ring at the interface between the window and the cabin lining.

After the filming session or photoshoot is finished, **Airbus recommends performing a visual inspection** of all cabin windows that were exposed to the lightning to check they are free of any damage or distortion before returning the aircraft to service.

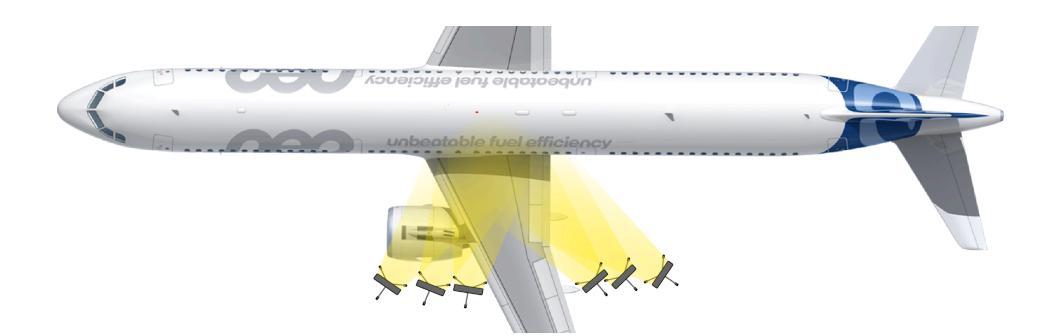
One day before the event, there was a filming session inside the aircraft, around the middle cabin area. There were 6 halogen (tungsten) lamphead spotlights, rated at 12 kW, placed outside the cabin windows to light the area being filmed. The 6 spotlights were first located on the right side of the aircraft at a distance between 6 to 9 meters from the fuselage, close to the overwing emergency exits, with the light beams focussed on the same area of fuselage **(fig.3)**. The lights were then moved to the left side of the aircraft for the second part of the filming session.

(fig.3) Lighting setup during the filming session (not to scale)

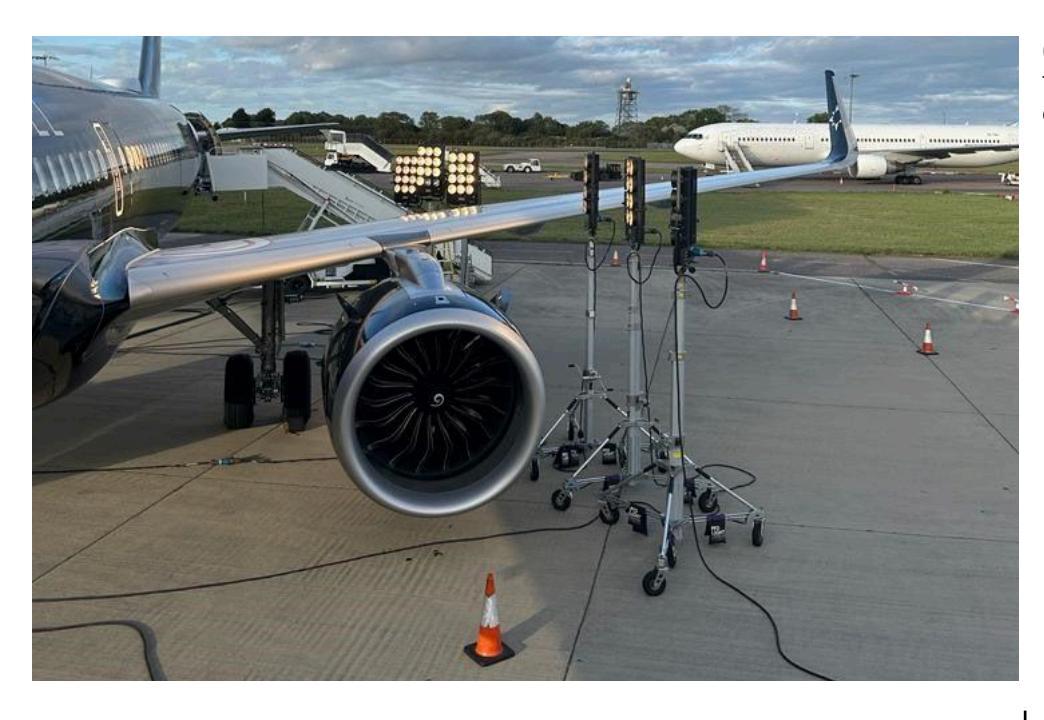
(fig.4) Picture of the filming session (source: operator)

The combined power of the 6 lamps in the halogen lighting setup was 72 kW. The exposure of the fuselage area to the spotlights lasted more than 4 hours on each side of the aircraft. The heat produced by the infrared radiation from the halogen spotlights damaged several cabin windows. This damage was not detected prior to the next flight.

Airbus recommends not to use high thermal radiation lighting devices, such as halogen (tungsten) or HMI lighting, during photoshoots or filming sessions outside or inside an aircraft. This type of lighting device emits a large amount of thermal energy. **Only use low energy lighting devices, such as LED lights,** which provide good lighting capabilities with low heat emission.

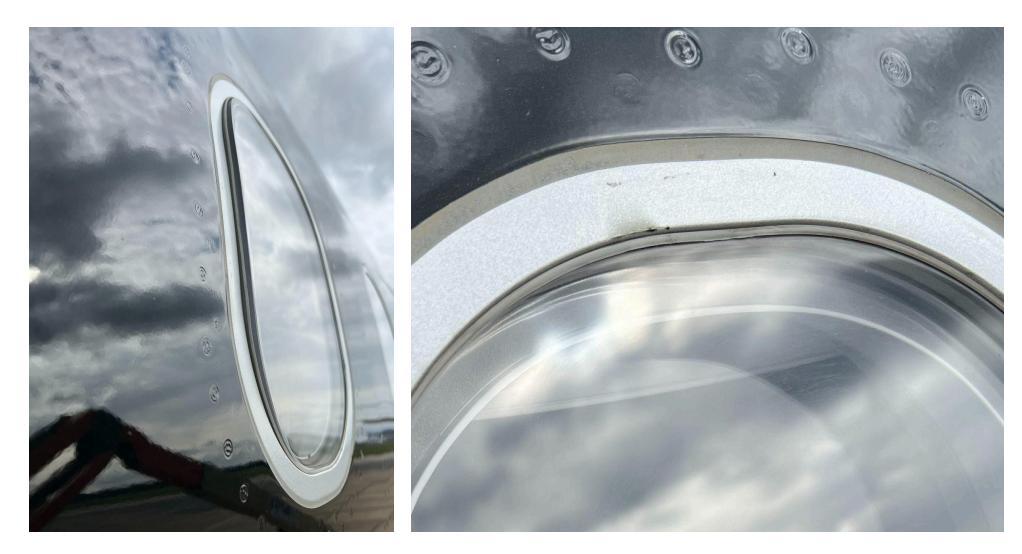
(fig.5) Window protrusion due to deformation (left) and burn marks on the top of an outer pane (right) (source: investigation board)

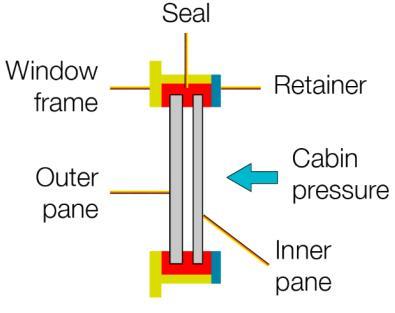
If the passenger window panes are exposed to an excessive amount of heat, **the panes may start to shrink and could become smaller than the window frame.** If a damaged window is not detected before the aircraft returns to service, as in the event described earlier, there is a risk that the cabin pressure differential at altitude will force the affected window pane outwards, causing cabin air pressure leaks and eventually the ejection of the window pane (**fig.8**). If both the inner and outer panes are affected by the heat damage, the complete window assembly could fail and be ejected.

Excessive heat conditions may cause window panes to shrink

(fig.8) Risk of window pane ejection if the heat damage is not detected before the next flight

Cabin pressure may push the panes outwards if damage is not detected before the next flight

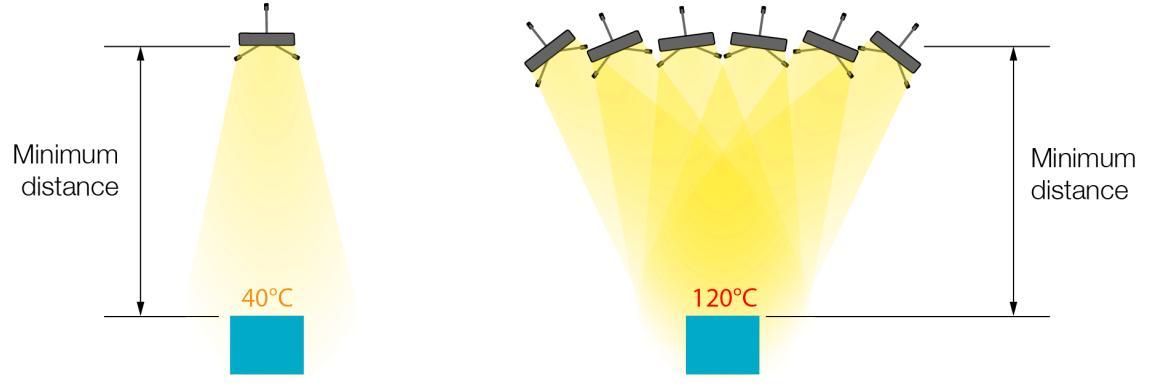
(fig.9) Thermal radiation cumulative effect

Even if the minimum distance to the subject defined by the lighting device instructions is respected, when multiple lighting units are used at the same time, there is a thermal radiation cumulative effect that may cause overheating and damage to the aircraft.

For example, one halogen lighting unit located at the minimum recommended distance, and pointed at the fuselage may increase the surface temperature of the fuselage to 40°C (fig.9).

Using six similar halogen lighting devices simultaneously, which are located at the recommended minimum distance and all pointed at the fuselage, may quickly raise the surface temperature to 120°C due to the cumulation of the thermal radiation emitted from each light. This high temperature may cause damage to the object.

hot weather regions, Airbus recommendation is to make sure that the surface temperature of cabin and passenger windows, fuselage, interior equipment and all aircraft parts exposed to the lighting sources, **are monitored and do not exceed 55°C**.
