**By: Marc BAILLION** Flight Safety Director

## 1 Introduction

## 2 Description of the event

Safety First # **06** Julv 2008

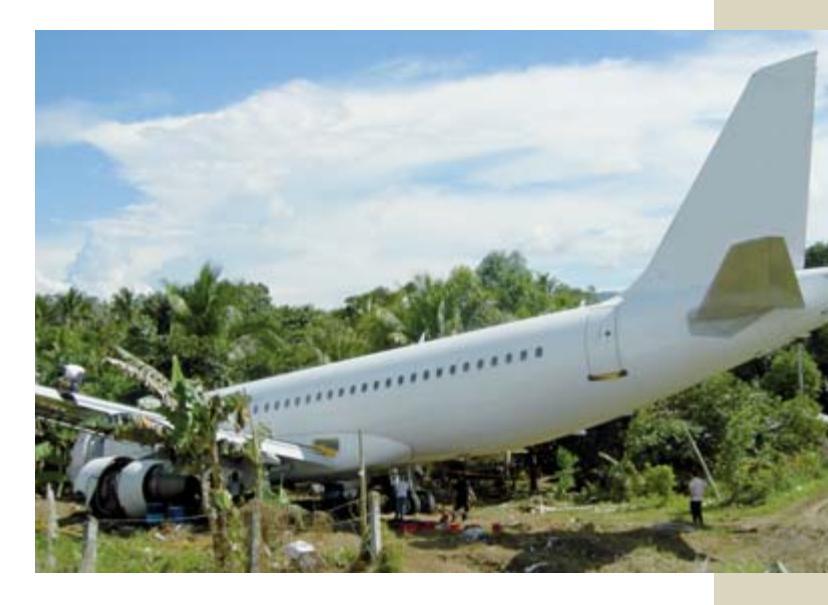
At about 1 150ft RA, during the LH turn to intercept the runway centerline, configuration FULL<sup>5</sup> was selected (CAS was 170kt; VFE = 177kt) and within about one second, speedbrake lever was pushed aft to command extension. To do that, the crew disarmed the ground spoilers.

The F/O announced "High speed he" and immediately after "Let's circle again it's too high" followed by "High".

Slats and flaps surfaces reached the position FULL about 3s after the crew selected this configuration. Speedbrakes started to retract (speedbrakes are inhibited in configuration FULL on A320).

A Single Chime (SC) sounded, which corresponds to the "SPD BRK DISAGREE" caution, triggered because of the difference between the actual position of the speedbrakes (retracted) versus the commanded position (extended).
