Incorrect pitch trim setting at takeoff

Safety first #09 February 2010 - 3/5

Safety First

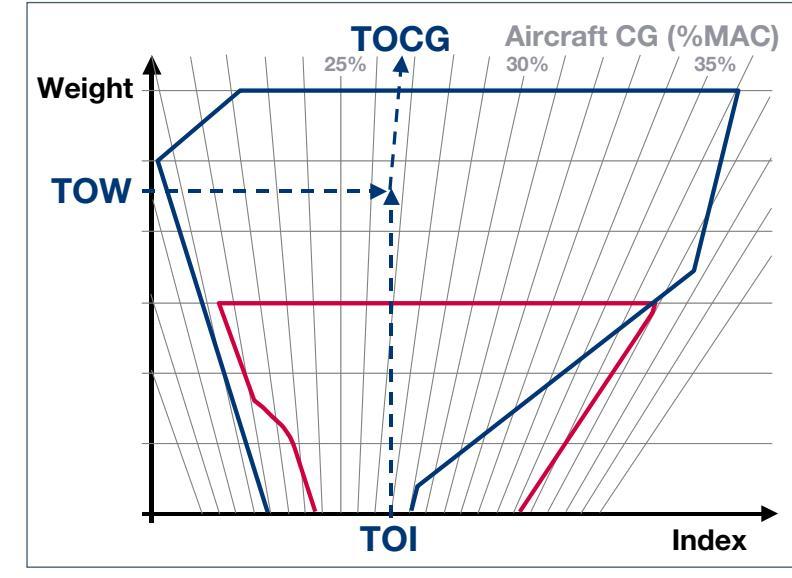
Figure 1 Determination of the TOCG

To determine the TOCG (expressed in percent of the Mean Aerodynamic Chord, %MAC) it is necessary to determine the Takeoff Weight (TOW) and the Takeoff Index (TOI) (fig. 1).

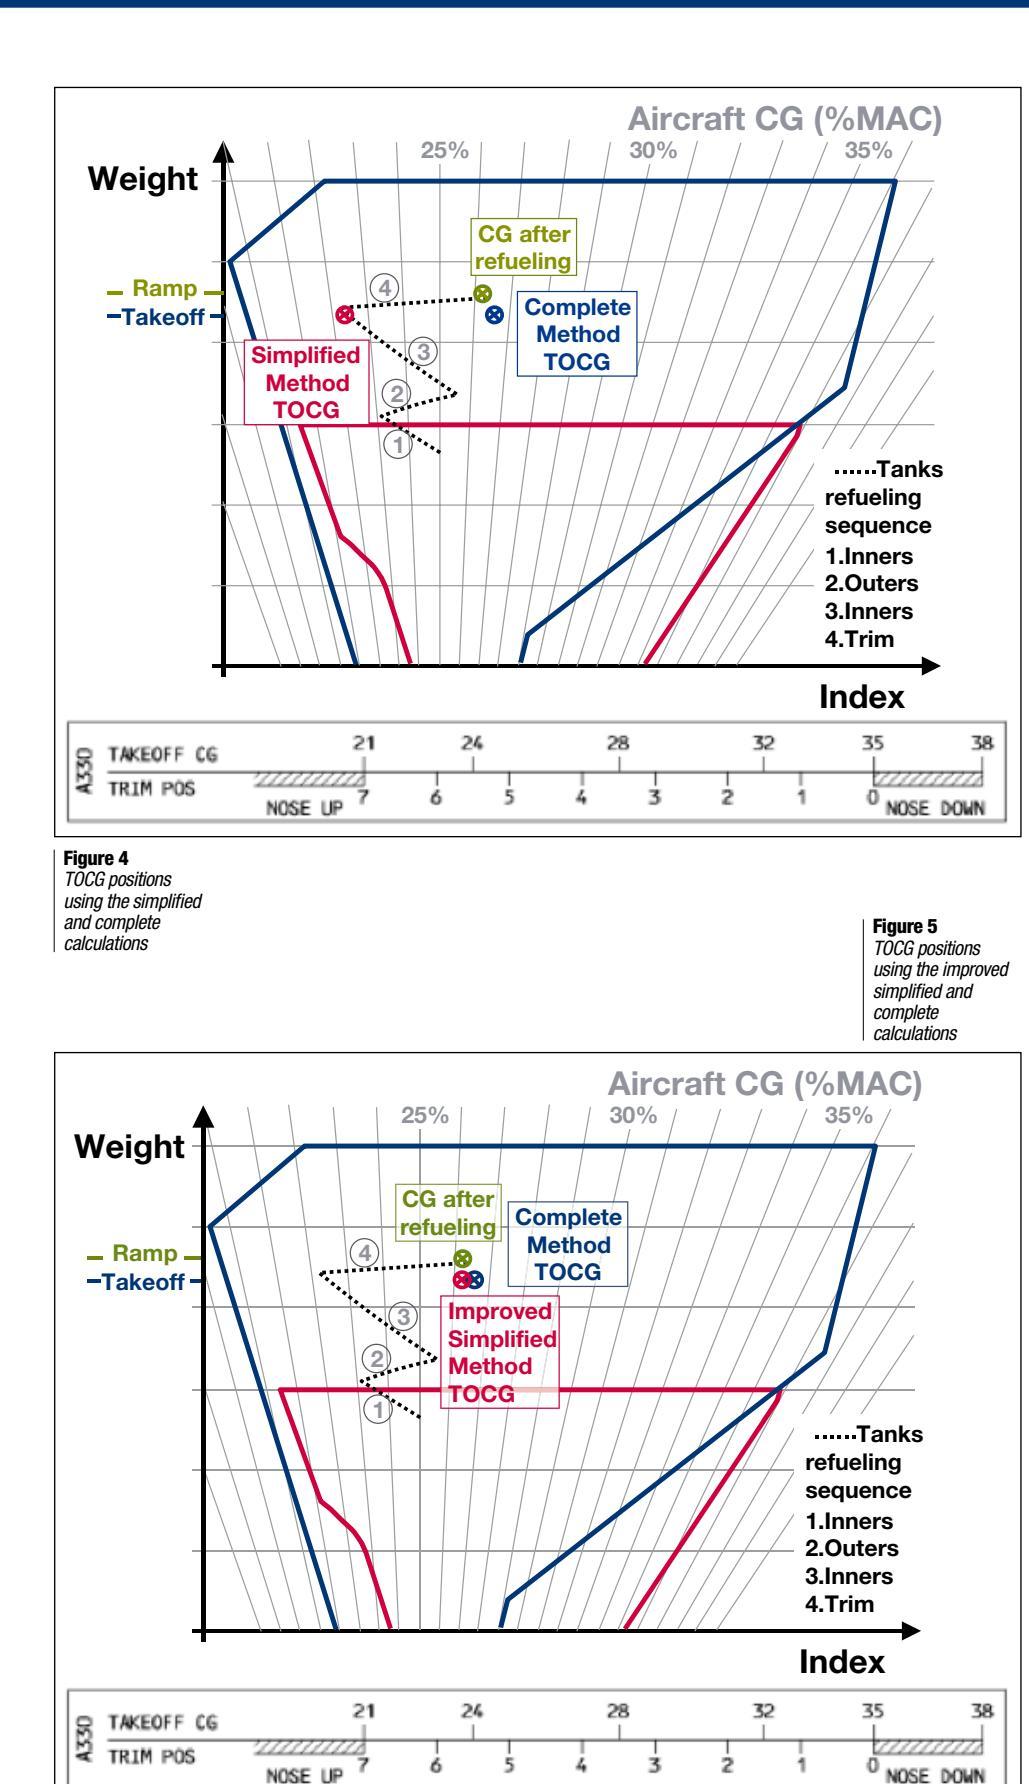
Figure 3 A330 fuel tank configuration

On the A330 example mentioned in the introduction, the Ramp Fuel was 39 tons and the Taxi Fuel was 2.6 tons. In this configuration, the last refueled tank is the trim tank, and the taxi fuel is burnt from the inner tanks, as shown in fig.3.

The simplified TOCG calculation gives a TOCG at 22.2%MAC, that corresponds to a pitch trim setting of 6.4 degrees NOSE UP. The complete calculation taking into account the taxi fuel burn gives a TOCG at 26.7%MAC, that corresponds to 4.1 degree NOSE UP.

The aircraft CG moves backward during the taxi-out, whereas the simplified method considers that the CG moves forward.

The cause of the rapid rate of rotation of the aircraft was the difference in pitch trim settings.

To avoid any large CG discrepancy, Airbus recommends an improved simplified method where the TOI is calculated with the following formula:

TOI = Zero Fuel Index + Ramp Fuel Index

The Ramp Fuel Index replaces the Takeoff Fuel Index of the original simplified calculation because, on all Airbus aircraft, the taxi fuel is burnt in the tanks located near the aircraft's CG position.
