# Flying a Go-Around Managing Energy

# Safety first

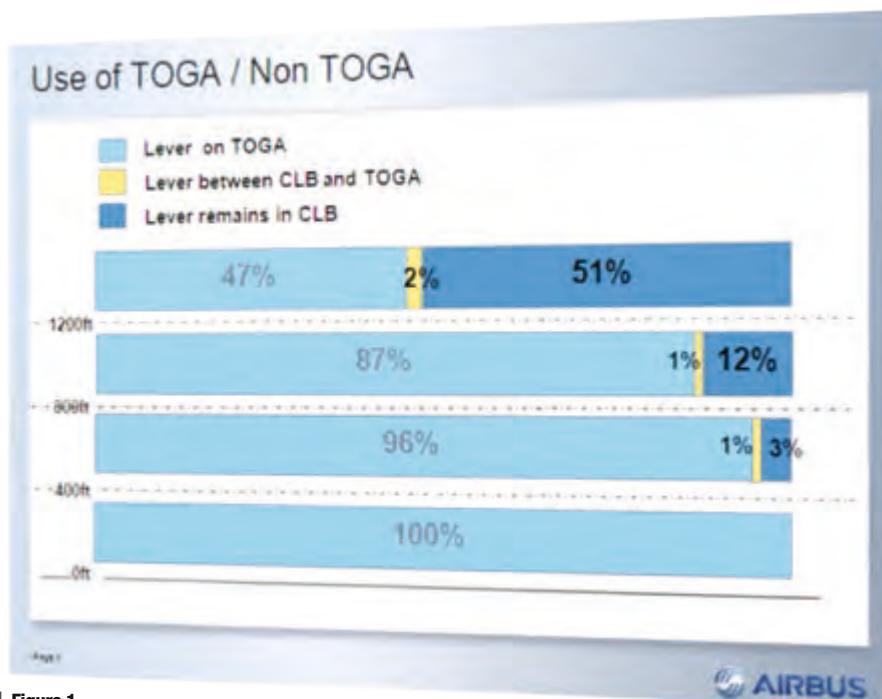
The main outcome of this survey was that, above 1,200 ft AAL, over half of the go-arounds were performed without selecting the thrust levers to the TOGA detent (fig1).

Perhaps the most obvious result of this research was that with go-arounds at heights above 1,200 ft the adherence to the Airbus standard go-around procedure was only about 50%.

The reason is that crews are reluctant to use TOGA power, even briefly, if they only have a short climb to their FCU Altitude.

**Figure 1**  
Airbus survey on the use of TOGA during go-around

**If TOGA thrust is not required, the flight crew should set the thrust levers to the CL detent, after having selected them to TOGA position just at the go-around initiation point.**

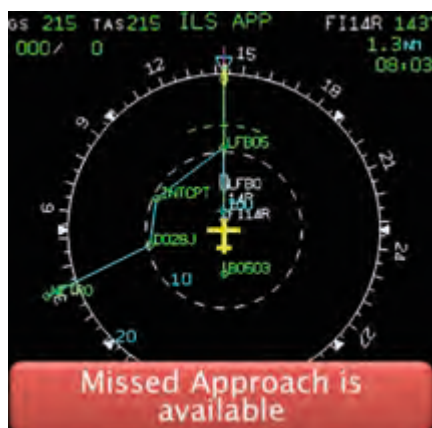
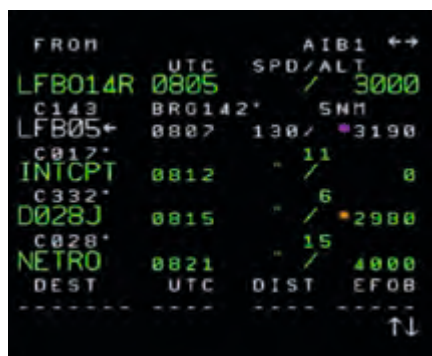
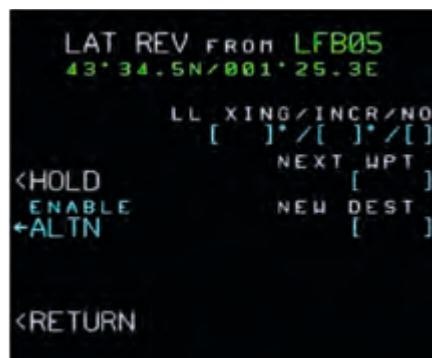
If the flight crew intends to fly the missed approach and overflies the last waypoint of the approach, the FMS considers that the “destination” in the F-PLN has been achieved. The flight crew will have to enter a new destination, which could be the same airport or a diversion airport.

**Figure 4**  
The missed approach remains available when discontinuing the approach. However, the FMS may have "lost" the destination
