The Airbus safety magazine

#26

Safety first, #26 July, 2018. Safety first is published by Airbus S.A.S. - 1, rond point Maurice Bellonte - 31707 Blagnac Cedex/France.

Look out for Ice Ridges on the Lower Nose Fuselage

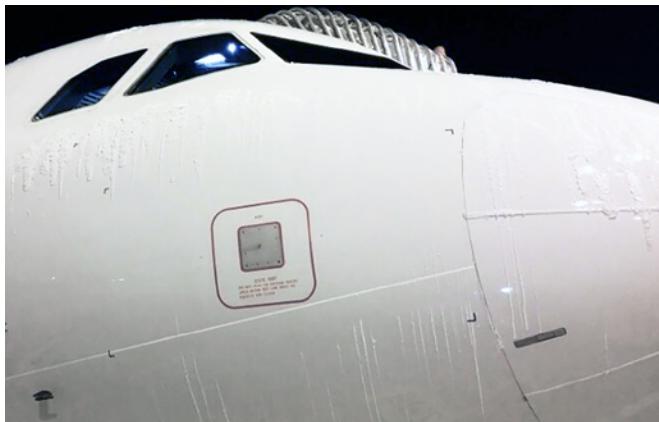
**(fig.3)**

The main cause of ice ridges over the lower nose fuselage of the aircraft is ice accretion during a long stay on ground in cold conditions (**fig.3**). A review of in-service events from the last 6 years shows that a large majority of ice ridges related events occurred during the first flight of the day.

Example of thin ice ridges forward of the pitot probes of an A320 family aircraft

The presence of ice ridges in front of Pitot probes during flight can occur when the lower nose fuselage is not de-iced at all or not completely de-iced. This is why all personnel working to dispatch an aircraft, from maintenance staff to flight crew, should pay particular attention to the potential presence of ice ridges in cold weather conditions, especially for the first flight of the day or after an extended stay on ground. The lower nose fuselage must be clear of ice before departure to avoid unreliable airspeed situation due to ice ridges and even thin ice ridges must be removed before departure.

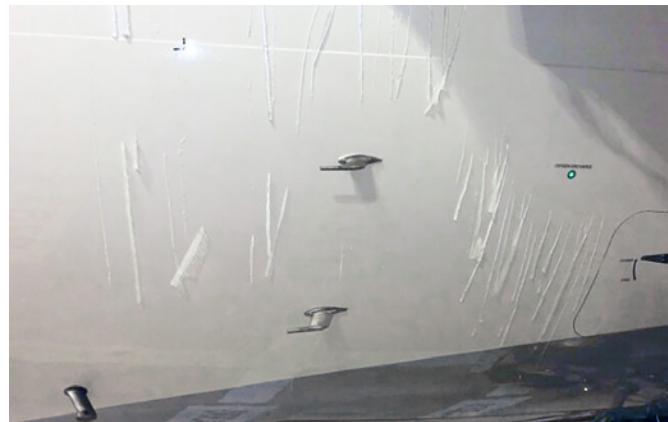
**(fig.4)**

Reported events also show that ice ridges may be dislodged during the flight or may remain attached to the lower nose fuselage for the entire flight (**fig.4**).

Example of ice ridges that remain on the lower fuselage even after completing a flight.

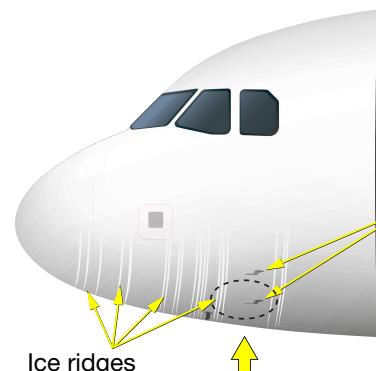
“ A large ice ridge but also successive thin ice ridges can significantly impact the airspeed measurement. **”**

Pitot probes

Ice ridges

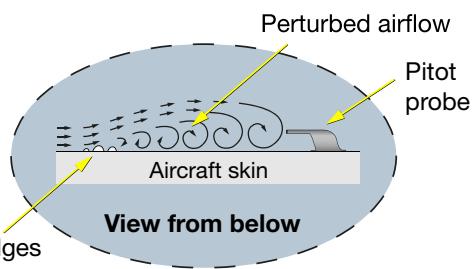
**(fig.5)**

Effects of the ice ridges on the airflow forward of the Pitot probes

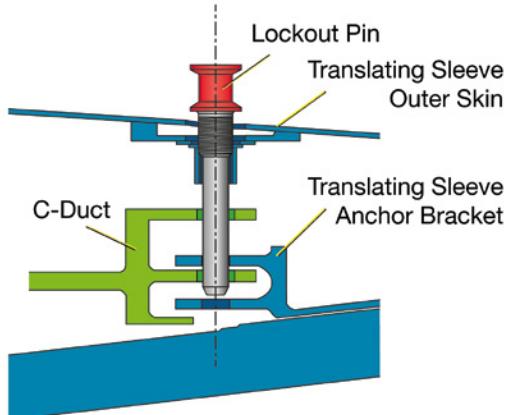
Case 1: Lockout pin partially engaged due to insufficient or incorrect threading

In this case, which is illustrated in **(fig.4)**, the lockout pin has engaged with the outer cascade ring hole, but only partially engaged with 1 of the 2 anchor bracket holes.

If the grey collar of the lockout pin is visible above the thrust reverser skin, the lockout pin is not correctly installed

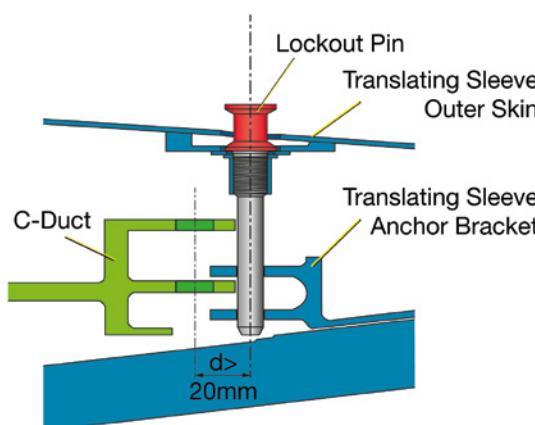
**(fig.7)**

Case 3: Lockout pin not engaged in the lockout assembly

In this case, which is illustrated in **(fig.7)**, the translating sleeve was not fully retracted and the lockout pin has engaged with the anchor bracket but NOT with in the aft cascade ring of the C-Duct.

Lockout pin not engaged in the lockout assembly

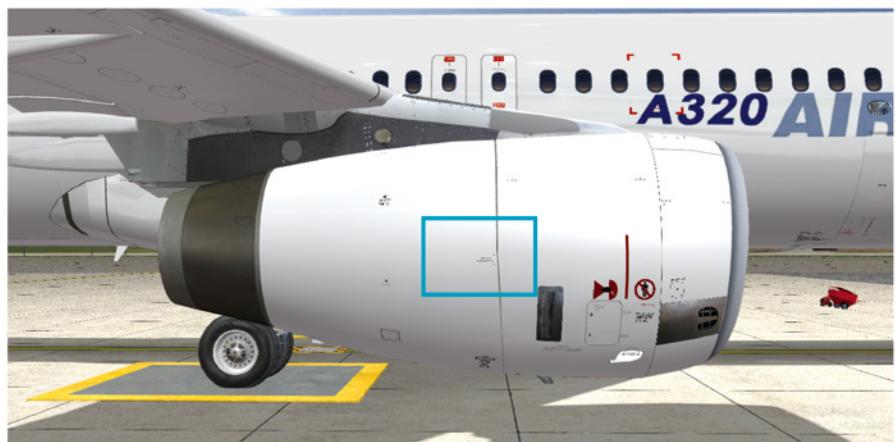
(fig.8)

Correct and Incorrect position of the thrust reverser

“ Always confirm that the thrust reverser translating sleeves are retracted to their fully stowed position before installing the lockout pins ”

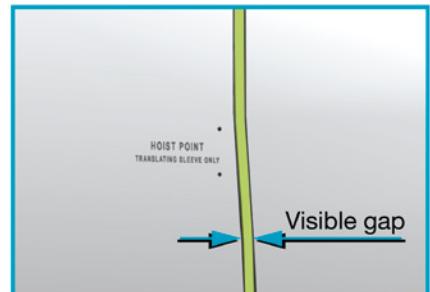
(fig.8b)

Reverser NOT fully retracted
