A350 Flight Crew Training Policy and Development

Automatic Landings in Daily Operation

The Airbus Safety Magazine

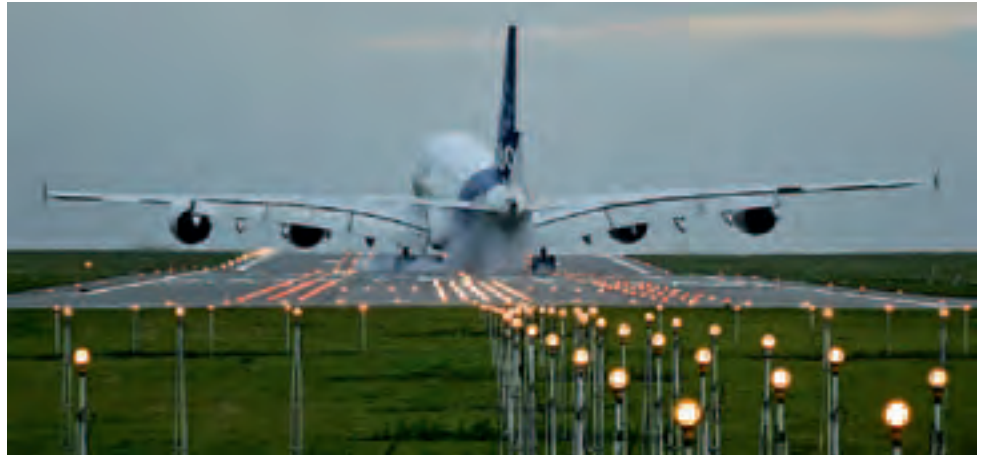
Flight Recorder data revealed that both LOC signals suddenly became unreliable (down to -137 microA / up to +36 microA), with similar values on both sides for approximately 10 seconds, starting at 300 ft RA.

When crossing 200 ft RA, the LOC signals reached up -137microA. The red AUTO LAND warning triggered for three seconds, as per design, and the LOC deviations were more than 20microA in LAND mode. Then, LOC deviations returned to approximately 0 microA and the flight crew manually performed the landing without any consequences.

This case illustrates a typical example of externally-caused disturbances of the LOC signal: the system worked as per design (AUTO LAND warning triggered) and the flight crew made an appropriate decision.
