Preventing Fan Cowl Door Loss

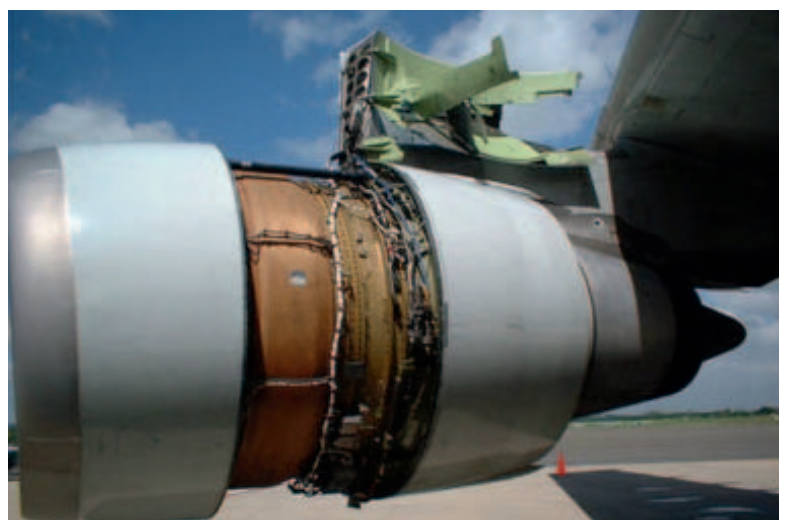
Figure 1
Fan cowl loss event

A fan cowl loss generally leads to twisted pylon cantilevers and/or minor damages to slats, wing leading edges, horizontal stabilizers and fuselage skins.

skin panel perforation or serious damage to the vertical or horizontal stabilizers. This type of damage represents a major hazard in terms of handling in flight and also often requires major repair work to rectify on the ground.

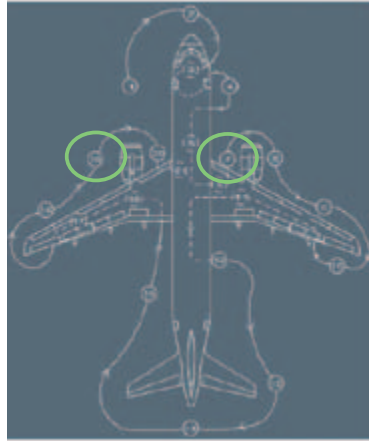
- Oil fill access door.....CLOSED
- Fan cowl doors CLOSED/LATCHED
- * Drain mast.....Condition/NO LEAK
- * Engine inlet and fan blades.....CHECK

- Oil fill access door (CFM and IAE only)..... CLOSED
- Master magnetic chip detector access door (IAE only) CLOSED
- * Thrust Recovery Nozzle (PW only)..... CLOSED/LATCHED
- Hydraulic filter visual access door (PW only).....CLOSED
- * Fan cowl doors CLOSED/LATCHED
- * Drain mast..... Condition/NO LEAK
- * Engine inlet and fan blades..... CHECK

Figure 4
FCOM Exterior walk-around check

As part of this inspection, it is essential that a flight crew member visually inspects the fan cowl doors prior to each flight to ensure that they are closed and latched (ref. 3, fig. 4).
