## Take Care of the Wheel Tie Bolts

A significant number of missing wheel tie bolts have been reported to Airbus over the last 5 years. A few of these reports have described significant damage to the wheel or brakes.

# Safety first

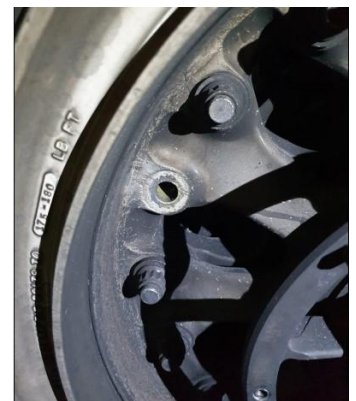
A missing or damaged tie bolt or may be detected during the daily check or preflight walkaround (**fig.3**). If the tie bolt damage is located on the inner hub side of a wheel equipped with brakes, or if the wheel has a brake cooling fan assembly fitted to it, it is more difficult to see if the tie bolts are damaged.

**(fig.3)** Example of missing tie bolt detected during a preflight walkaround (picture sent by an operator)

As per the AMM/AMP/MP procedure, if one of the tie bolts is found missing, the wheel must be removed and visually inspected for damage as well as the brake assembly.
