Using Approved Tools and Ground Support Equipment for Maintenance

This article describes events where the use of unapproved GSE or tools led to serious incidents. It explains why it is important to only use GSE or tools from approved suppliers to ensure safe aircraft maintenance and operations.

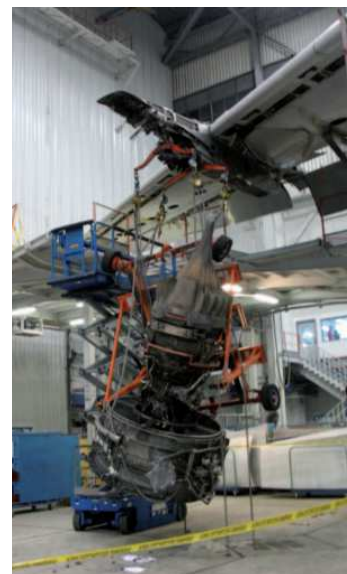
(fig.1) Picture of the event

The engine of an A321 aircraft was being replaced. The maintenance team installed the engine bootstrap equipment that is used to hold and lower the engine during the removal task. When the engine was disconnected and separated from the pylon, the engine suddenly fell (**fig.1**). Fortunately, nobody was injured. The engine pylon was damaged and needed to be partially replaced. The engine was damaged beyond economical repair.

Inspection of the bootstrap equipment on the hanging engine showed that one of its attachments had bent under the load of the engine and it eventually ruptured, which released the engine it was supporting, causing it to be damaged from the fall.

The investigation found that the bootstrap equipment was not compliant with the Airbus technical specifications. The sizing and material of the attachments, which were a part of this equipment, were not correctly sized and this caused the equipment to fail.

The supplier of the engine bootstrap equipment was not listed in the Airbus Tools and Equipment Manual (TEM). The Operator had found the equipment supplier on the internet. The bootstrap equipment advertised on this supplier's website indicated the same part number as the one listed in the AMM, but its cost was significantly lower than the equipment available from approved suppliers listed in the TEM. ■

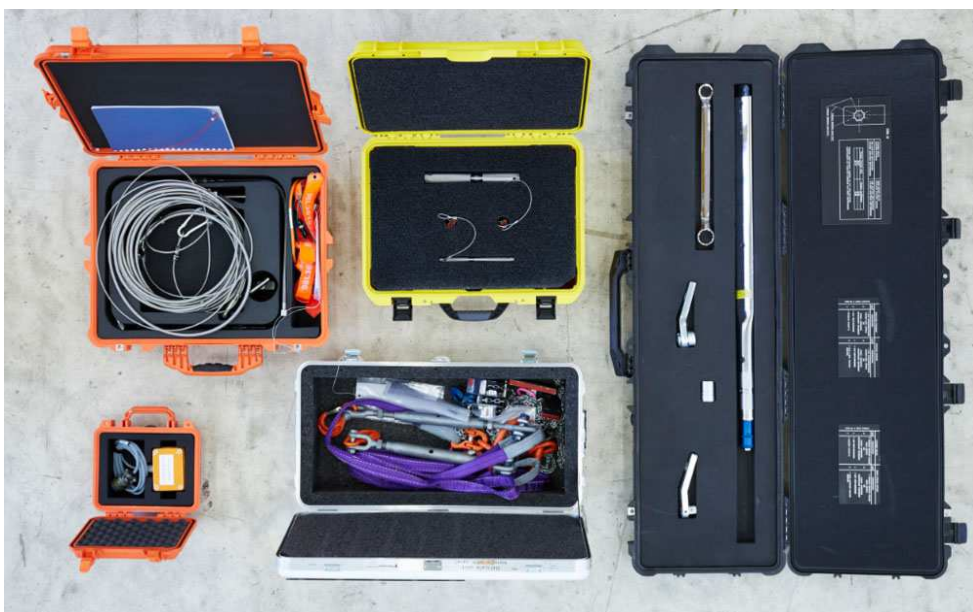
(fig.4) Example of approved tools

Approved GSE and special tools are designed so that they can precisely fit and sustain the loads that they will be exposed to when used. Specific materials, dimensions, and manufacturing processes for GSE and tools ensure that when used correctly, they will not fail in use, cause damage to the aircraft, or injure people.
