The Airbus Safety magazine

Under the Spotlights

Two recent events with damage to the passenger windows of the aircraft were reported to Airbus. Similar events also happened on non-Airbus aircraft. The damage was caused by the heat of spotlights used during promotional filming sessions. One of these events could have had serious safety consequences as damage was not detected on ground, and caused some window panes to detach from the aircraft during the next flight.

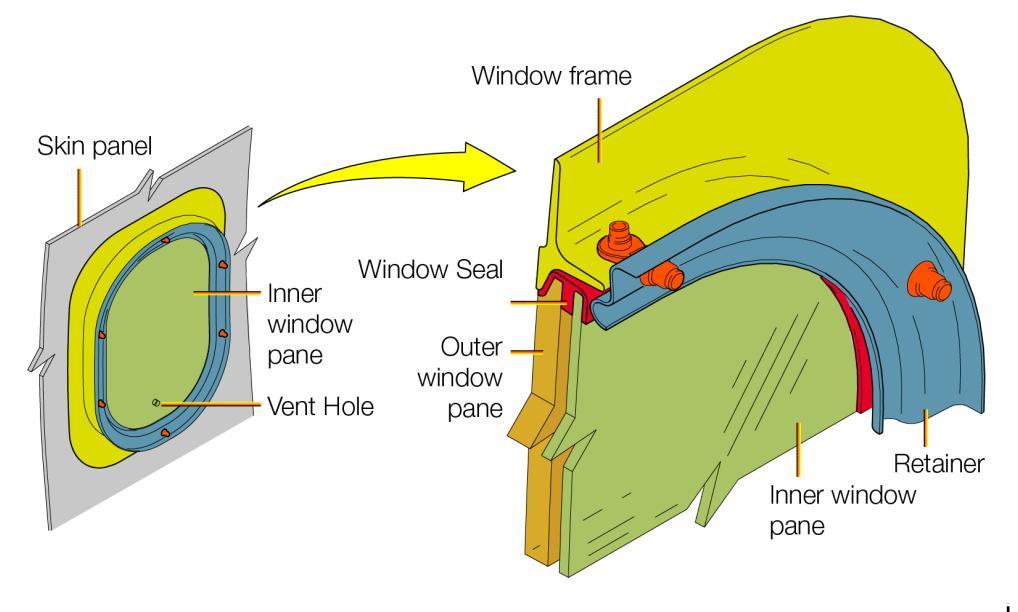
(fig.6) Typical structure of a cabin window

A cabin window assembly is typically composed of one inner and one outer pane made of **stretched acrylic** contained in a window seal **(fig.6)**. An additional transparent lining (not shown in the illustration) is present on the cabin side to protect the inner pane from impacts or scratches from the passenger side.

If the outer pane fails during a flight, the inner pane is designed to sustain the differential pressure loads and maintain the cabin pressure, which allows the continuation of the flight. The window assembly can then be replaced when the aircraft is back on the ground.

If the passenger window panes are exposed to an excessive amount of heat, **the panes may start to shrink and could become smaller than the window frame.** If a damaged window is not detected before the aircraft returns to service, as in the event described earlier, there is a risk that the cabin pressure differential at altitude will force the affected window pane outwards, causing cabin air pressure leaks and eventually the ejection of the window pane (**fig.8**). If both the inner and outer panes are affected by the heat damage, the complete window assembly could fail and be ejected.

Airbus recommends not to use high thermal radiation lighting devices, such as halogen (tungsten) or HMI lighting, during photoshoots or filming sessions outside or inside an aircraft. This type of lighting device emits a large amount of thermal energy. **Only use low energy lighting devices, such as LED lights,** which provide good lighting capabilities with low heat emission.

hot weather regions, Airbus recommendation is to make sure that the surface temperature of cabin and passenger windows, fuselage, interior equipment and all aircraft parts exposed to the lighting sources, **are monitored and do not exceed 55°C**.
