# A320 landing gear downlock

# Safety First

## The Airbus Safety Magazine

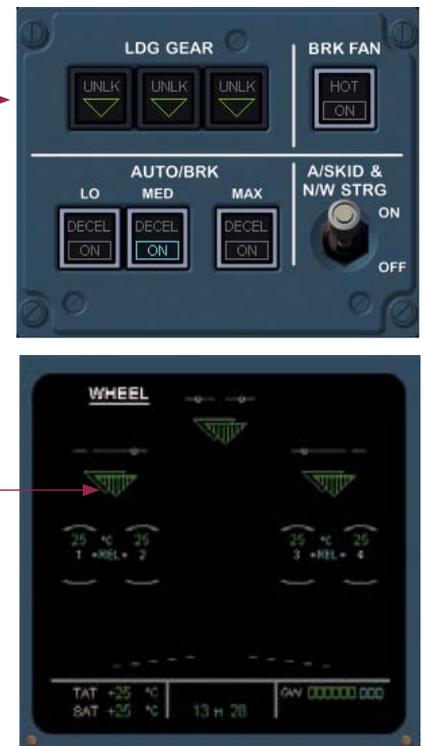
**Figure 1**  
Landing gear control and indication architecture

LDG GEAR CTL panel receives landing gear position feedback from LGCIU1 ONLY

ECAM WHEEL Systems Display (SD) page displays the landing gear position feedback from both LGCIU1 and LGCIU2

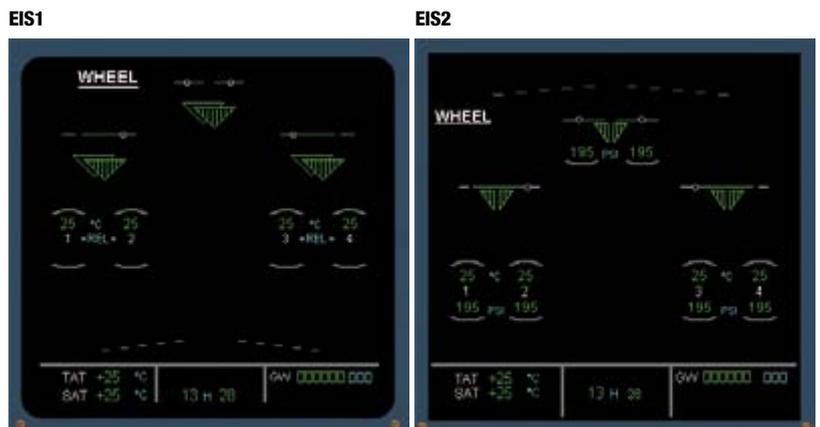
**Figure 2**  
EIS 1 versus EIS 2 WHEEL Systems Display Page

This article will utilise the EIS 1 display for the illustrations. However the article is applicable to both EIS 1 and EIS 2 displays.

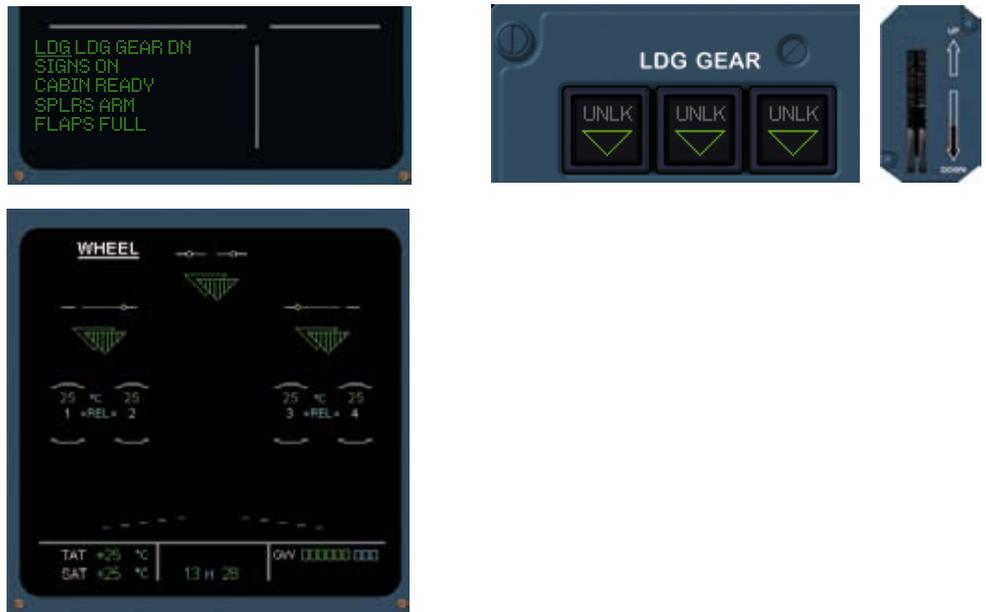
**Figure 3**  
Normal landing gear panel and WHEEL Systems Display landing gear downlocked indications following gear down selection

Following gear selection and downlock, the flight crew will observe the green downlock lights on the landing gear panel and two green triangles per landing gear position on the ECAM WHEEL Systems Display (SD) page. This provides confirmation that the gear is properly downlocked (fig 3).
