Christopher MCGREGOR

Director, Flight Safety

A320 landing gear downlock

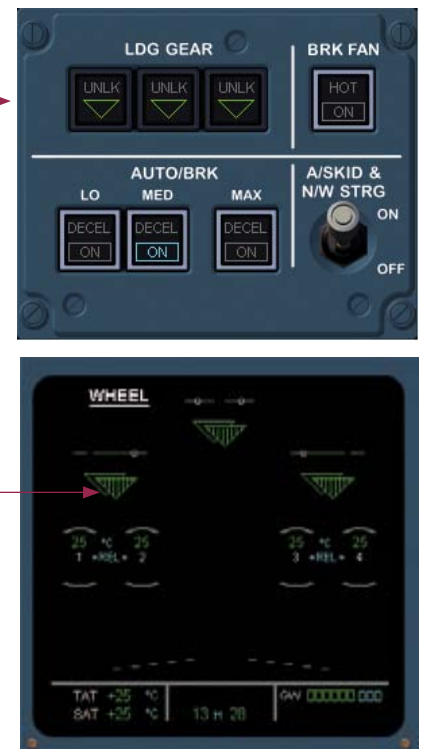
Figure 1
Landing gear control and indication architecture

LDG GEAR CTL panel receives landing gear position feedback from **LGCIU1 ONLY**

ECAM WHEEL Systems Display (SD) page displays the landing gear position feedback from both **LGCIU1 and LGCIU2**

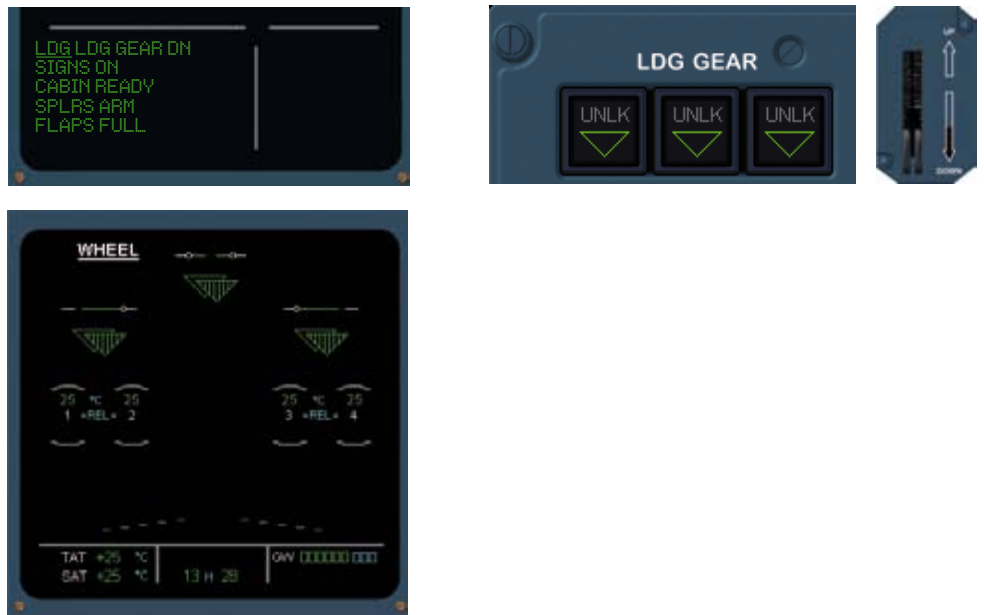
Figure 3
Normal landing gear panel and WHEEL Systems Display landing gear downlocked indications following gear down selection

Following gear selection and downlock, the flight crew will observe the green downlock lights on the landing gear panel and two green triangles per landing gear position on the ECAM WHEEL Systems Display (SD) page. This provides confirmation that the gear is properly downlocked (fig 3).
