# A340 Thrust Reverser Unlocked

**By: Vincent SWIDERSKI**  
*A340 Propulsion System Engineer CFM56-5C*  
**Per-Oliver GUENZEL**  
*A330/A340 Flight Safety Coordinator*

**Safety First**  
# 03 December 2006

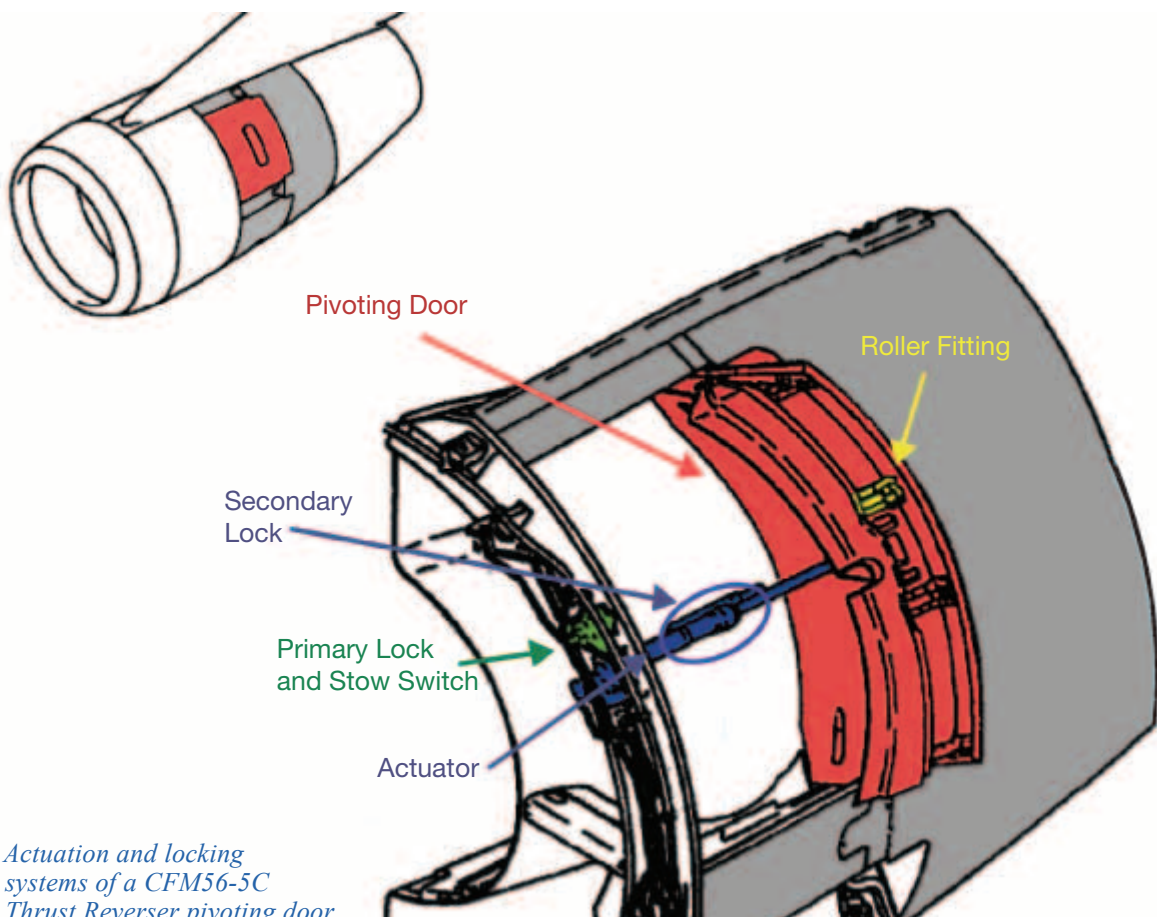
*Fig 2: Actuation and locking systems of a CFM56-5C Thrust Reverser pivoting door*

When the locking system is not pressurized, the secondary lock is engaged, ready to retain the actuator in its almost full-retracted position. If the primary lock fails, the door will extend slightly above the flush position before the secondary lock engages. In that case, the stow switch sensor is released (Fig 3), which leads to the generation of an “**ENG X REV UNLOCKED**” warning on the ECAM.

The above-described root causes usually lead to an unstable position of the primary lock between open and closed position. This unstable position switches to the open position (secondary lock activated) during the following flight due to engine acceleration/vibration. In most cases this happens during the takeoff run. An “**ENG X REV UNLOCKED**” warning is triggered and the crew performs a Rejected Take Off.

This is why troubleshooting has to be done in accordance with Ref. D or E in order to find the root cause and to apply the appropriate corrective action.
