Facing the Reality of Everyday Maintenance Operations

This article will cover the subject of tooling issues related to engine removal and installation procedures. However, the points raised here are illustrative as well of other maintenance operations.

The Airbus Safety Magazine

Safety First, #13 January 2012. Safety First is published by Airbus S.A.S. - 1, rond point Maurice Bellonte - 31707 Blagnac Cedex/France. Editor: Yannick Malinge, Chief Product Safety Officer, Nils Fayaud, Director Product Safety Information. Concept Design by Airbus Multi Media Support Ref. 20111714. Computer Graphic by Quat'coul, Fixion. Copyright: GS 420.0043/11. Photos copyright Airbus. Photos by ExM Company: P. Masclet. Printed in France by Airbus Print Centre.

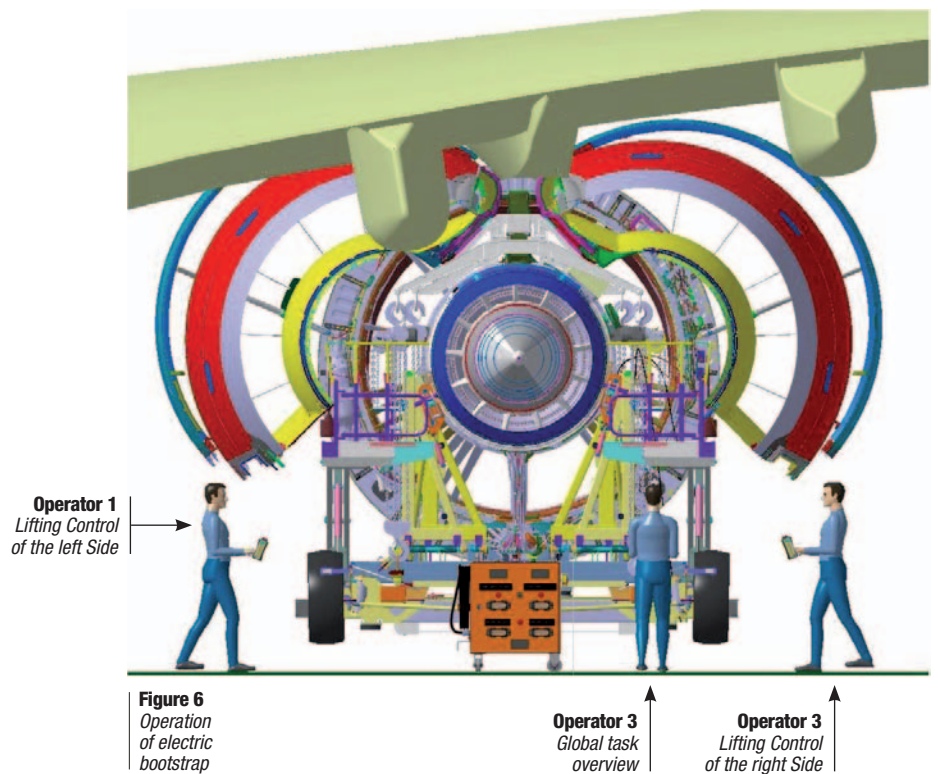
Figure 6
Operation of electric bootstrap

order to ensure a balanced bootstrap movement and an adequate load monitoring at all times. An overload may cause a life threatening structural failure of the bootstrap.

The lifting control achieved for the right and left hand side, as well as for the forward and aft hoists is performed by remote control devices (fig. 6), which include integrated load control displays. A warning system prevents any risks of overload.
