**Benoît DUVAL**

Safety Enhancement Manager
Aircraft Architecture and Integration

Transient Loss of Communication due to Jammed Push-To-Talk

A320 and A330/A340 Families

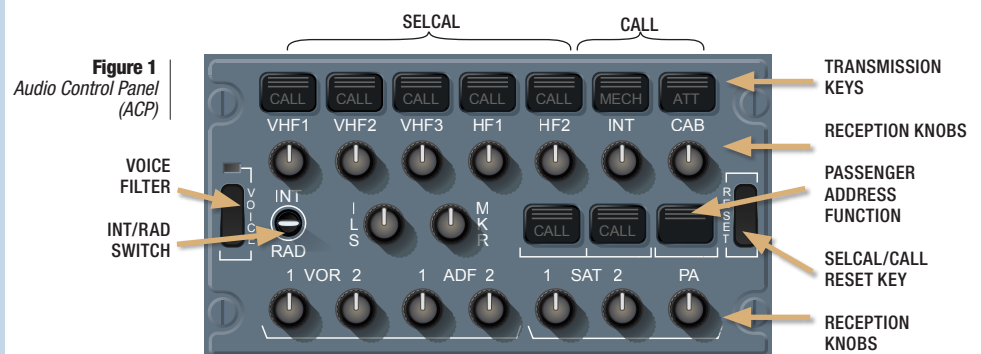
Figure 2
Push-To-Talk devices

devices: side stick radio selector, hand mike PTT, or INT/RAD switch on the ACP (fig.2).

When a Push-To-Talk device is jammed in the transmit position, the VHF transceiver transmits continuously as soon as it is selected, and no reception is possible on the tuned frequency.

1. If any Push To Talk (PTT) transmission selector (sidestick radio selector, hand mike selector, or PTT switch) is jammed in the transmit position, try to release it in order to remove the caution.
2. If unsuccessful, deselect the identified failed VHF/HF transmission keys on the associated Audio Control Panel (ACP) to remove the caution. This ACP should only be used in reception mode. The associated PTT transmission selectors must not be used.
