Transient Loss of Communication due to Jammed Push-To-Talk

A320 and A330/A340 Families

The Airbus Safety Magazine

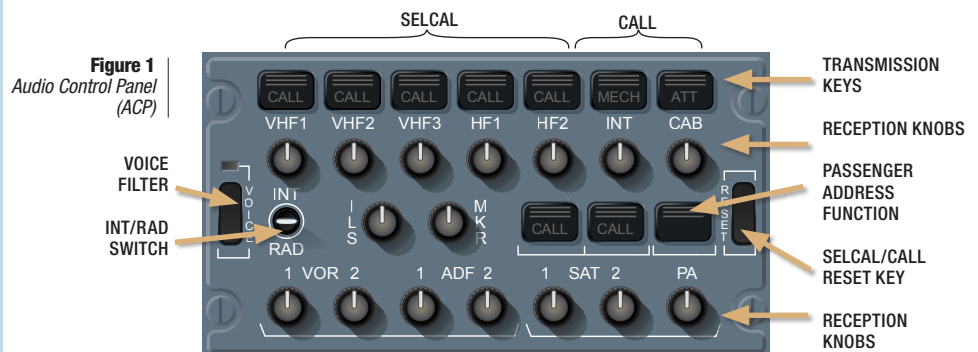
Figure 2
Push-To-Talk devices

devices: side stick radio selector, hand mike PTT, or INT/RAD switch on the ACP (fig.2).

When a Push-To-Talk device is jammed in the transmit position, the VHF transceiver transmits continuously as soon as it is selected, and no reception is possible on the tuned frequency.

1. If any Push To Talk (PTT) transmission selector (sidestick radio selector, hand mike selector, or PTT switch) is jammed in the transmit position, try to release it in order to remove the caution.
2. If unsuccessful, deselect the identified failed VHF/HF transmission keys on the associated Audio Control Panel (ACP) to remove the caution. This ACP should only be used in reception mode. The associated PTT transmission selectors must not be used.
