# A320 Family cargo Containers/pallets movement

No crew likes the idea of Unit Load Devices (ULD – containers and pallets) moving around in the cargo holds of their aircraft during flight. This type of occurrences may have multiple causes.

**Safety first, #18** July, 2014. Safety first is published by Airbus S.A.S. - 1, rond point Maurice Bellonte - 31707 Blagnac Cedex/France. Publisher: Yannick Malinge, Chief Product Safety Officer, Editor: Corinne Bieder, Director Product Safety Strategy & Communication. Concept Design by Airbus Multi Media Support 20141680. Reference: GS 420.0045 Issue 18. Photos by Airbus, H. Goussé, Lindner Fotografie, A. Doumenjou, C. Brinkmann, JB. Accariez, HGE, W. Schroll, S. Ramadier, F. Lancelot, F. Lepissier, A. Barth, P. Masolet, M. Fyrol, Aneese, P. Pigeyre. Computer rendering by Fixion. Printed in France by Art & Caractère.

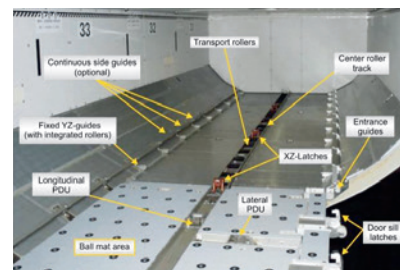
**(fig.1)**  
A320 Family CLS components

The CLS is composed of several components, which can be grouped according to their intended functions **(fig. 1)**:

- Guidance, thanks to entrance guides and YZ guides along each side of the holds.
- Transport and Conveyance, performed by power drive units on ball mats and roller tracks.
- Restraint of ULDs, ensured by XZ latches, installed on the centre roller track.

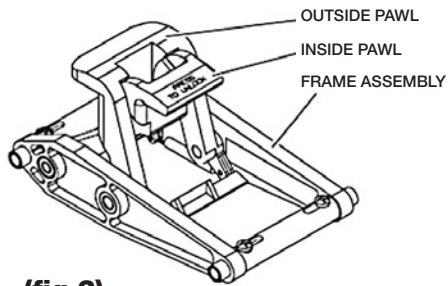
(fig.2)

XZ latch 2842T100 series

The ULDs are maintained in position by XZ latches, which consist of an aluminium frame and a pair of spring-loaded interlocking pawls.

If the outside pawl is lifted up, the inside pawl extends and locks automatically. Conversely, if the inside pawl is depressed into the retracted position, the outside pawl automatically folds down (fig.2).

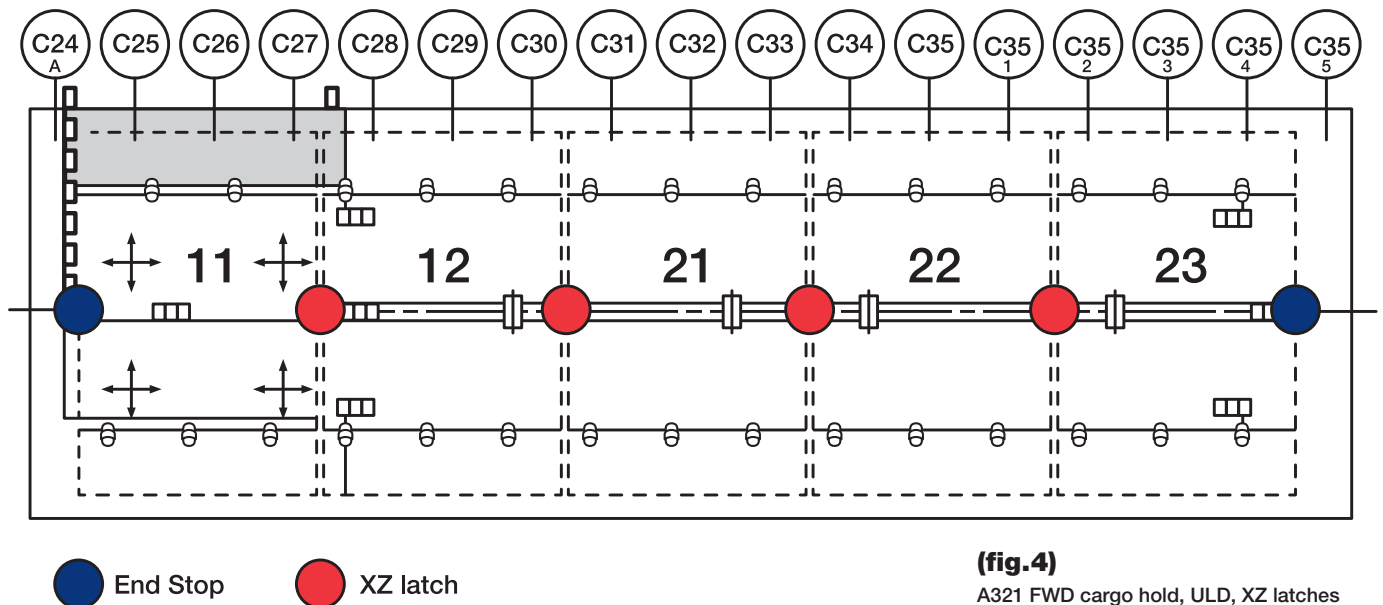
(fig.4)

Each ULD is then restrained by one XZ latch on each side of their baseplate or by one latch and one end-stop for those located at the borders of each holds (fig.4).

A321 FWD cargo hold, ULD, XZ latches and End stops positions
