The Airbus safety magazine

#28

Safety first, #28 July, 2019. Safety first is published by Airbus S.A.S. - 1, rond point Maurice Bellonte - 31707 Blagnac Cedex/France.

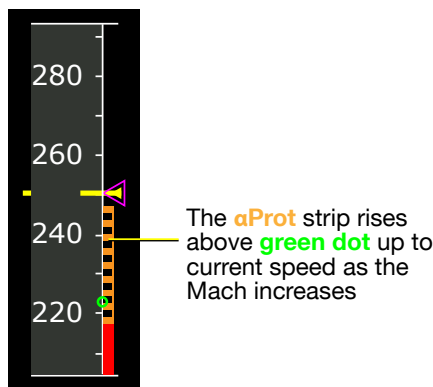
(fig.7)
Plot of the recorded airspeed, green dot speed, Valpha prot, Valpha max and Vmax during the event

In the event described, the flight crew of the A340 improperly applied OEB49. The **αProt** strip increase above green dot speed did not occur with Mach increasing and in stabilized wings-level flight, but instead resulted from sidestick pitch up inputs **(fig.7)**.

The preventive entry condition of the OEB49 was therefore not fulfilled. The reactive entry was not fulfilled either as the aircraft was climbing when the OEB was applied.

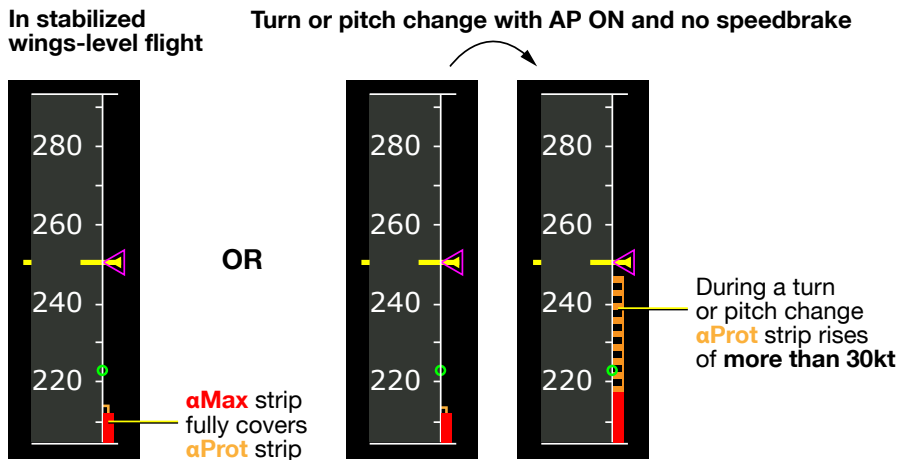
**(fig.8)**

- 1st preventive entry: The **αMax** strip completely hides the **αProt** strip in a stabilized wings-level flight path (without an increase in load factor)
- 2nd preventive entry: With the Auto Pilot (AP) engaged and the speed brakes in the retracted position, the **αProt** strip rapidly moves by more than 30 kt during flight maneuvers with an increase in load factor, for example turns or pitch variations.

Preventive entry conditions of the OEB48 for A320 aircraft

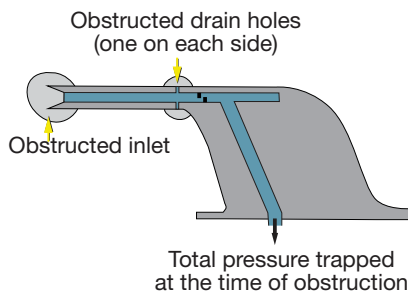
The “TOTAL PITOT BLOCKED” failure is available on simulators. This failure simulates a simultaneous obstruction of both the inlet and drain holes of a Pitot probe. As a consequence, the measured total pressure remains at a constant value corresponding to the total pressure measured at the time of the total obstruction.

(fig.1)
Illustration of the “TOTAL PITOT BLOCKAGE” simulated failure

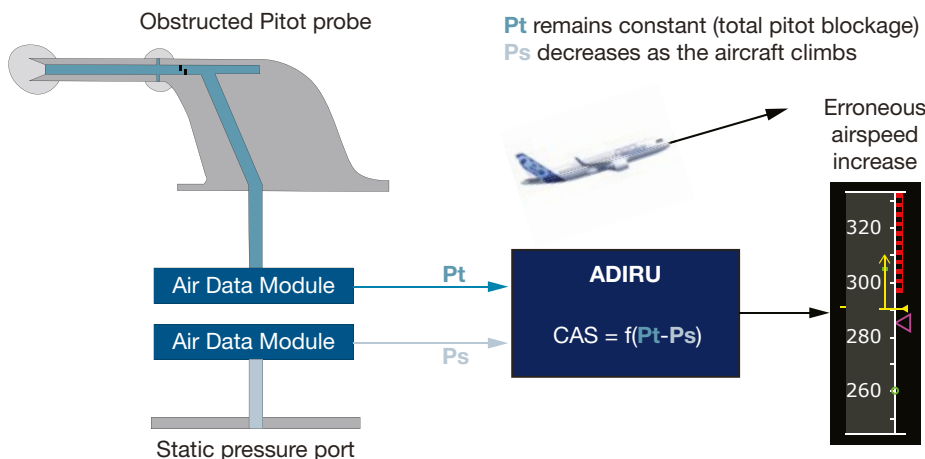
In the case of full Pitot blockage, at low altitude, when the aircraft climbs, the airspeed is computed wrongly based on the difference between the constant total pressure trapped inside the Pitot tube at the time of the obstruction and the current static pressure which is decreasing with increasing altitude. Therefore, when the aircraft climbs, the measured airspeed is permanently wrong and more and more overestimated. ■

(fig.2)
Example of the effect of the “TOTAL PITOT BLOCKAGE” simulated failure on the airspeed computation when in climb

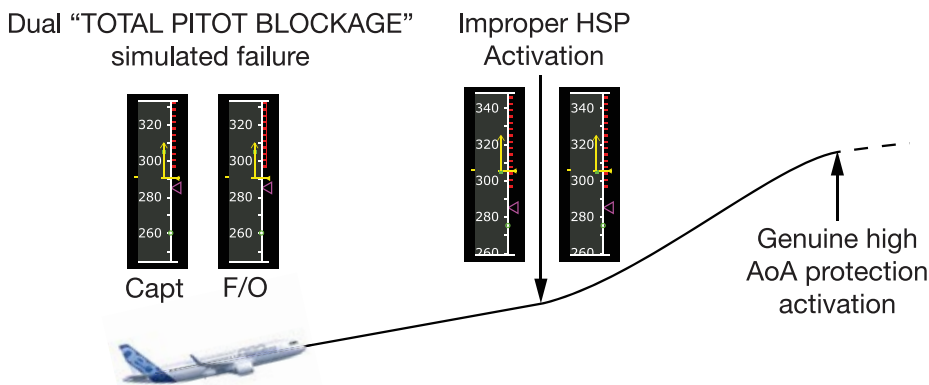
**(fig.3)**

This leads to a genuine increasing Angle of Attack (AoA) that will eventually result in the activation of the high Angle-of-Attack protection (as the high AoA protection has priority on High Speed protection). The high AoA protection will command a pitch down movement of the aircraft as long as the AoA remains above the AoA protection activation threshold.

Then either the aircraft exceeds the threshold that activates the abnormal attitude flight control law, or the high speed protection and the AoA protection alternatively activates. This results in large pitch oscillations with high speed protection becoming active again when the AoA becomes back below the high AoA protection activation threshold.

effects of a DUAL "TOTAL PITOT BLOCKAGE" simulated failure in climb

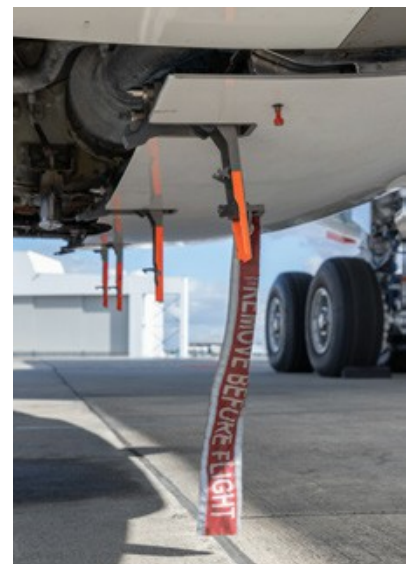
An improved latch with a key and a **REMOVE BEFORE FLIGHT** flag attached to the key (**fig.1**) has been introduced in December 2015 on the A320ceo aircraft. The key is needed to open the latch. When the fan cowl door is opened, the key remains on the latch. It can only be removed if the latch is fully closed. When not used, the latch key has to be stored in the cockpit with the landing gear pin.

(fig-1)
Latch with key and "Remove before flight" red flag on A330neo aircraft

The following Airworthiness Directives (ADs) mandate the retrofit of this new lockable latch on A320ceo aircraft equipped with IAE and CFM56 engines:

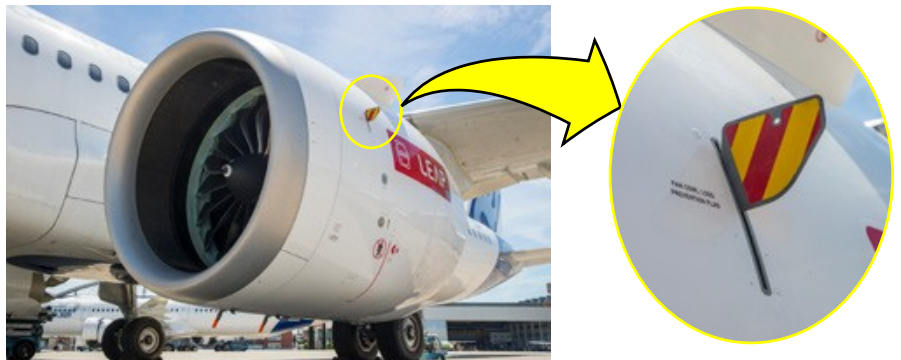
(fig.2)

In addition to the cowl position monitoring, a prevention flag extends mechanically from the surface of the left hand fan cowl when the forward latch is opened to warn the ground personnel and the flight crew that the latch is not closed **(fig.2)** on A320neo equipped with CFM LEAP-1A engines.

Mechanical prevention flag on an A320neo equipped with LEAP engines

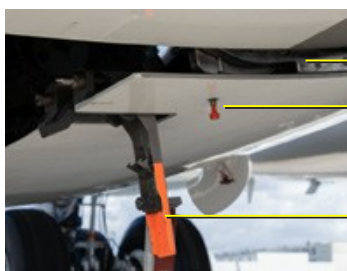
(fig.3)

A U-arrestor device holds the fan cowls in a partially open position when the cowls are lowered on A340 equipped with TRENT 500 engines and on A330neo with TRENT 7000 engines. It is obvious to the operator that the cowls are not fully closed when looking from below or from the side of the cowl. The U-arrestor pin must be pressed to close the fan cowl door **(fig.3)**.

A330neo U-arrestor

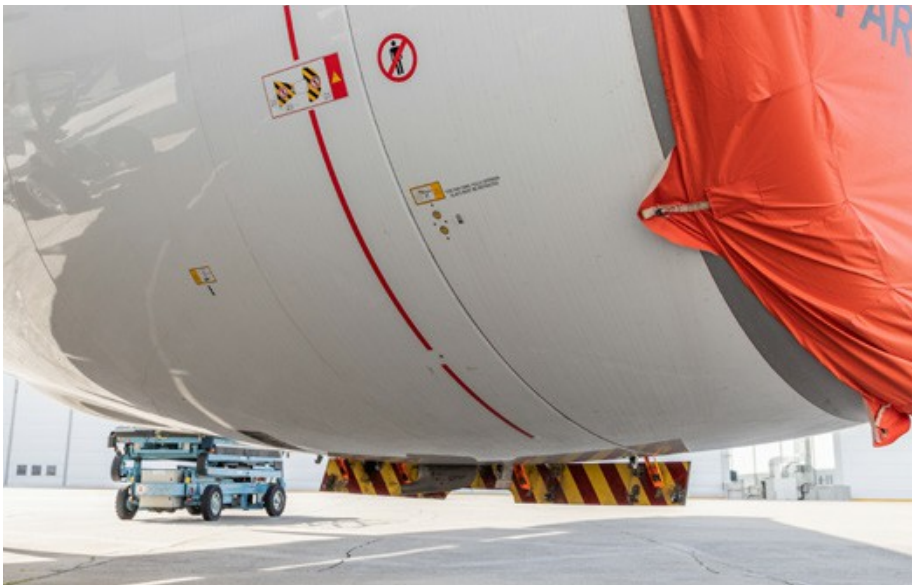
(fig.4)

If the fan cowl door latches are left open on the A350 or A380 aircraft, the latch access panel cannot be closed. This will be visible to ground operator or flight crew during an exterior walkaround check **(fig.4)**.

Engine of an A350 with fan cowl door latch access panel open

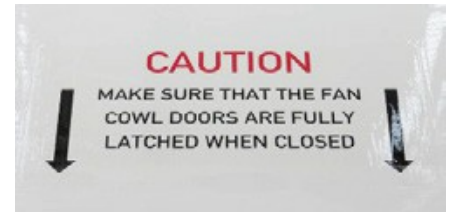
(fig.6)

Decals with cautions located at eye level ensure that fan cowl doors are closed and correctly latched before flight **(fig.6)** on A320 aircraft. They are installed on recent A320ceo production aircraft and on A320neo. They can also be installed by retrofit with the following VSBs:

Eye level decal with cautions

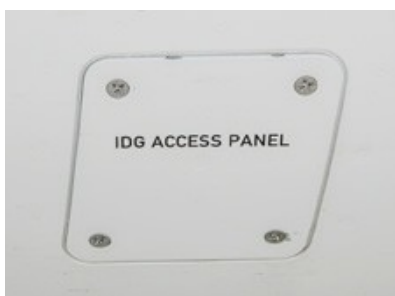
(fig.8)

An optional IDG access door is available on A320ceo aircraft equipped with CFM56-5A/5B engines. IDG oil level can be checked via this access door without opening the fan cowl doors. A320neo LEAP, A330ceo RR Trent 700 and A340-500/600 RR Trent 500 are already equipped with this IDG access door **(fig.8)**.

IDG oil access door on A320neo LEAP

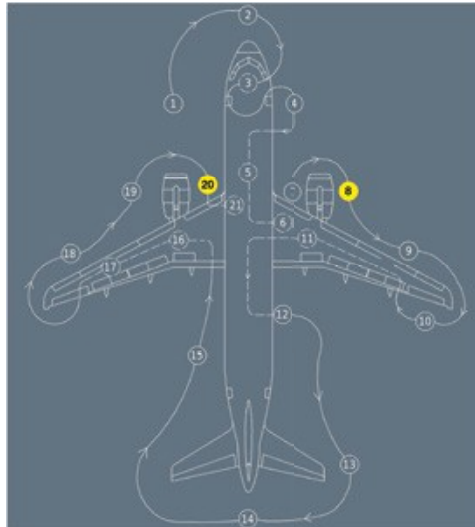
(fig.11)

Airbus updated the exterior walkaround section of the FCOM Standard Operating Procedures for all aircraft by introducing additional steps in the walkaround (**fig.11**). This change requests that the correct latching of the fan cowls is now checked from both sides of each engine.

Additional steps at stations 20 and 8 in the exterior walkaround of the A320 FCOM

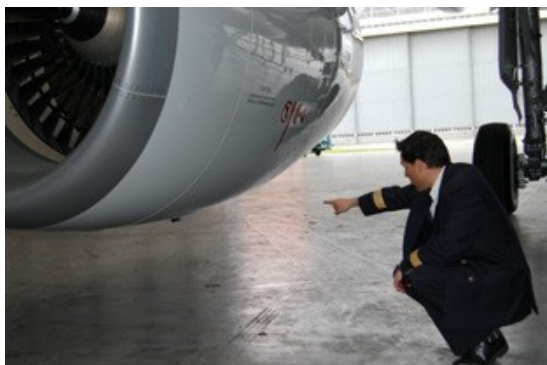
(fig.12)

The most effective way to confirm that all latch handles are correctly engaged and flush with the fan cowls is to crouch down to get a good line of sight with the latches. The flight crew needs to check on both sides of the engine to confirm there is no gap around the cowl and all latches are secured (**fig.12 and fig.13**). Use a torch light if the lighting conditions are poor or if the inspection is done by night. ■

The flight crew should crouch down to correctly check the fan cowl door latching

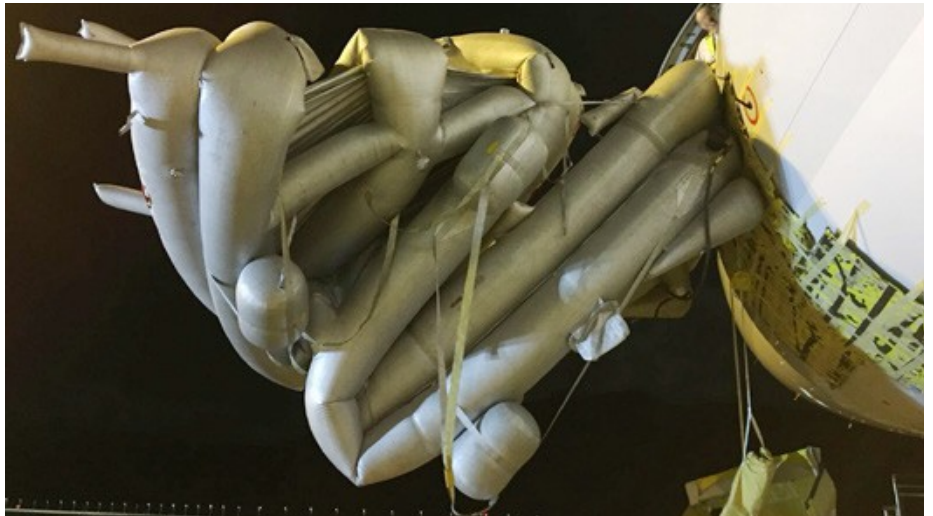
(fig.4)

Calibrated restraints are used to control the slide deployment sequence in various environmental conditions. They are designed to break with a pre-determined load when pulled during the slide inflation sequence. If an incorrect restraint is used, it may not release the slide during inflation and prevent the slide extending **(fig.4)**.

Consequence of the use of an incorrect restraint during packing. The slide extension is blocked.

To avoid this kind of event, a color code on restraints is a visual indicator of the the correct restraints load calibration and the slide folding instructions must be carefully followed.
