The Airbus safety magazine

Safety first

Safety first, #27 January, 2019. Safety first is published by Airbus S.A.S. - 1, rond point Maurice Bellonte - 31707 Blagnac Cedex/France. Publisher and Editor: Yannick Malinge, Chief Product Safety Officer. Concept Design by Airbus Multi Media Support 20182972. Reference: X00D16031905 Issue 27. Photos by Airbus, H. Goussé, J.V. Reymondon, A. Doumenjou, P. Masclet, F. Lancelot, C. Koshorst. Cover by: J.V. Reymondon.

Engine Thrust Management - Thrust Setting at Takeoff

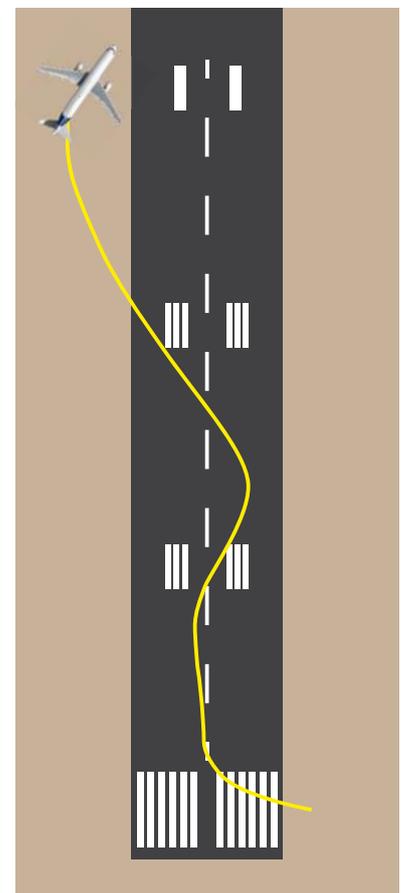
(fig.1)

View from above of the aircraft trajectory

Eventually, the PF released the brakes and moved the thrust levers forward to the FLX detent. Engine 2 accelerated more rapidly than engine 1 and the resulting thrust asymmetry caused the aircraft to veer to the left. The PF tried to recover the trajectory by applying right rudder input and retarding the thrust levers to reduce thrust on both engines. Consequently, this caused the aircraft to sharply veer to the right. The PF applied differential thrust combined with left rudder pedals and tiller inputs. This caused the aircraft to veer sharply to its left while continuing to accelerate. The PF reacted again to apply full right rudder input combined with asymmetric braking and applied maximum thrust reversers in an attempt to stop the aircraft. The aircraft eventually came to rest to the left of the runway at 300 meters from the threshold **(fig.1)**. During this event, the ground speed did not exceed 31 kt.

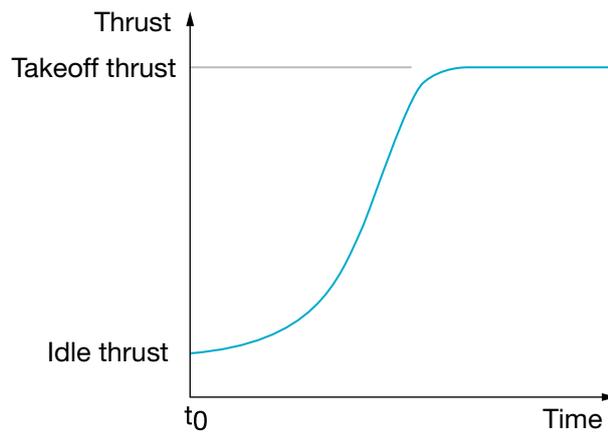
(fig.2)
Typical engine acceleration profile.

On all jet engines, but particularly on high bypass ratio engines, the engine acceleration profile is not linear (**fig.2**). It follows the engine control law that is defined to optimize the acceleration in a way that the risk of engine stall is reduced. It also takes into account the influence of the position of the engine installed on the aircraft and the effect on the airflow at the engine's inlet due to its proximity to the ground and the surrounding aircraft structure.

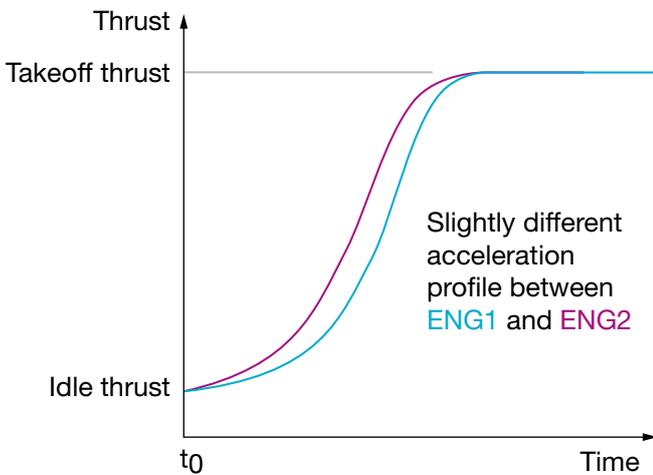
(fig.3)
Difference between engines' acceleration profile.

Every engine has its own performance level due to manufacturing tolerances. In addition, engine performance evolves with time due to wear and ageing. As a consequence, the acceleration profiles may slightly differ from one engine to another on an aircraft (**fig.3**), even if fitted with new engines.

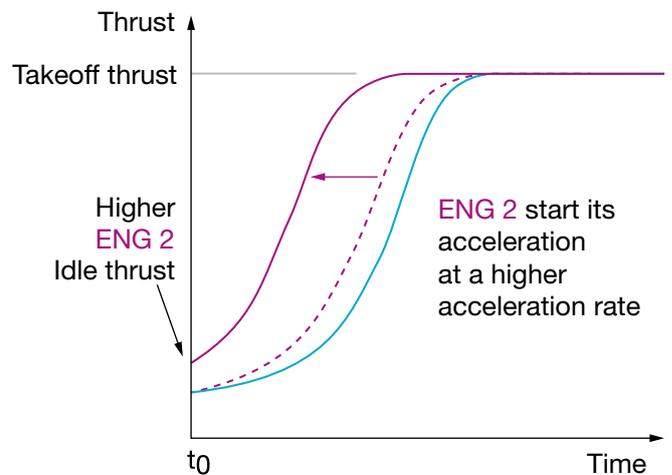
(fig.4)
Difference between engines' idle thrust.

Similarly, the idle thrust can slightly differ from one engine to the other, moving the acceleration profile to the left on the graph (**fig.4**).

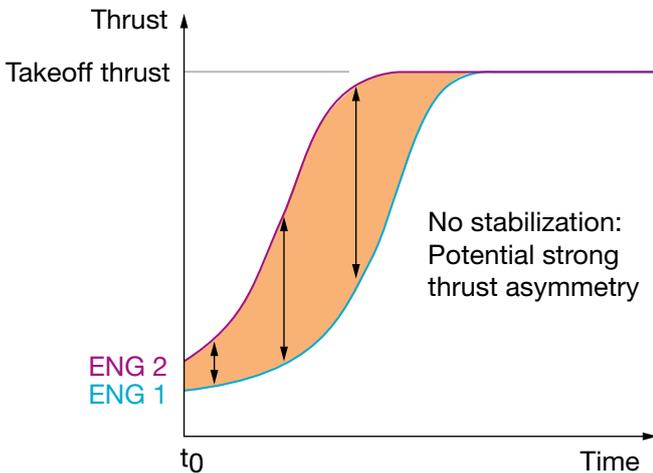
(fig.5)
Direct takeoff thrust application with no thrust stabilization step potentially creates a strong thrust asymmetry that may be difficult to counteract.

Taking into consideration both of these parameters, if the flight crew applies the takeoff thrust directly from idle thrust, without doing any stabilization step, the difference in engine acceleration performance could cause a strong asymmetric thrust condition **(fig.5)** that could be difficult to counteract with nose wheel steering only, due to limited effectivity of the rudder at low speed. ■

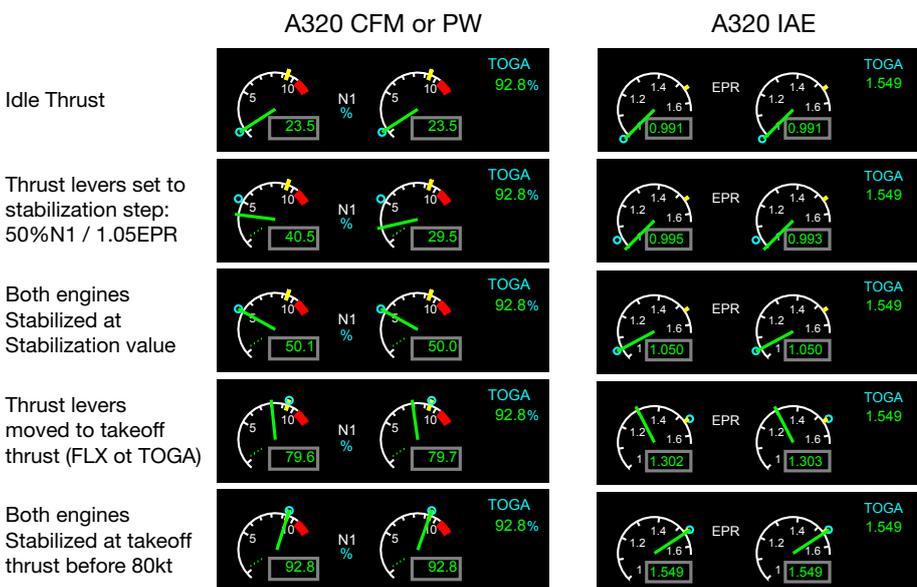
(fig.6)
Example of the standard thrust setting procedure at takeoff for an A320 aircraft depending on the engine type.

To avoid this potential strong thrust asymmetry, the FCOM SOP for takeoff provides a procedure that requests pilots to apply takeoff thrust in two distinct steps **(fig.6)** with some additional guidance for certain aircraft operating in the case of tailwind or significant crosswind conditions.

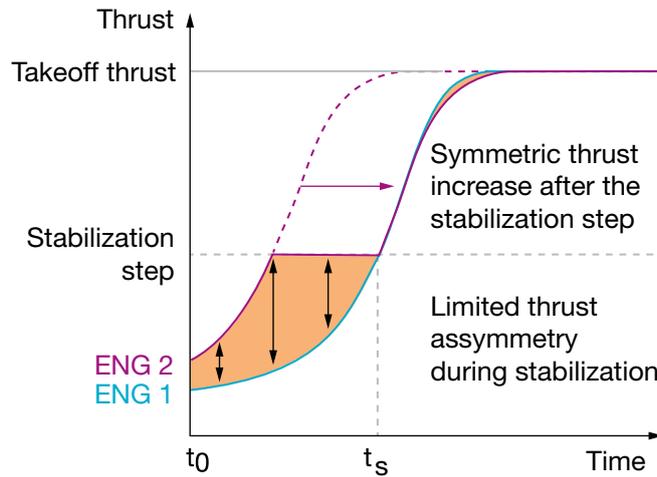
(fig.7)

The stabilization step ensures that all engines reach a rotation speed value from where the increase of engine thrust will be almost identical to each other **(fig.7)**. The N1/EPR/THR stabilization value is defined during flight test campaign for every engine type with collaboration from engine manufacturers.

During static takeoff, the brakes are released at t_s **(fig.7)** once all engines have reached the stabilization step value, therefore, the aircraft is not affected by any potential thrust asymmetry that can happen between t_0 and t_s .

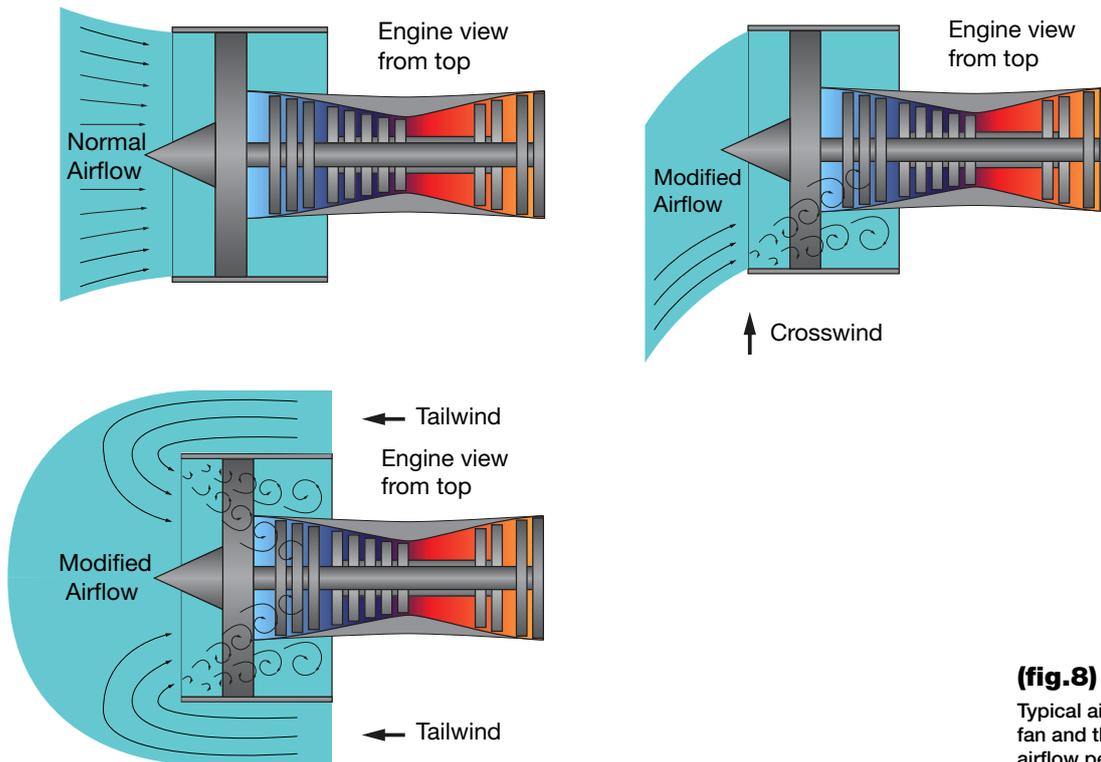
(fig.8)

Typical airflow distortion affecting the fan and the engine core with associated airflow perturbations.

In tailwind and significant crosswind conditions, the airflow entering into the engines is modified (**fig.8**). Some perturbations may appear downstream of the leading edge of the engine inlet and potentially cause an engine stall if the perturbed airflow enters the core of the engine.

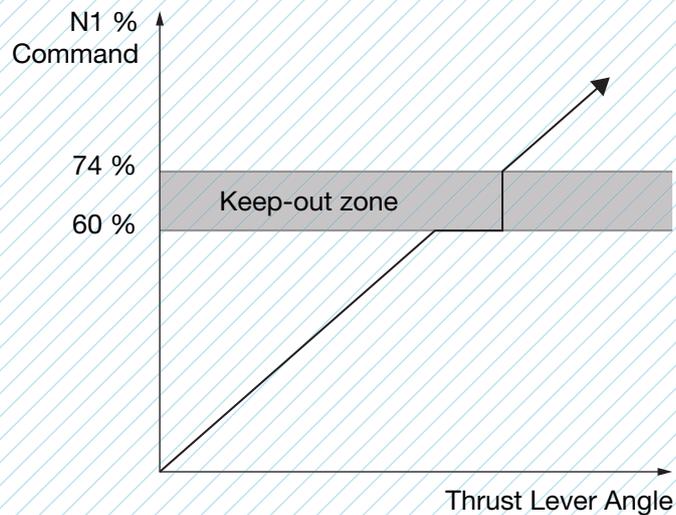
(fig.9)

Example of the keep-out zone on A320 aircraft equipped with IAE engines

On aircraft equipped with Rolls Royce or IAE engines, a “keep-out zone” prevents stabilized engine operation in a specific N1/EPR range, when on ground below a certain speed, to prevent fan instability. During the progressive application of the takeoff thrust after the stabilization step, the flight crew should ensure that the levers are advanced **continuously and simultaneously**. Moving the thrust levers too slowly may lead to asymmetric engine acceleration if one thrust lever is moved outside of the keep-out zone before the other.

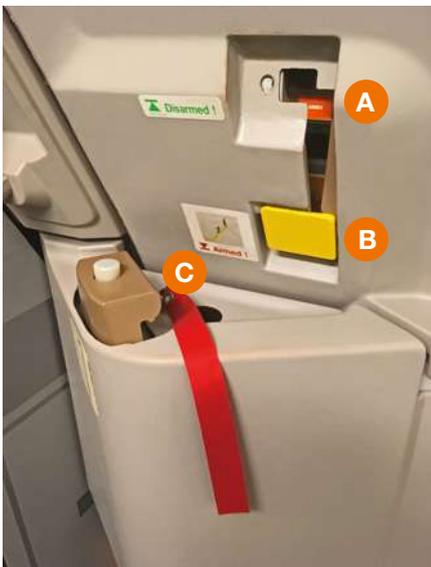
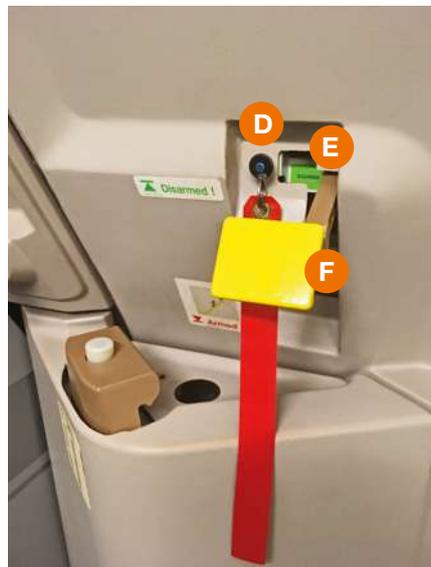
(fig.2)

ARMED/DISARMED conditions for A320 Family cabin door

- A** Visual indicator shows **ARMED** condition
- B** Arming lever in the **ARMED** position
- C** Safety pin in its stowage
- D** Safety pin installed
- E** Visual indicator shows **DISARMED** condition
- F** Arming lever in the **DISARMED** position

Once the arm or disarm action is complete, the principle means of confirmation of the door condition of the door is by use of the Visual Indicator **(fig.2)**.

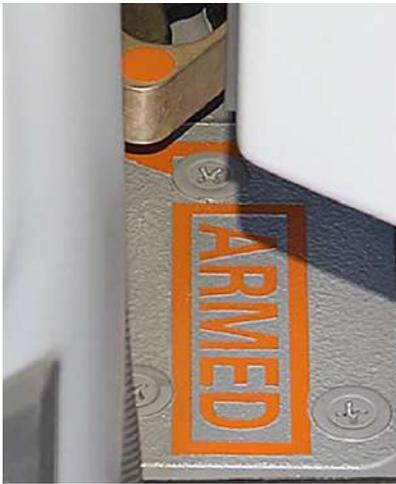
(fig.3)

Girt Bar Floor Indicator on A320 Family aircraft

For A320 Family aircraft, Girt Bar Floor indicators at doors 1 and 4 provide an additional visual indicator to aid crew awareness of the slide's arming condition **(fig.3)**. When the door is armed the indicator (orange spot) aligns with an arrow. ■

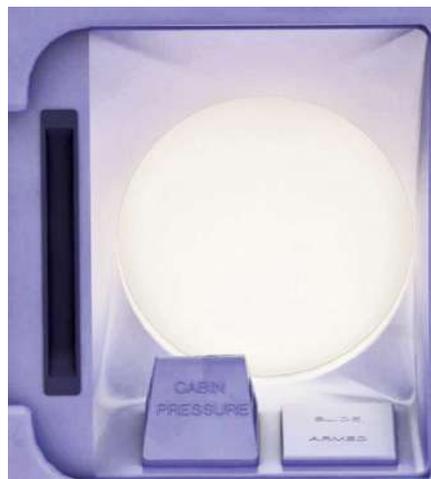
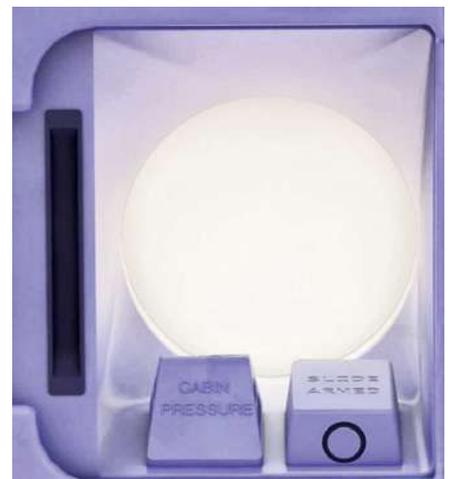
(fig.4)

Example of pre and post-modification ISDPL

Standard Slide Armed Warning Light

ISDPL

ISDPL is a maintenance free plug & play replacement to the standard Slide Armed Warning Lights, which are installed under the passenger door window **(fig.4)**.

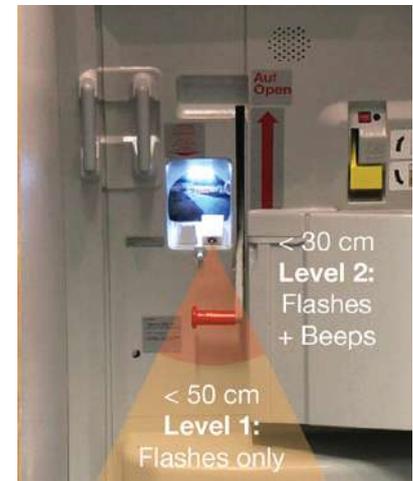
(fig.5)

The levels of warning generated by ISDPL depend on proximity to the detection sensor

As operatives approach the door, warnings are triggered. Two different warning levels occur, depending on the person's proximity to the ultrasonic detection device, located near the door handle **(fig.5)**.

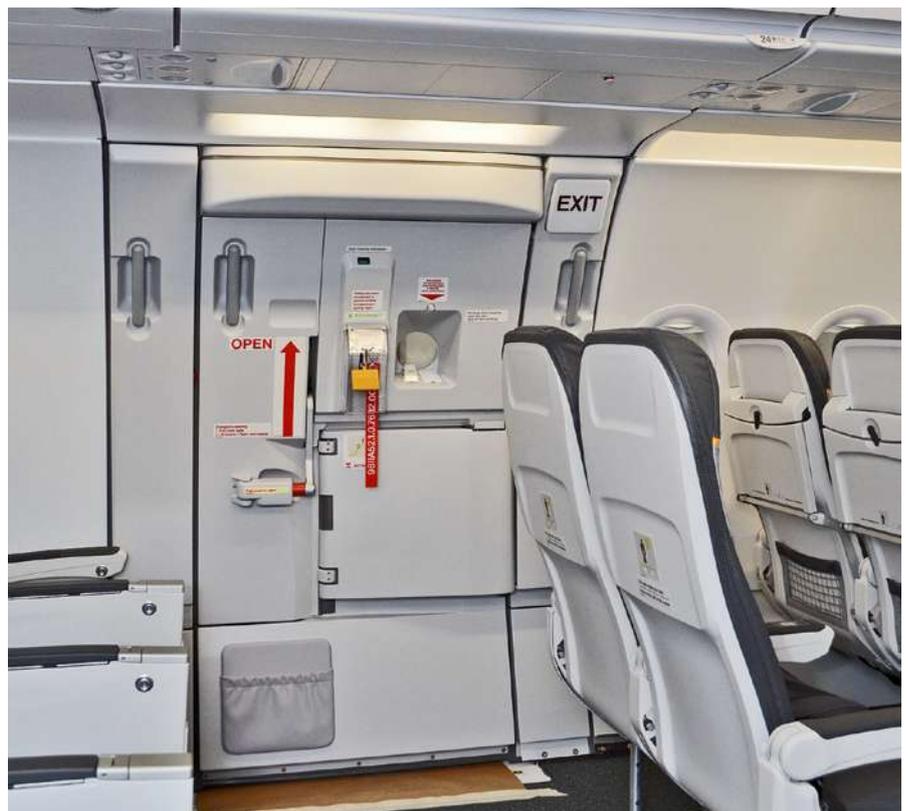
(fig.6)

Example of an A321ceo Emergency Exit Door, installed at Doors 2 and 3. Reports to Airbus indicate that 25% of ISDs on Airbus fleets occur on these doors. Reports indicate that the slides of these doors are sometimes left in the armed condition during turnaround.

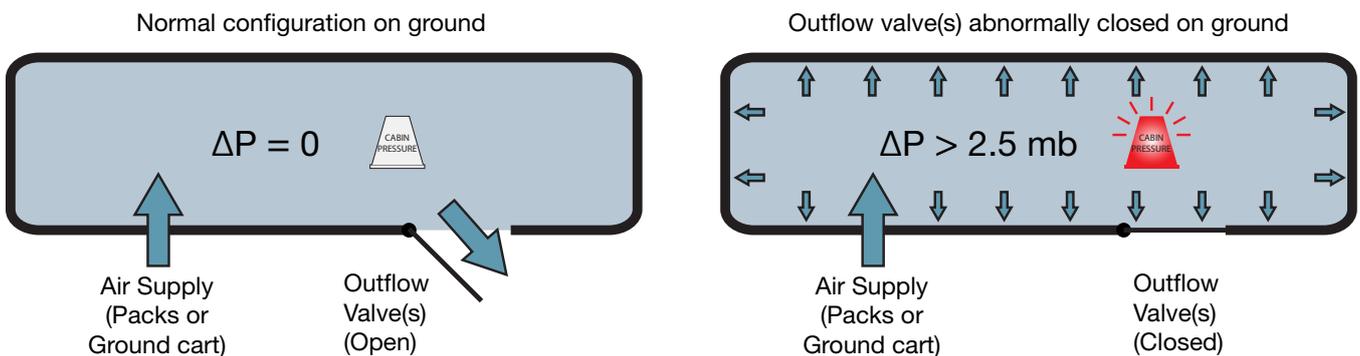
(fig.1)
Normal and abnormal configuration of the outflow valves on ground

After landing, the cabin pressure equalizes with the external air pressure when the outflow valves are fully open (fig.1). There is one outflow valve on the A320 family, two on A300/A300-600/A310/A330/A340 and A350 aircraft, and four on A380 aircraft.

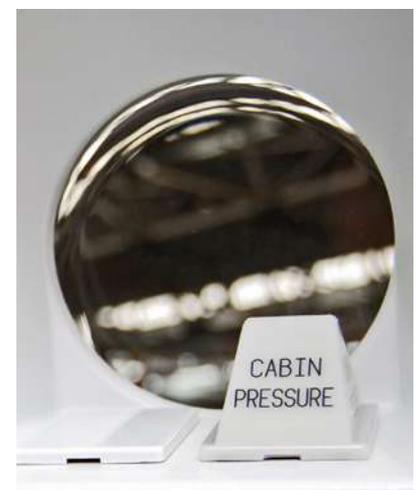
(fig.2)
Cabin door with the residual pressure warning light

The Residual Pressure Warning Light (**fig.2**), part of the residual pressure warning function, warns anyone who wants to open a door if the aircraft is pressurized. This device is installed on all Airbus aircraft except for some A300, A310 and A300-600 where it was offered as an option. On these aircraft not fitted with the warning light, a caution placard located on the door reminds the operator of the risk that residual pressure may cause violent door opening.

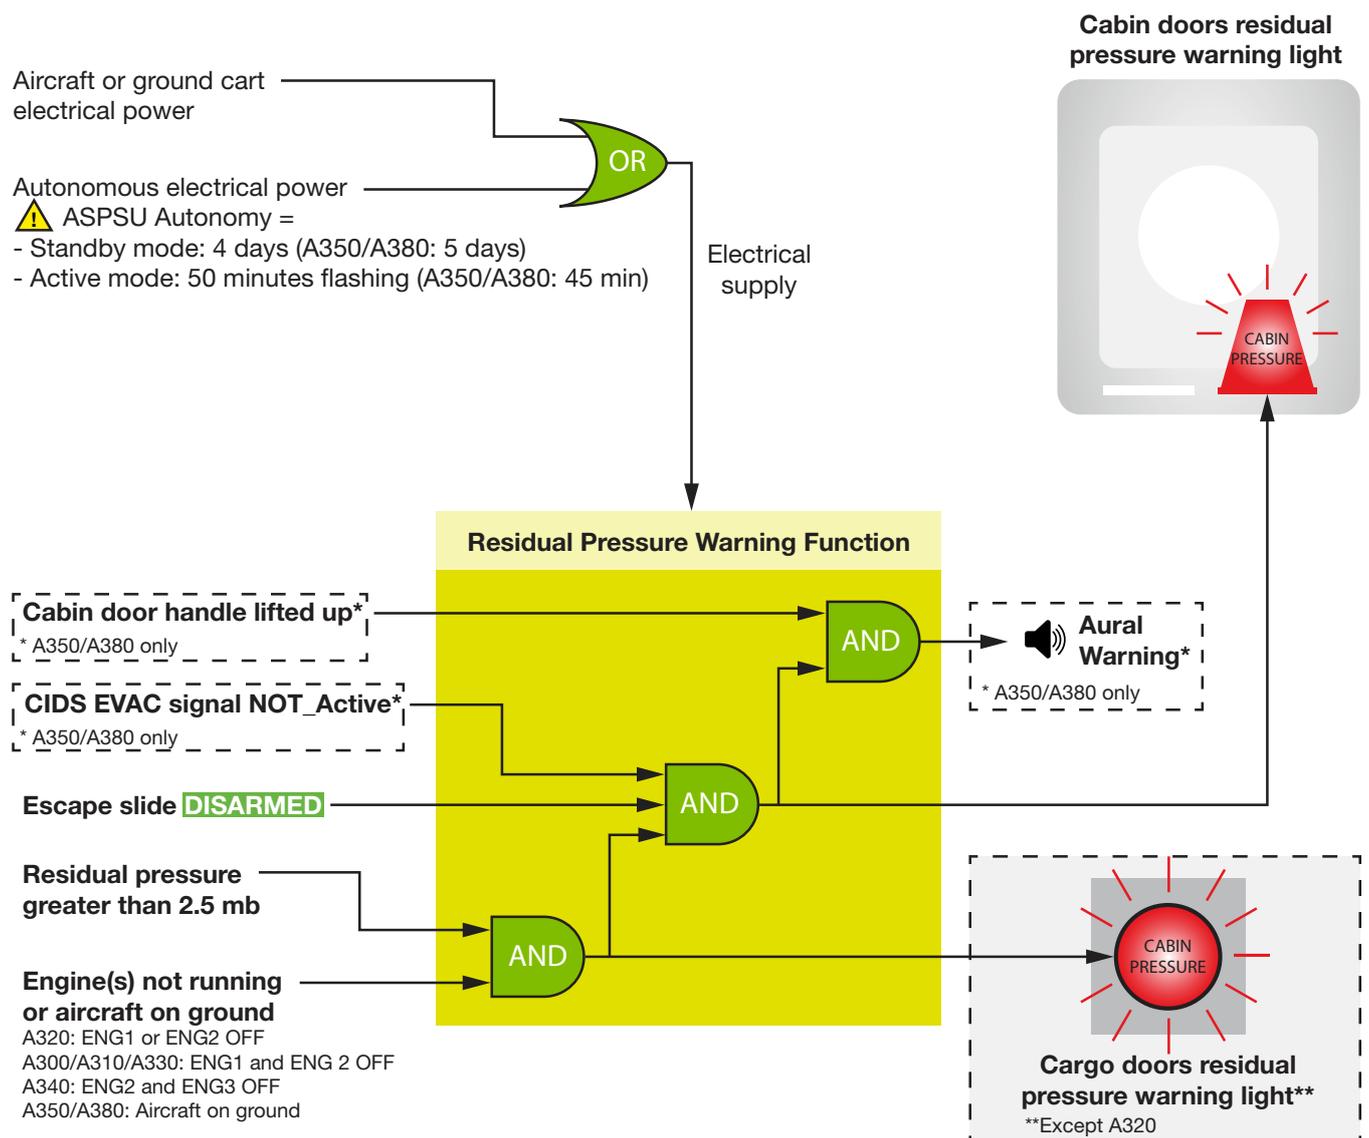
(fig.3)

Residual pressure warning function activation logic

The Residual Pressure Warning Light flashes if the following conditions are met at the same time **(fig.3)**:

In the case of an emergency evacuation, due to the logic of the system, the residual pressure warning light will not flash as long as the slides are **ARMED** (**fig.3**).

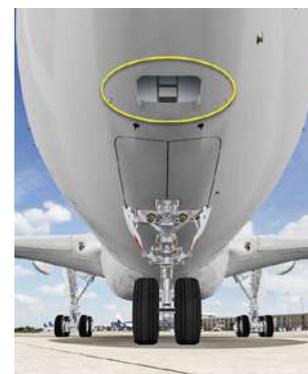
(fig.4)

A350 Outflow valve in the open position

If the Residual Pressure Warning Light is seen flashing from the outside of an aircraft, the position of the outflow valves should be checked (**fig.4**). If outflow valves are observed closed, the ground staff should remove any connected external air source and check if an inward opening door, such as the forward avionics compartment door (**fig.5**) can be opened. If the avionics door cannot be opened, residual pressure still remains. The operator should then wait until the pressure dissipates by leakage.

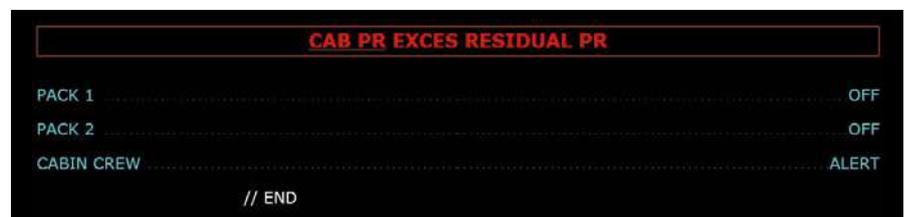
(fig.6)

A320 **CAB PR EXCES RESIDUAL PR** ECAM Warning

In addition to the residual pressure warning function, the **CAB PR EXCES RESIDUAL PR** ECAM warning (**fig.6**) triggers if residual pressure is detected in the cabin after landing and the engines are switched off. The flight crew must follow the ECAM procedure, alert cabin crew and ground crew about the situation, and advise them not to operate the aircraft doors. ■

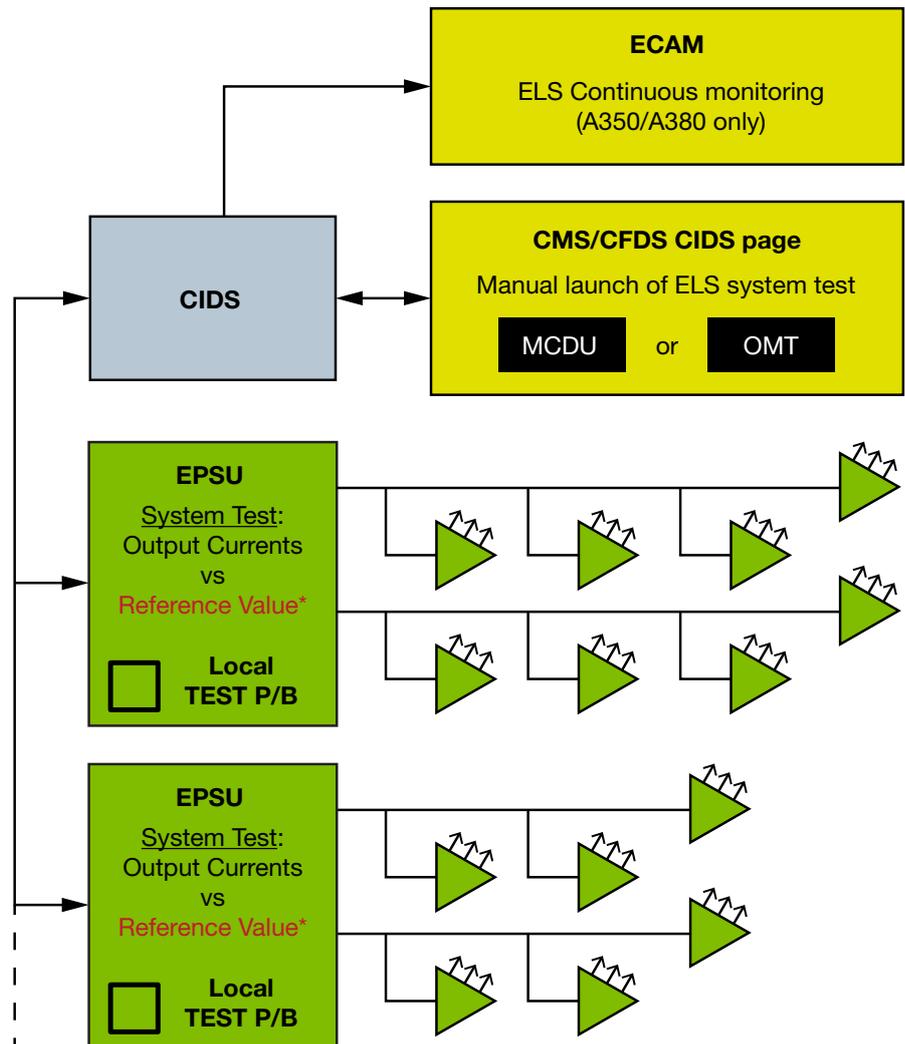
(fig.1)

Emergency Light System Test is triggered centrally from the MCDU/OMT or locally on the EPSU TEST P/B (pushbutton).

The Emergency Light System Test is triggered either centrally from Multifunction Control Display Unit (MCDU on A320/A330/A340 family aircraft), Onboard Maintenance Terminal (OMT for A350XWB/A380) or locally on the EPSU itself (**fig. 1**). The EPSU starts a test routine that includes a self-test and a test of all the electrical components connected to it, including its battery and the emergency lights.

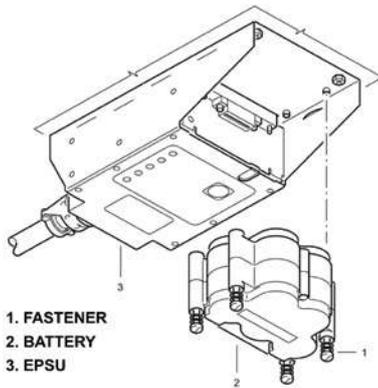
(fig.2)

EPSU with battery removed – The “Teach-In” function will activate when 28V DC power is available on the aircraft and the battery is reinstalled.

Teach-In starts automatically on A320/A330/A340 family aircraft, and for A380 aircraft, when an EPSU is connected to an aircraft which is powered, or when a battery pack is reconnected to the EPSU **(fig.2)**. On A350XWB aircraft, the Teach In is manually triggered by pressing the test button on the EPSU for more than 5 seconds.

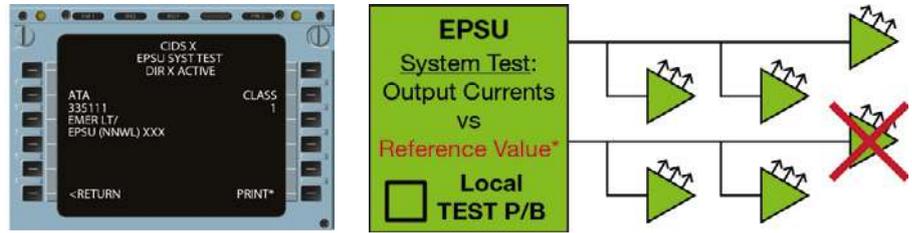
(fig.3)

Emergency Light System Fault – DO NOT USE TEACH-IN FUNCTION TO CLEAR A FAULT.

After the Teach-In procedure is completed on the EPSU, it will no longer detect the defect is present and a fault message will not be displayed. The defect is effectively hidden from the system test because the EPSU has stored a new reference value that was measured with the defective component in the system **(fig.3)**.

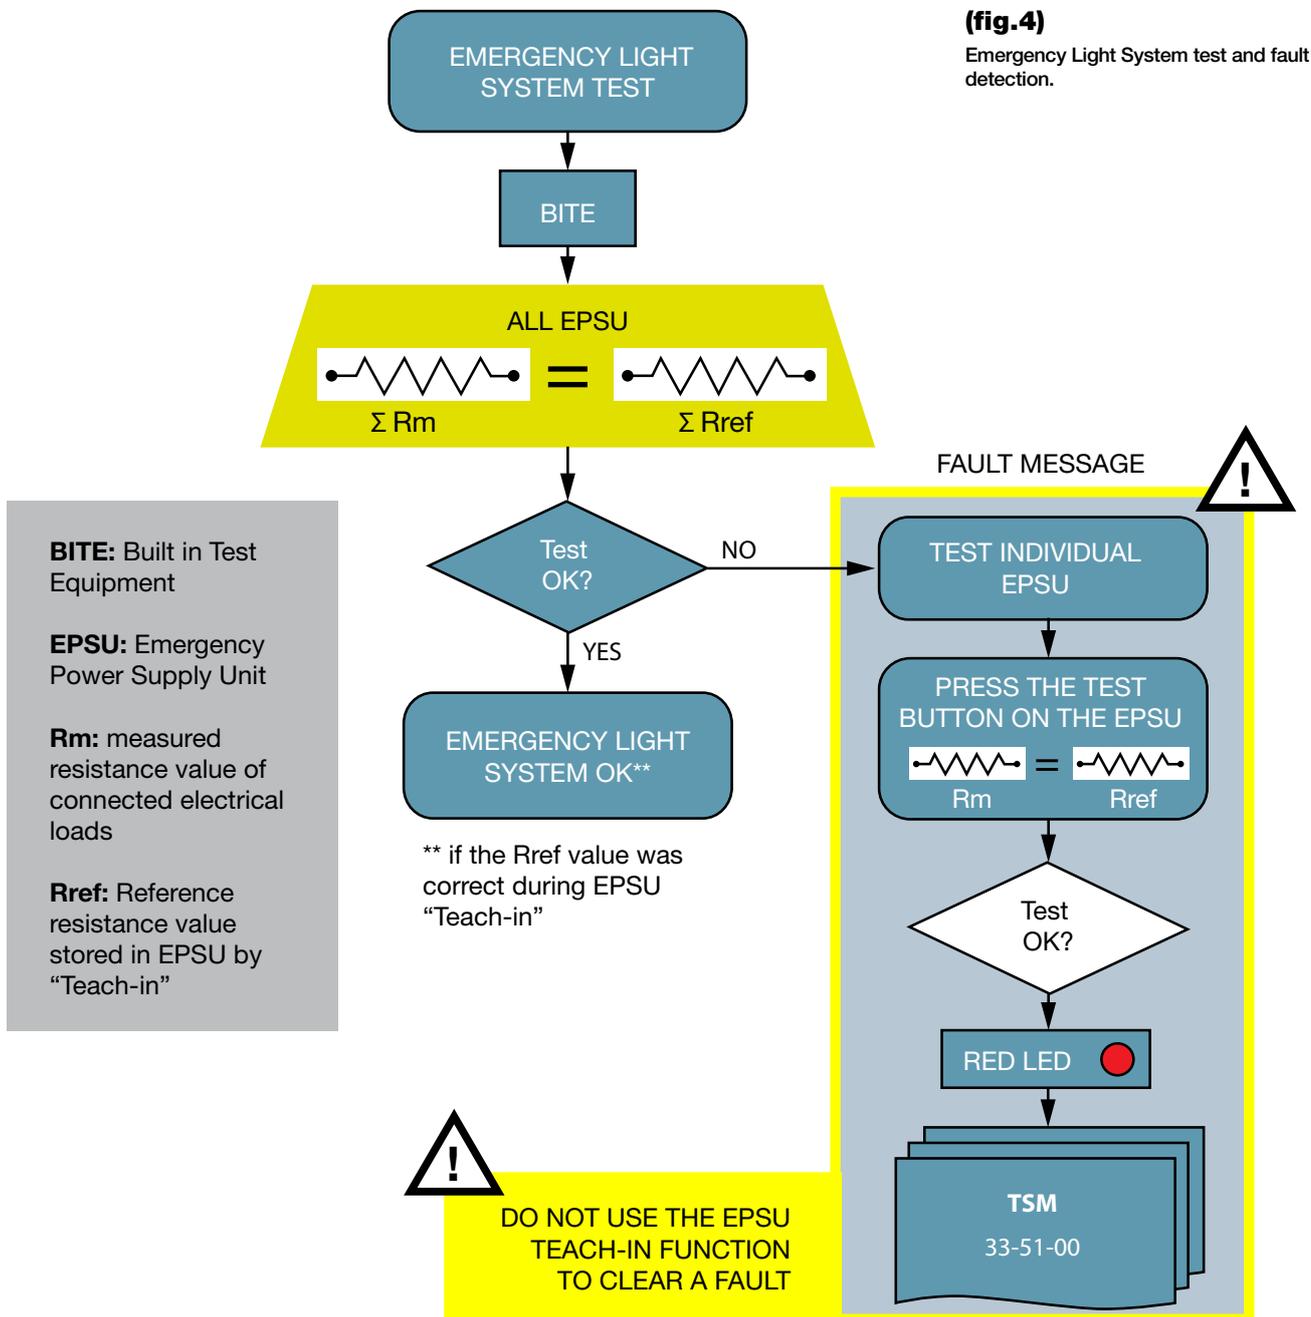
On A350XWB and A380 aircraft, a continuous system monitoring compares the electrical loads at the outputs of the EPSU with a stored reference value during its previous Teach-In process. If the measured electrical load deviates from the stored reference value, a maintenance message (or “dispatch message” for A350XWB aircraft), will appear to alert Flight crew and maintenance of a defect in the aircraft’s Emergency Lighting System **(fig.4)**. In this case, refer to the Troubleshooting procedure in TSM & AMM/MP 33-51-00 and DO NOT use the EPSU Teach-In process to clear the fault.

3. System Test

Emergency Light System test is carried out by maintenance personnel in accordance with AMM/MP 33-51-00. This will manually launch the system monitoring described above (for System BITE monitoring). The LED indicator on the EPSU will advise what components to check to find the cause of the fault.

Teach-In function on the EPSU is not a reset function and it shall not be used to troubleshoot a fault message related to the Emergency Light System. To avoid the risk of dispatching the aircraft in a NO-GO condition, DO NOT use the Teach-In function to clear EPSU failure messages coming from a system test or monitoring. Caution also needs to be taken to ensure that the Teach-In function is not inadvertently activated. This could cause the EPSU to store an incorrect electrical load reference value, and a wrong value may hide any defective emergency lights during the system test.

A pre-requisite prior to activating the Teach-In function is to first check that all of the emergency lights connected to an EPSU illuminate. By correctly configuring the Emergency Lighting System, conducting regular visual inspections and performing scheduled system tests to find and fix defects, it will ensure that all of the aircraft's emergency lights are operational when they are most needed – for lighting the path to the nearest and safest exit for passengers and crew during an emergency cabin evacuation.
