A380: Development of the Flight Controls

Part 2

The Lateral Flight Control Laws

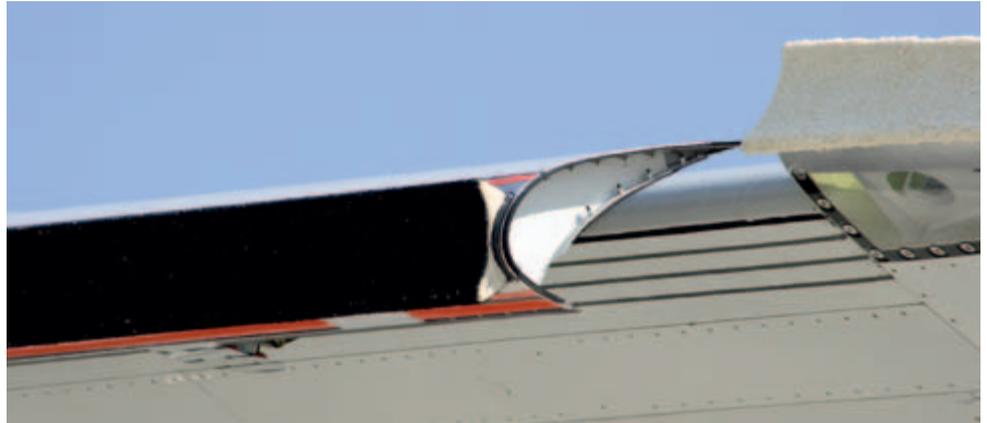
The ice shapes are then manufactured. They are made of polystyrene with some additional particles glued on in order to simulate the granularity of the ice. These shapes have a thickness of three inches, which is considered to be the maximum that an aircraft will keep on a leading edge. The regulations also consider that the de-icing system may fail. In this failure case, the relevant part of the wing is equipped with a smaller ice shape, as the crew will follow the procedures to leave the icing area, and therefore will accumulate a smaller

Figure 1
*Polystyrene shapes
simulating ice
accretion*

amount of ice. These ice shapes are then glued on the leading edge for the duration of the tests.

On the A380, on each wing, the slats are divided in seven sections and only slat 4, close to the outer engine, on the fuselage side, is de-iced. Within the flight test team, we were convinced that this de-icing was not necessary. What could be the effect of a couple of inches of ice on such a huge leading edge? This design change could save around sixty kilograms of weight (about half a passenger!). Therefore we decided to start the tests with a configuration without the de-icing, which means with the three inches leading edge ice shapes on all the wings, including slats 4.
